Inspection Report (On-Highway Flatbed Truck)

| B&B Stock Number | A8948586 |
| Year | 2009 |
| Make | Mack |

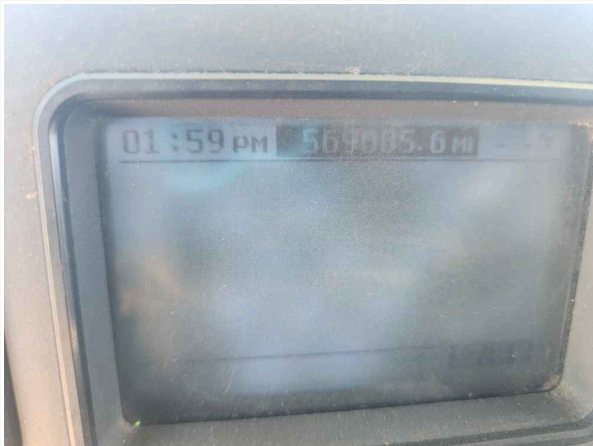
| Odometer | |

| Odometer Reading | 569085.6 |

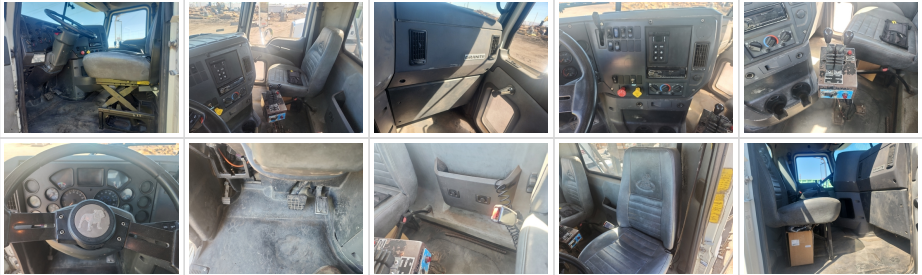
| Cab Interior Photos | |

| Comments | odometer is good just a little hard to see through dash screen, dirty |
| Comments | battery light on. |

| Seats/Seat Belt | Seat belt has nicks, cuts, holes, or fraying |

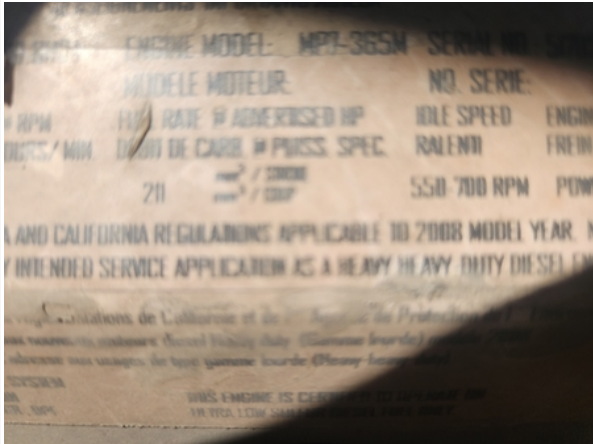
| Engine Data Plate | | | | | |

| Engine Type (Make, Model, Cylinders, Hp) | MACK MP7, 6 cylinder. 335hp @ 2000rpm | | | | |

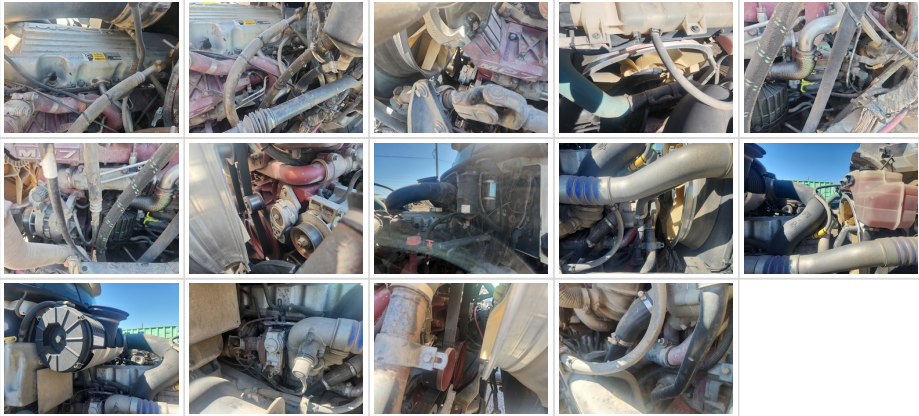
| Engine Compartment Photos | | | | | |

| Hose Condition | Leaks in one or more hoses or fittings observed |
| Comments | turbo lines leaking, ac fitting is damp, |
| Oil Leak Notes | Wet areas with drops forming due to oil leakage |
| Overall Engine Appearance | Areas of dried seepage seen on engine hoses & components |
| Overall Engine Comments | Overall good condition, signs of slow engine oil leaks |

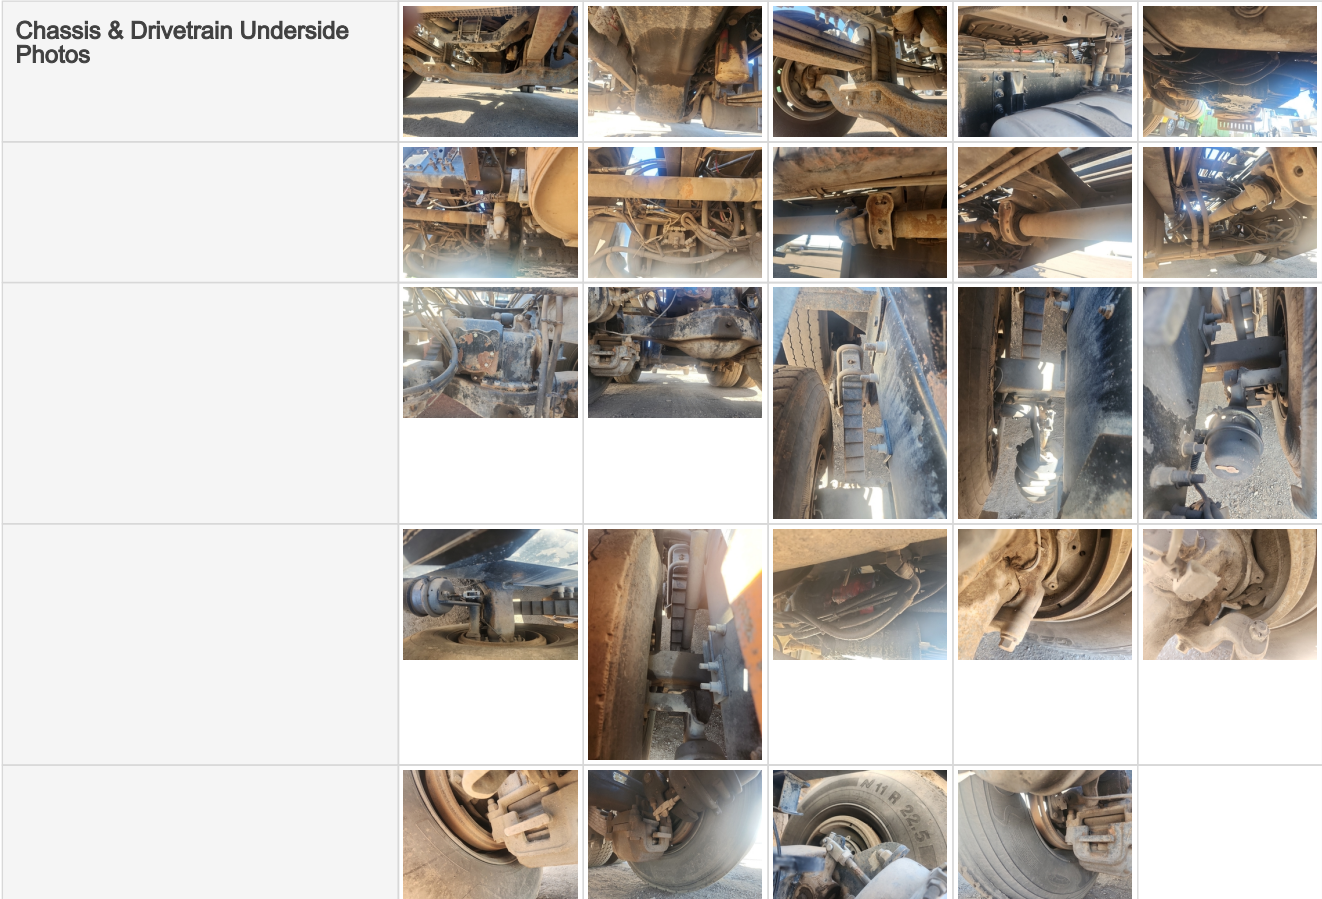
Chassis & Drivetrain Photos

| Transmission Condition | Leaking transmission fluid observed |
| Comments | pto appears to be leaking |

| Front Differential Condition | Dried seepages seen on differential housing cover |
| Overall Drivetrain Comments | Appears to have some active leaks. |

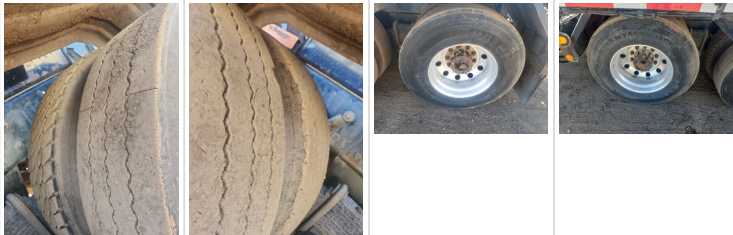
| Rear Left Tire Photos | |

| Rear Left Tire - Ratio Remaining | 50% |
