Inspection Report (Forklift)

B&B Stock Number	A8539608
Year	2008
Make	Caterpillar
Model	P5000-LP
Serial Number	AT3511482
Serial Plate Photo

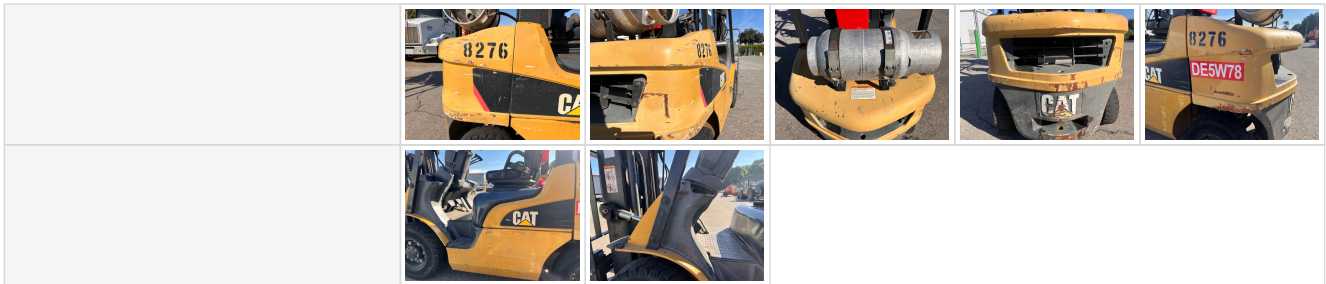
Glass	0	
Mirrors	1 - Service Required	
Mirror Condition	One or more mirrors are broken or missing	
Exterior Lights	3 - Normal Wear & Tear	
Overall Exterior	3 - Normal Wear & Tear	
Comments	Normal wear and tear no major issues to report

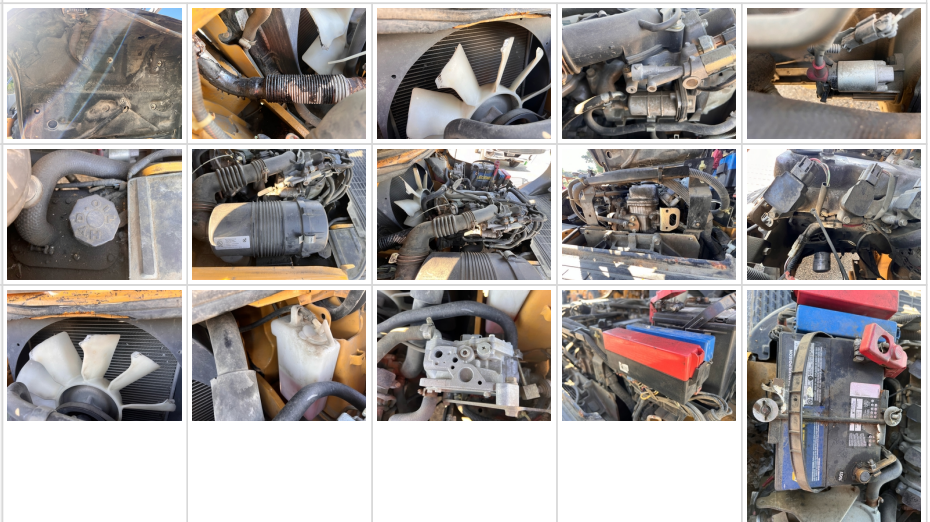
Engine Compartment Photos

Engine Smoke (Upon Start-up, Idle, Shutdown)	No
Engine Exhaust Color	Clear
Battery	3 - Normal Wear & Tear
Radiator	3 - Normal Wear & Tear
Belts	3 - Normal Wear & Tear
Hoses	3 - Normal Wear & Tear
Water Pump	3 - Normal Wear & Tear
Cooling System Leaks	No
Coolant Appearance	3 - Normal Wear & Tear
Oil Leaks	No
Oil Appearance	3 - Normal Wear & Tear
Fuel Leaks	No
Equipped with DPF (Diesel Particulate Filter)	No
Requires DEF (Diesel Exhaust Fluid)	No
Overall Engine Rating	3 - Normal Wear & Tear
Overall Engine Appearance	Areas of dried seepage seen on engine hoses & components
Overall Engine Comments	Areas of dry seepage found throughout engine compartment

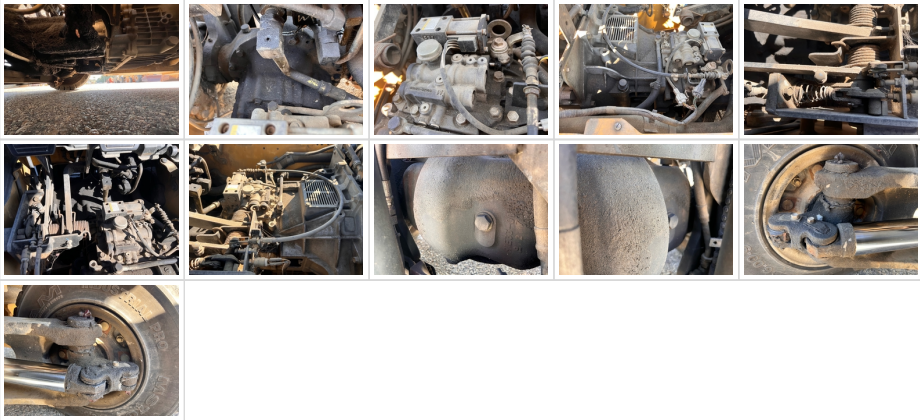
Drivetrain Photos

Transmission Components	2 - Above Average Wear & Tear
Transmission Condition	Other (see comments)
Comments	Dried seepage found throughout transmission components
Drive Motors	0
Parking Brake	3 - Normal Wear & Tear
Overall Drivetrain Rating	2 - Above Average Wear & Tear
Overall Drivetrain Comments	Dry seepage found out transmission components
Front Axle	2 - Above Average Wear & Tear
Comments	Dried seepage found around axle
Rear Axle	0

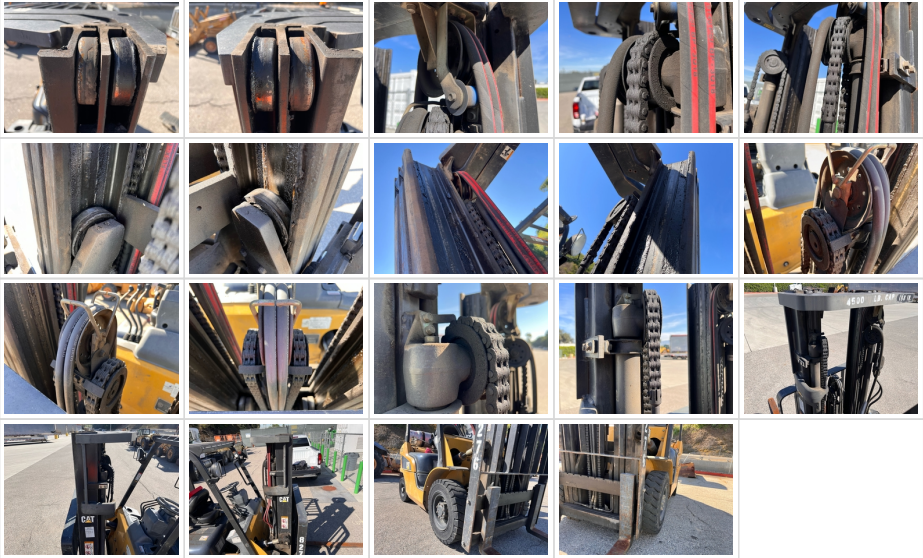
Chassis Photos

Frame	3 - Normal Wear & Tear
Stance	3 - Normal Wear & Tear
Carriage Appearance	2 - Above Average Wear & Tear
Comments	Bent backrest
Mast Condition	3 - Normal Wear & Tear
Chain / Tensioners	3 - Normal Wear & Tear
Rollers & Guides	3 - Normal Wear & Tear
Overall Chassis	3 - Normal Wear & Tear
Overall Chassis Comments	Normal wear and tear no major issues to report

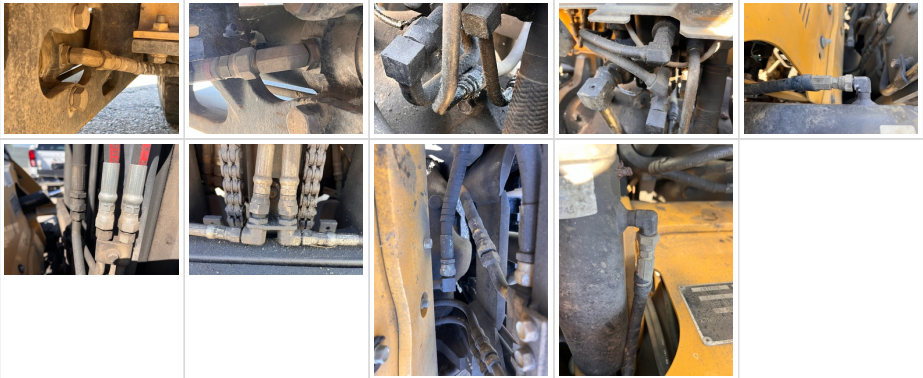
Hydraulic System Photos

Wet or Damp Hydraulic Lines / Fittings	Yes
Hydraulic Lines/Fittings	2 - Above Average Wear & Tear
Hydraulic Lines / Fittings Condition	Dried seepages observed

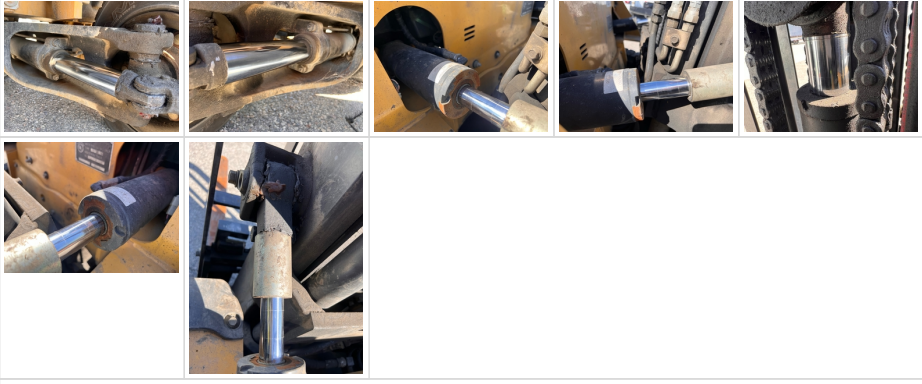
Hydraulic Cylinder Photos

Mounting Pins	3 - Normal Wear & Tear				
Cylinder Oil Leaks	No				
Hydraulic System Overall	2 - Above Average Wear & Tear				
Comments	Dried seepage found on hydraulic hose fittings

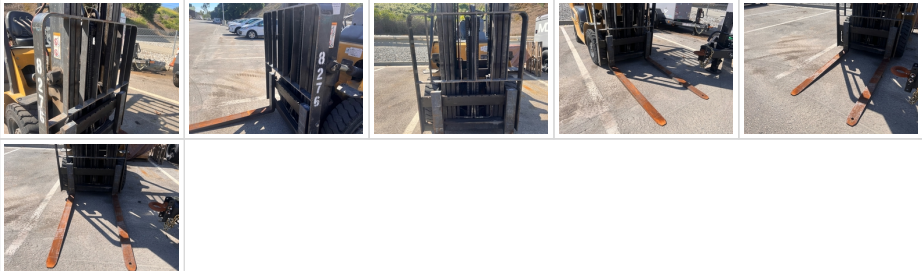
Attachment Condition	2 - Above Average Wear & Tear				
Comments	Hole in left fork				
Attachment Photos

Hydraulic System	3 - Normal Wear & Tear
Electric Operating System	3 - Normal Wear & Tear
Controls	3 - Normal Wear & Tear
Safety Systems	3 - Normal Wear & Tear
Core Functions	3 - Normal Wear & Tear
Attachments	2 - Above Average Wear & Tear
Comments	Hole in left fork
Overall Functional Test Comments	Normal wear and tear no major issues to report
