## Inspection Report (Wheel Loader)

B&B Stock Number	A4060909
Year	2013
Make	Caterpillar
Model	950K
Serial Number	CAT0950KCR4A00783
Serial Plate Photo

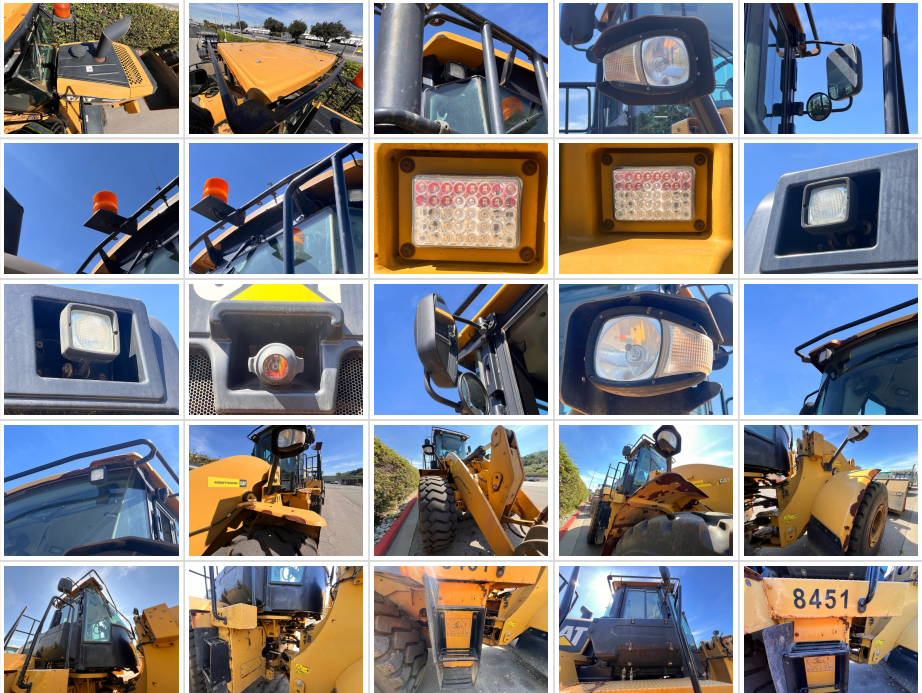
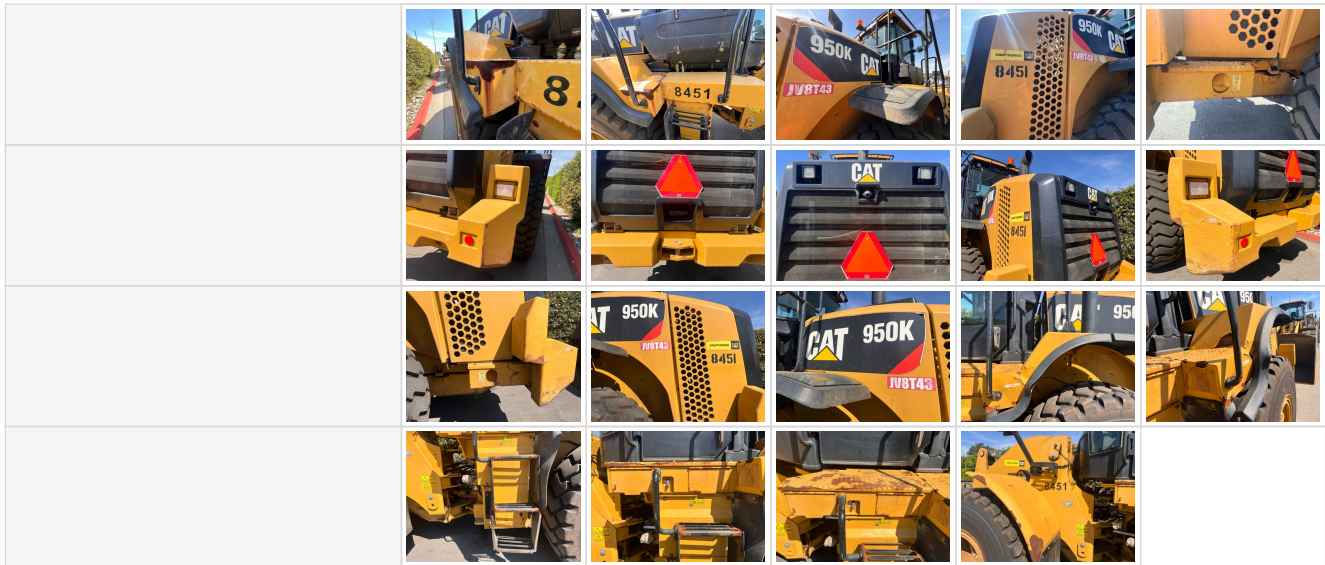
Close-up Exterior Photos

Comments	Rusted steps	
Handrails	2 - Above Average Wear & Tear	
Handrails Condition	Bent or broken railings	
Glass	3 - Normal Wear & Tear	
Mirrors	3 - Normal Wear & Tear	
Exterior Lights	3 - Normal Wear & Tear	
Overall Exterior	2 - Above Average Wear & Tear	
Comments	Areas of rust corrosion throughout exterior of machine, bent steps and bent railing

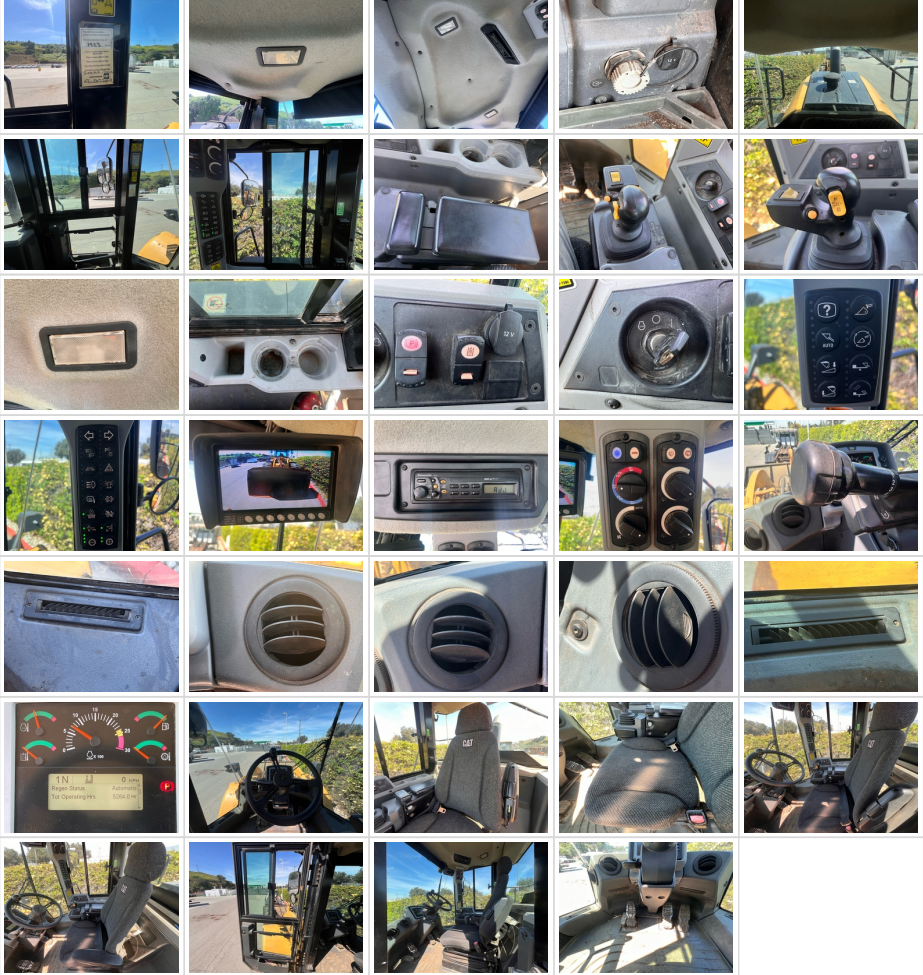
Control Station Photos

Control Station Type	Enclosed Cab (EROPS)
Control Type	Pilot Controls
Control Configuration	N/A
Seat	3 - Normal Wear & Tear
Seat Condition	Seat(s) in good condition, no stains or tears in upholstery, Seat belt secures properly
Cabin Lights	3 - Normal Wear & Tear
Safety Lock Out / Stop	3 - Normal Wear & Tear
Controls & Switches	3 - Normal Wear & Tear
Hour Meter Activity	3 - Normal Wear & Tear
Other Gauge Activity	3 - Normal Wear & Tear
Heater & A/C	2 - Above Average Wear & Tear
Heater & A/C Condition	Only heat functionality works
Travel Alarm	0
Horn	3 - Normal Wear & Tear

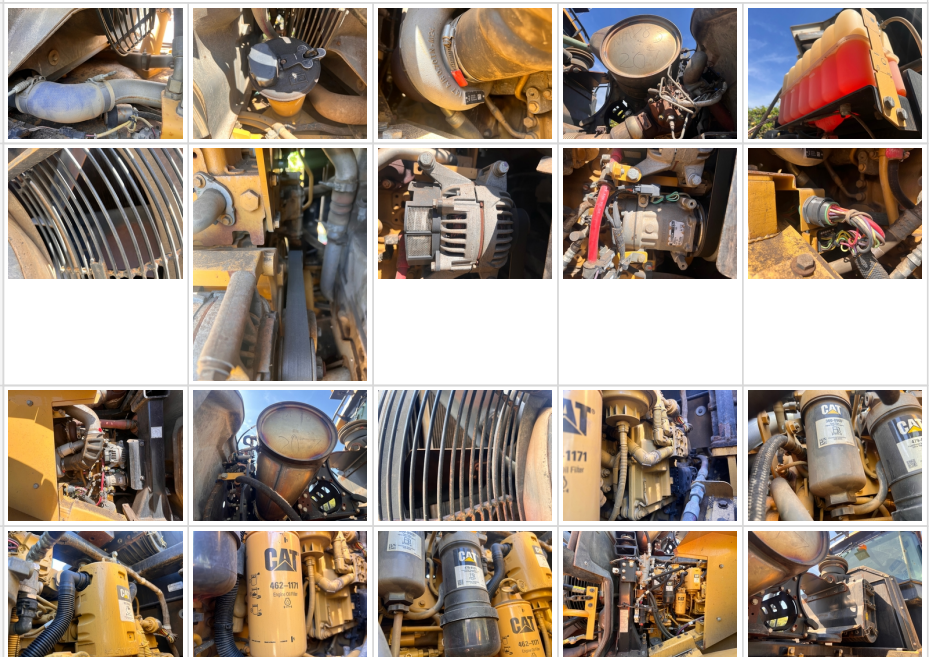
Engine Compartment Photos

Overall Engine Rating	3 - Normal Wear & Tear
Overall Engine Appearance	Dusty & dry
Overall Engine Comments	Normal wear and tear no major issues to report

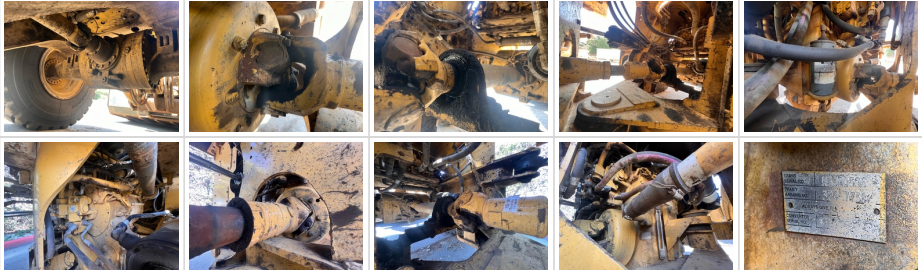
Drivetrain Photos

Hydrostatic Transmission?	No
Transmission Info (Make/Model/Speeds)	N3J00596(serial )
Drive Type	4WD
Transmission Components	3 - Normal Wear & Tear
Parking Brake	3 - Normal Wear & Tear
Overall Drivetrain Rating	3 - Normal Wear & Tear
Overall Drivetrain Comments	Normal wear and tear no major issues to report

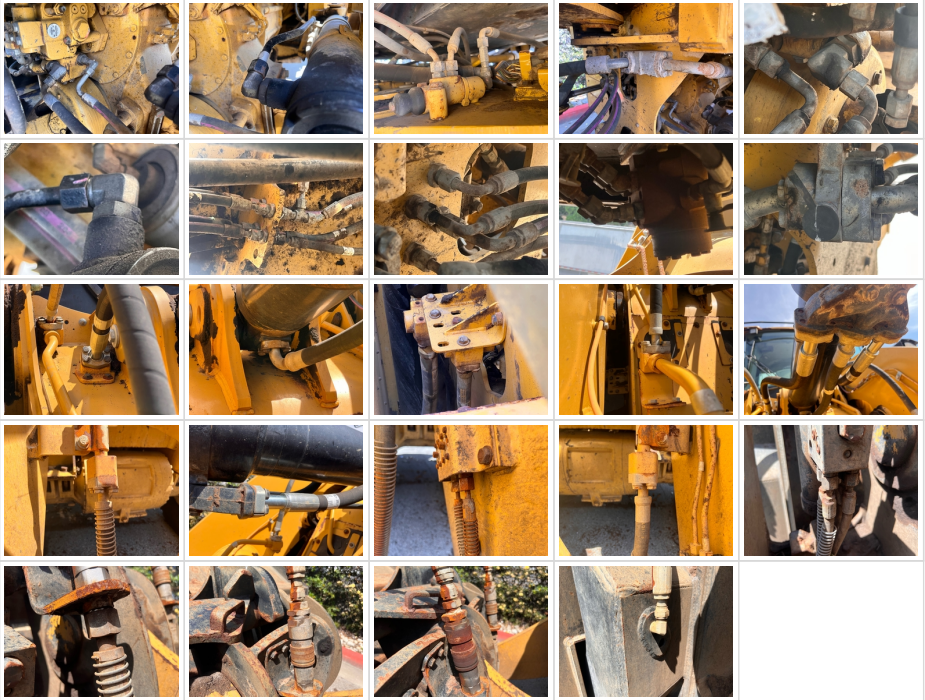
Hydraulic System Photos

Wet or Damp Hydraulic Lines / Fittings	No
Hydraulic Lines/Fittings	2 - Above Average Wear & Tear
Hydraulic Lines / Fittings Condition	Other (see comments)
Comments	Rusted fittings
Hydraulic Pump(s)	3 - Normal Wear & Tear
Unusual Noises	No
Hydraulic Pump Notes	No unusual noises heard during operation
