## Inspection Report (Scissor Lift)

B&B Stock Number	A8912439
Year	2011
Make	JLG
Model	2630ES
Serial Number	0200204446
Serial Plate Photo

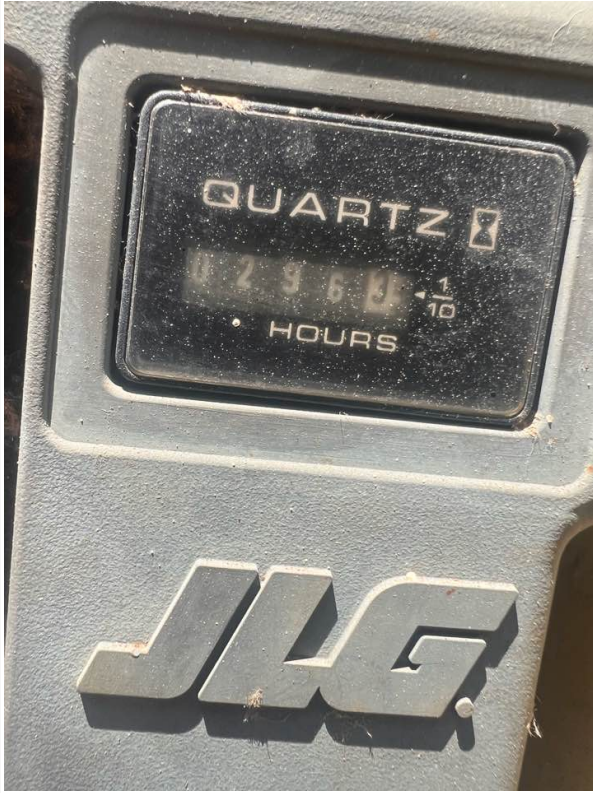
Hour Meter Reading	296.3
Hour Meter Photo

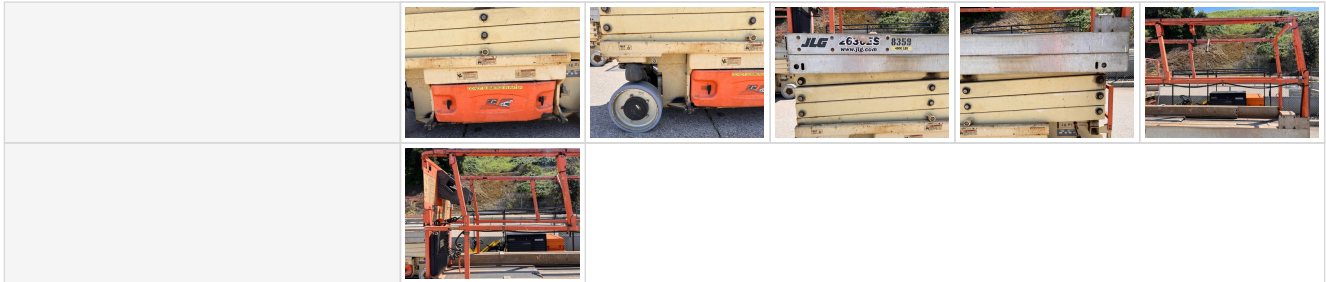
Close-up Exterior Photos	 
--------------------------	--

Handrails	1 - Service Required	
Handrails Condition	Bent or broken railings, Handrails are not structurally sound	
Comments	Hardware missing causing misalignment with deck rails	
Glass	0	
Mirrors	0	
Exterior Lights	0	
Overall Exterior	2 - Above Average Wear & Tear	
Comments	Above average wear and tear. Signs of surface rust. Bent rails.

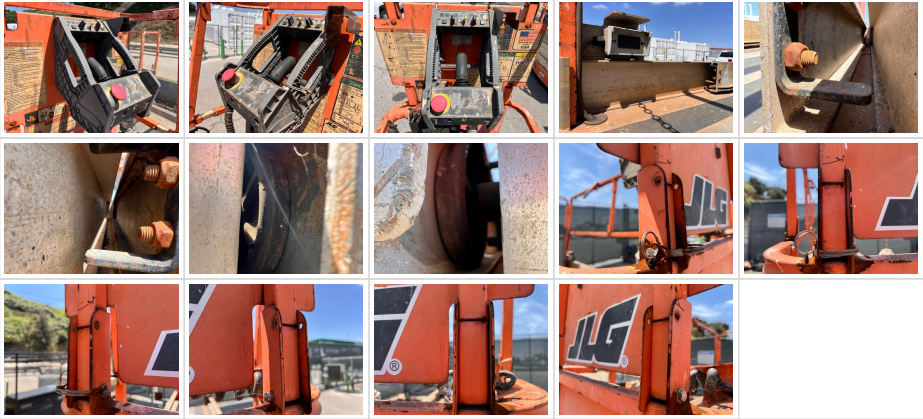
#### Control Station Photos

<b>Control Station Type</b>	Platform
<b>Control Type</b>	Other
<b>Control Configuration</b>	N/A
<b>Seat</b>	0
<b>Cabin Lights</b>	0
<b>Safety Lock Out / Stop</b>	3 - Normal Wear & Tear
<b>Safety Lock Out / Stop Condition</b>	Safety lock out device is present, in good condition, and functional
<b>Controls &amp; Switches</b>	3 - Normal Wear & Tear
<b>Controls &amp; Switches Condition</b>	All switches are installed and functional
<b>Hour Meter Activity</b>	3 - Normal Wear & Tear
<b>Hour Meter Condition</b>	Hour meter is functional and in good condition
<b>Other Gauge Activity</b>	0
<b>Heater &amp; A/C</b>	0
<b>Travel Alarm</b>	3 - Normal Wear & Tear
<b>Travel Alarm Condition</b>	Travel alarm is installed and functioning as expected
<b>Horn</b>	1 - Service Required
<b>Horn Condition</b>	One or more elements of the horn assembly are missing
<b>Backup Camera</b>	0
<b>Control Station Overall Rating</b>	2 - Above Average Wear & Tear

<b>Control Station Overall Condition</b>	Minor cosmetic wear to cabin surfaces, floors, panels, and ceiling
