Inspection Report (Skip Loader)

B&B Stock Number	A5246690
Year	1998
Make	Case
Model	570LXT
Serial Number	JJG0260804
Serial Plate Photo

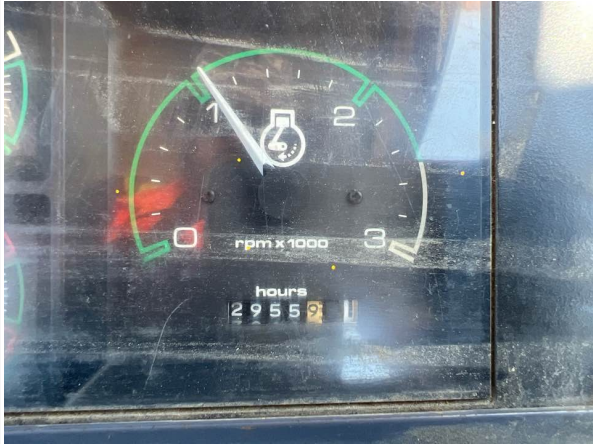
Hour Meter Reading	2955.9
Hour Meter Photo

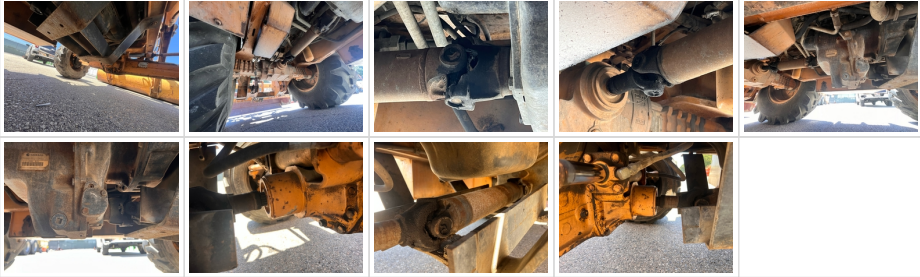
Drivetrain Photos

Hydrostatic Transmission?	No
Drive Type	2WD
Differential Lock	Yes
Transmission Components	3 - Normal Wear & Tear
Parking Brake	2 - Above Average Wear & Tear
Overall Drivetrain Rating	3 - Normal Wear & Tear
Overall Drivetrain Comments	Normal wear and tear no major issues to report

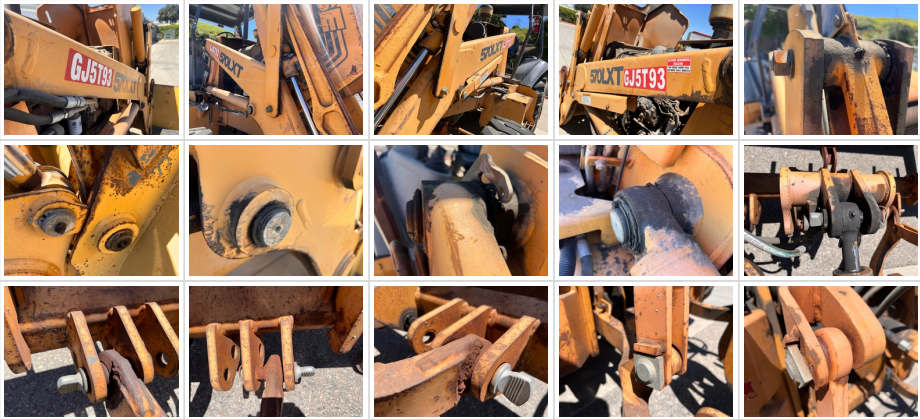
Chassis Photos

Frame	3 - Normal Wear & Tear
Stance	3 - Normal Wear & Tear
Front Axle	3 - Normal Wear & Tear
Rear Axle	3 - Normal Wear & Tear
Oscillating Pin	0
Lift Arm	3 - Normal Wear & Tear
Chassis to Arm Pins	3 - Normal Wear & Tear
Tilt Linkage	3 - Normal Wear & Tear
Tilt Linkage Pins & Bushings	3 - Normal Wear & Tear
Bucket to Arm Pins	3 - Normal Wear & Tear

Overall Chassis	3 - Normal Wear & Tear
Overall Chassis Comments	Norma wear and tear no major issues to report

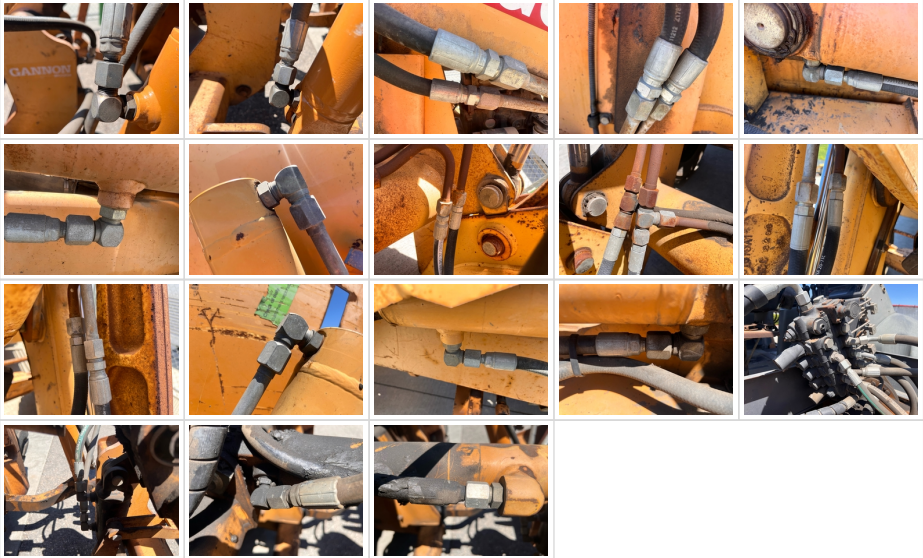
Hydraulic System Photos

Wet or Damp Hydraulic Lines / Fittings	No
Hydraulic Lines/Fittings	3 - Normal Wear & Tear
Hydraulic Pump(s)	3 - Normal Wear & Tear
Unusual Noises	No

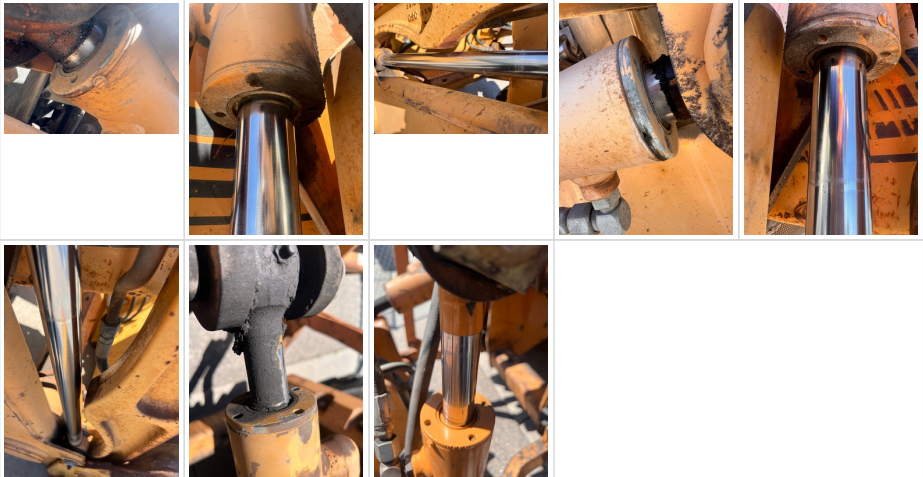
Hydraulic Cylinder Photos

Mounting Pins	3 - Normal Wear & Tear
Cylinder Oil Leaks	No
Hydraulic System Overall	3 - Normal Wear & Tear
