Inspection Report (Scissor Lift)

B&B Stock Number	A7169965
Year	2013
Make	JLG
Model	2630ES
Serial Number	B200012407
Serial Plate Photo

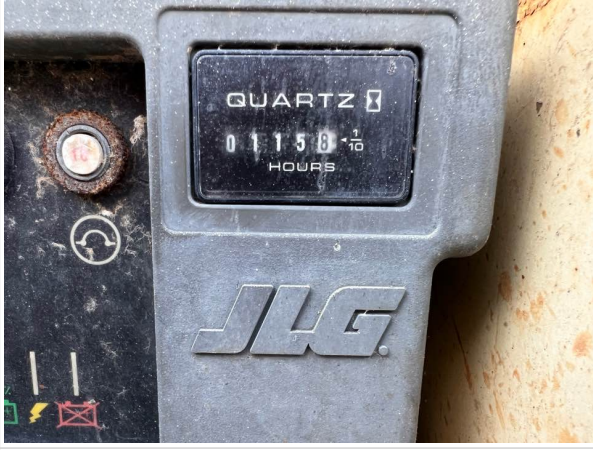
<p>QUARTZ</p> <p>0 1 1 5 8 . 1 6</p> <p>HOURS</p> <p>JLG</p>
Previous Application (e.g., earth moving, mining, demolition, etc)	Sanitation district

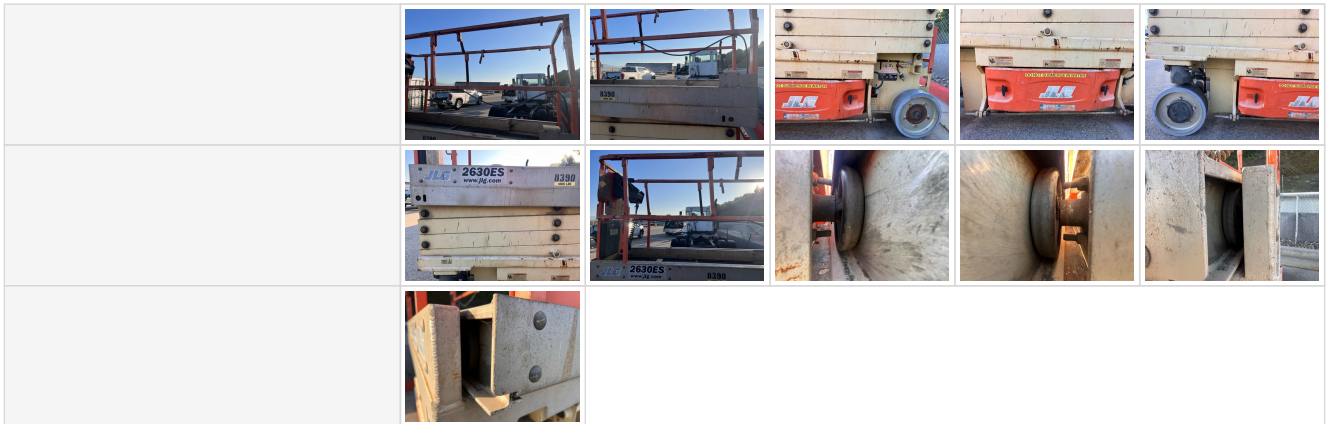
Inspection Rating Criteria	Rating Scale	Explanation
	1 - Service Required	Requires immediate repairs to function as expected.
	2 - Above Average Wear & Tear	Exhibits greater wear than expected given age and usage. While operable, further diagnosis may be needed.
	3 - Normal Wear & Tear	Exhibits wear that is consistent with age and usage. Operation is normal, and as expected.
	4 - Very Light or Minimal Wear	Exhibits very minimal wear. Operation is better than expected given age and usage.
	5 - Like New, Recently Replaced	Excellent condition, free of visible wear or damage. Operation is within factory specifications.
Body Panels	2 - Above Average Wear & Tear	
Body Panel Condition	Visible chipped paint or dents, Areas of surface rust observed	
Doors / Canopy Latches	0	
Steps / Ladders	3 - Normal Wear & Tear	
Steps / Ladders Condition	Steps/ladders are fully intact and appear structurally sound	
Handrails	2 - Above Average Wear & Tear

Handrails Condition	Other (see comments)	
Comments	Loose hardware causing misalignment of rails	
Glass	0	
Mirrors	0	
Exterior Lights	0	
Overall Exterior	2 - Above Average Wear & Tear	
Comments	Surface rust observed, loose hardware, rail misalignment

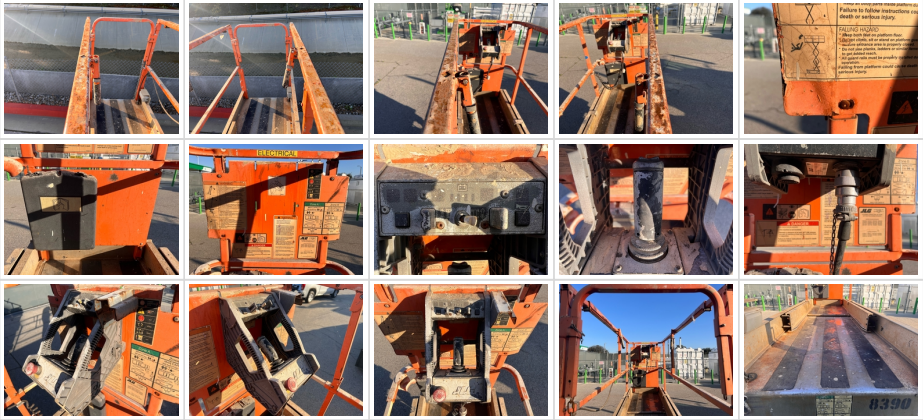
Control Station Photos

Control Station Type	Platform
Control Type	Other
Control Configuration	N/A
Seat	0
Cabin Lights	0
Safety Lock Out / Stop	3 - Normal Wear & Tear
Safety Lock Out / Stop Condition	Safety lock out device is present, in good condition, and functional
Controls & Switches	2 - Above Average Wear & Tear
Controls & Switches Condition	Switches have good functionality, minor cosmetic damage observed
Hour Meter Activity	3 - Normal Wear & Tear
Hour Meter Condition	Hour meter is functional and in good condition
Other Gauge Activity	0
Heater & A/C	0
Travel Alarm	3 - Normal Wear & Tear
Travel Alarm Condition	Travel alarm is installed and functioning as expected
Horn	1 - Service Required
Horn Condition	One or more elements of the horn assembly are missing
Backup Camera	0
Control Station Overall Rating	2 - Above Average Wear & Tear
Control Station Overall Condition	Significant wear and tear to cabin floor, panels, and ceiling

Comments	Deck slides out 3-6 inches while operating machine forward and reverse

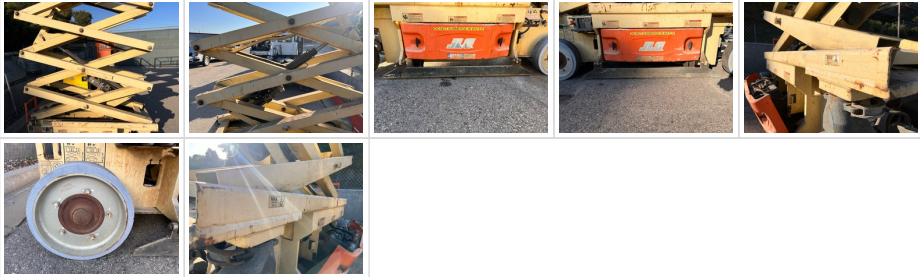
Chassis Photos

Frame	3 - Normal Wear & Tear
Front Axle Appearance	0
Rear Axle Appearance	0
Wheels & Tires	3 - Normal Wear & Tear
Tire Brand	Camso
Tire Size	406x12.5
Front Left Tire - Ratio Remaining	70%
Rear Left Tire - Ratio Remaining	70%
Front Right Tire - Ratio Remaining	70%
Rear Right Tire - Ratio Remaining	70%
Overall Chassis	3 - Normal Wear & Tear

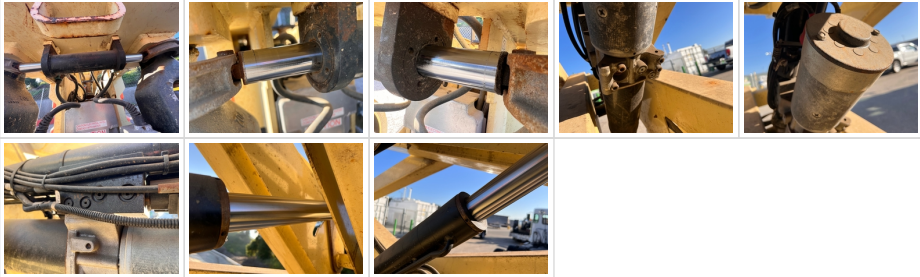
Hydraulic System Photos

Wet or Damp Hydraulic Lines / Fittings	No
Hydraulic Lines/Fittings	3 - Normal Wear & Tear
Hydraulic Pump(s)	3 - Normal Wear & Tear
Unusual Noises	No
Hydraulic Pump Notes	No unusual noises heard during operation
