Inspection Report (Rough Terrain Crane)

| Year | 2010 |
| Make | Link-belt |
| Model | RTC 8050 |

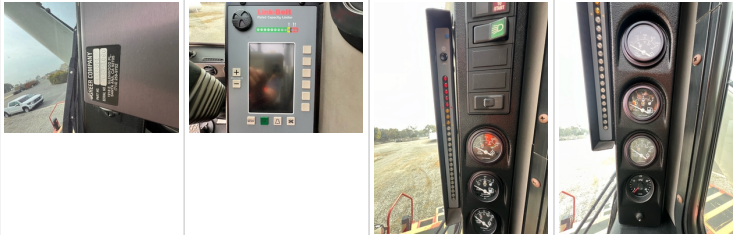
| Load Movement Indicator (LMI) Photos | |

| Load Movement Indicator (LMI) | 3 - Normal Wear & Tear |

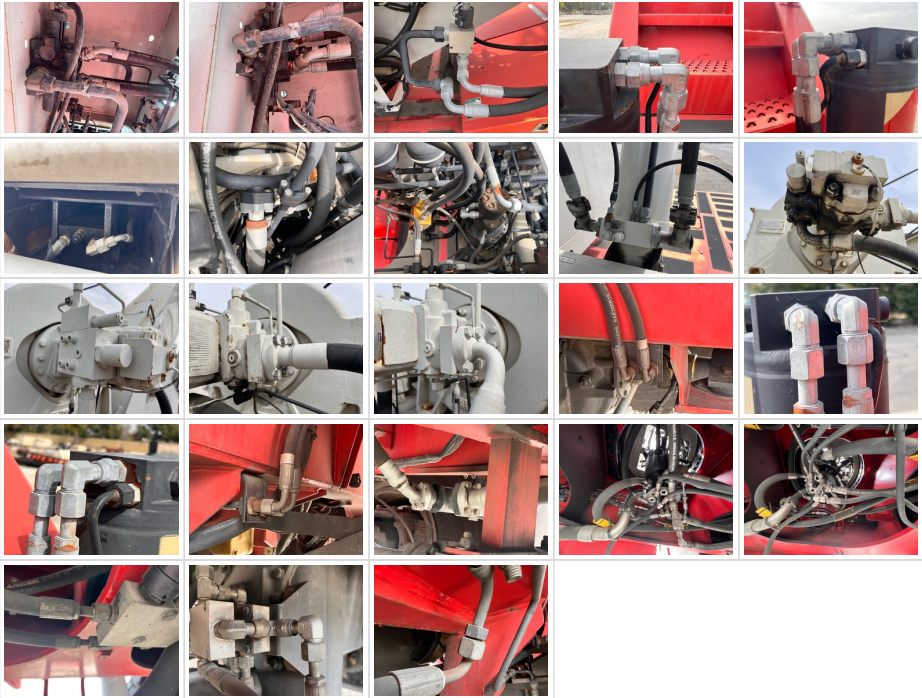
| Hydraulic System Photos | |

| Wet or Damp Hydraulic Lines / Fittings | Yes |
| Hydraulic Lines/Fittings | 2 - Above Average Wear & Tear |
| Hydraulic Lines / Fittings Condition | Dried seepages observed, Twisted, kinked, or flattened hydraulic hoses |
| Comments | Hard line to rear right outrigger bent |

| What Needs Work | The things that need work on this machine are the bent hard line to the rear right outrigger and the areas of dry seepage found around main swivel components |

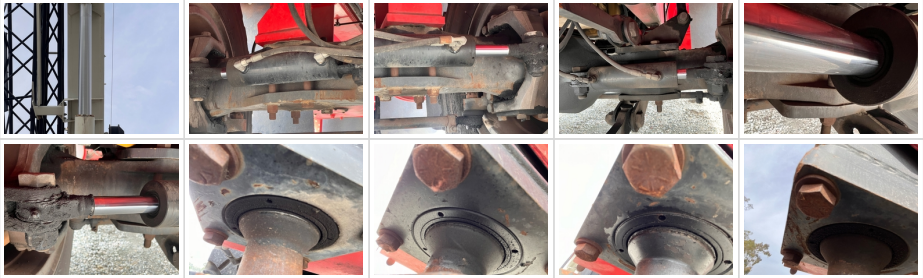
| Hydraulic Cylinder Photos | |

| Mounting Pins | 3 - Normal Wear & Tear |
| Cylinder Oil Leaks | No |

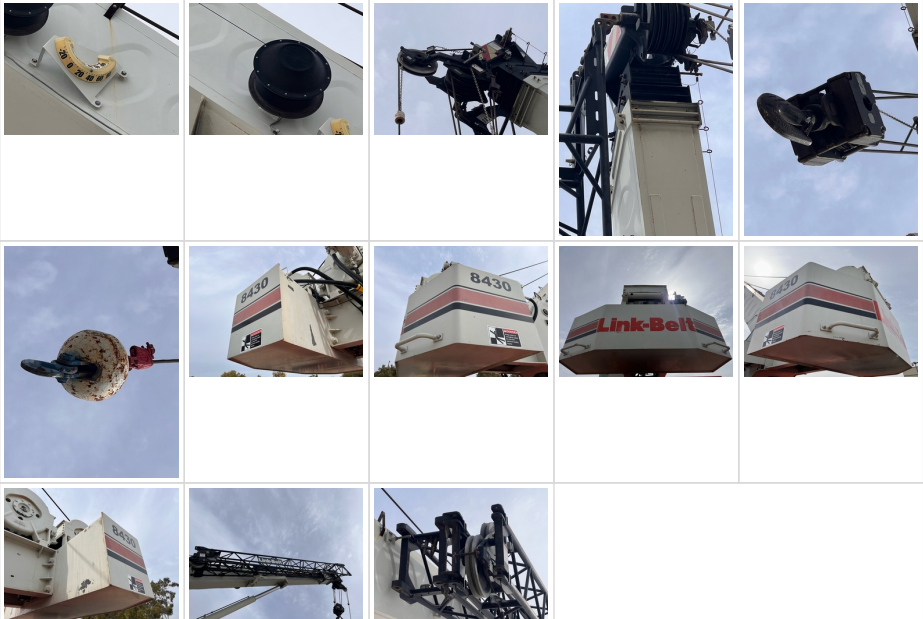
| Crane Component Photos | |

| Counterweight | 3 - Normal Wear & Tear |
| Main Boom Sections | 3 - Normal Wear & Tear |

| Crane Components Overall | 3 - Normal Wear & Tear |
