## Inspection Report (Skip Loader)

B&B Stock Number	A2101830
Year	1994
Make	Case
Model	480F LL
Serial Number	JJG0006140
Serial Plate Photo

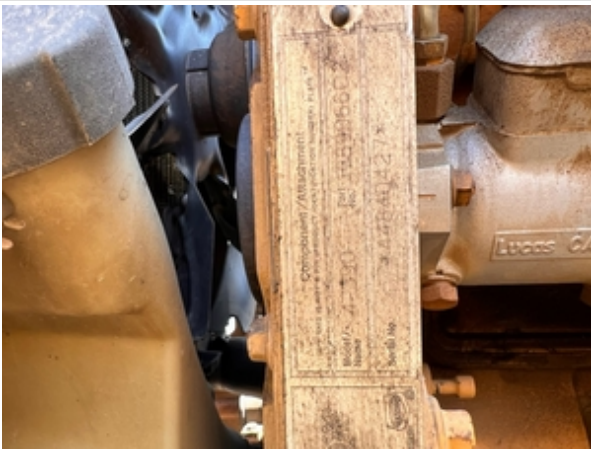
Engine Data Plate

Engine Type (Make, Model, Cylinders, Hp)	Case, 4-390,				
Emissions Tier	Undetermined				
Engine Serial Number	44840427				
Engine Fuel Type	Diesel				
Blow-by (Visual Observation Check)	No				
Unusual Noises (Upon Start-up, Idle, Shutdown)	No				
Engine Smoke (Upon Start-up, Idle, Shutdown)	No				
Engine Exhaust Color	Clear				
Battery	3 - Normal Wear & Tear				
Battery Condition	Clean & dry appearance, tight connections				
Radiator	3 - Normal Wear & Tear				
Radiator Condition	Radiator fins & components appear to be in good working order, no signs of damage or leaks

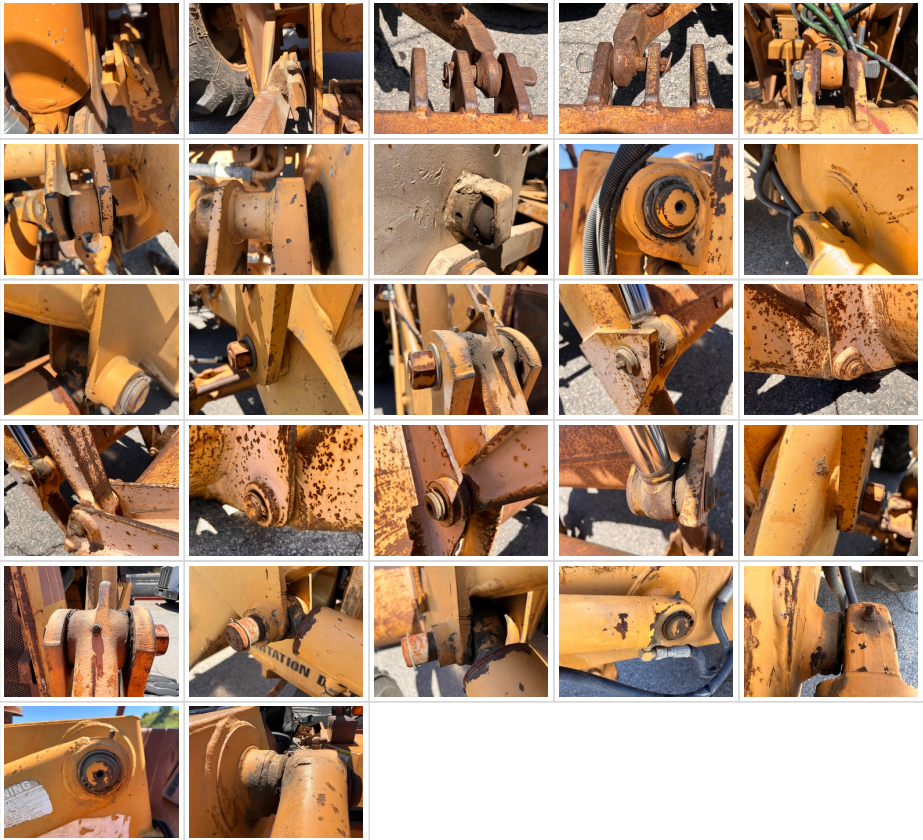
Chassis Photos

Frame	3 - Normal Wear & Tear
Stance	3 - Normal Wear & Tear
Front Axle	3 - Normal Wear & Tear
Rear Axle	3 - Normal Wear & Tear
Oscillating Pin	0
Lift Arm	3 - Normal Wear & Tear
Chassis to Arm Pins	3 - Normal Wear & Tear
Tilt Linkage	3 - Normal Wear & Tear
Tilt Linkage Pins & Bushings	2 - Above Average Wear & Tear
Comments	Component slop noticed due to worn bushings
Bucket to Arm Pins	3 - Normal Wear & Tear
Overall Chassis	3 - Normal Wear & Tear
Overall Chassis Comments	Normal wear, and tear with some noticeable component slop due to worn bushings

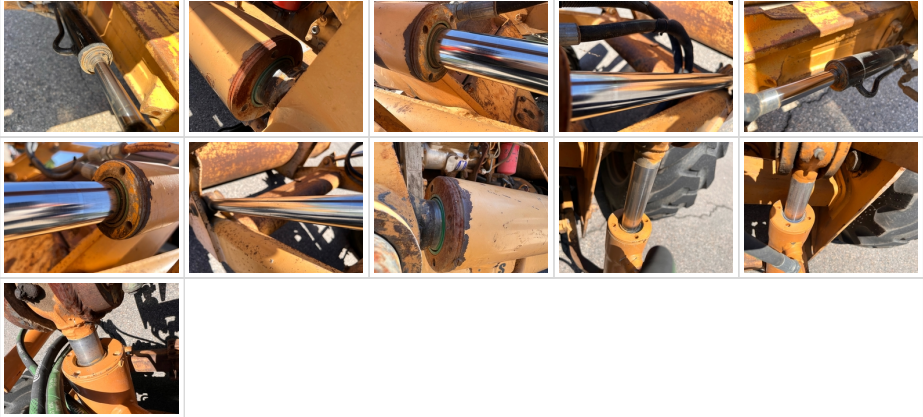
Hydraulic Cylinder Photos

Mounting Pins	3 - Normal Wear & Tear
Cylinder Oil Leaks	No
Hydraulic System Overall	3 - Normal Wear & Tear
