Inspection Report (Wheel Loader)

B&B Stock Number	A8092946
Year	2015
Make	Caterpillar
Model	966M
Serial Number	CAT0966MPKJP01166
Serial Plate Photo

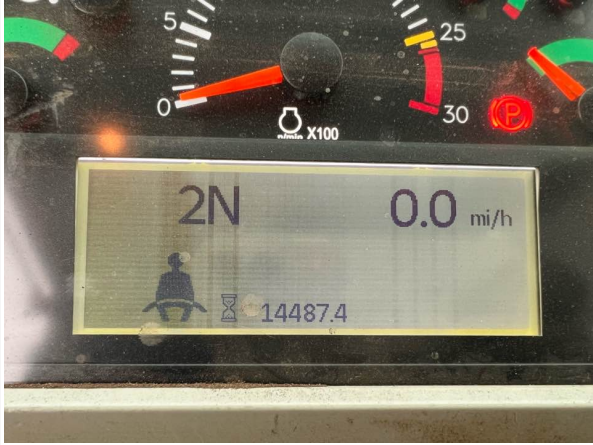
Hour Meter Reading	14487.4
Single Photo

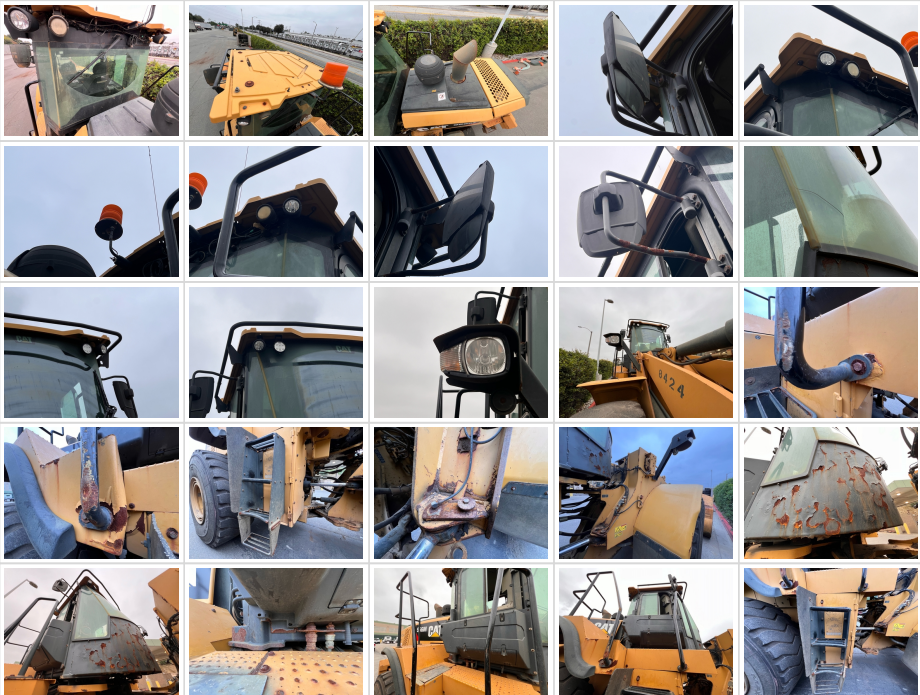
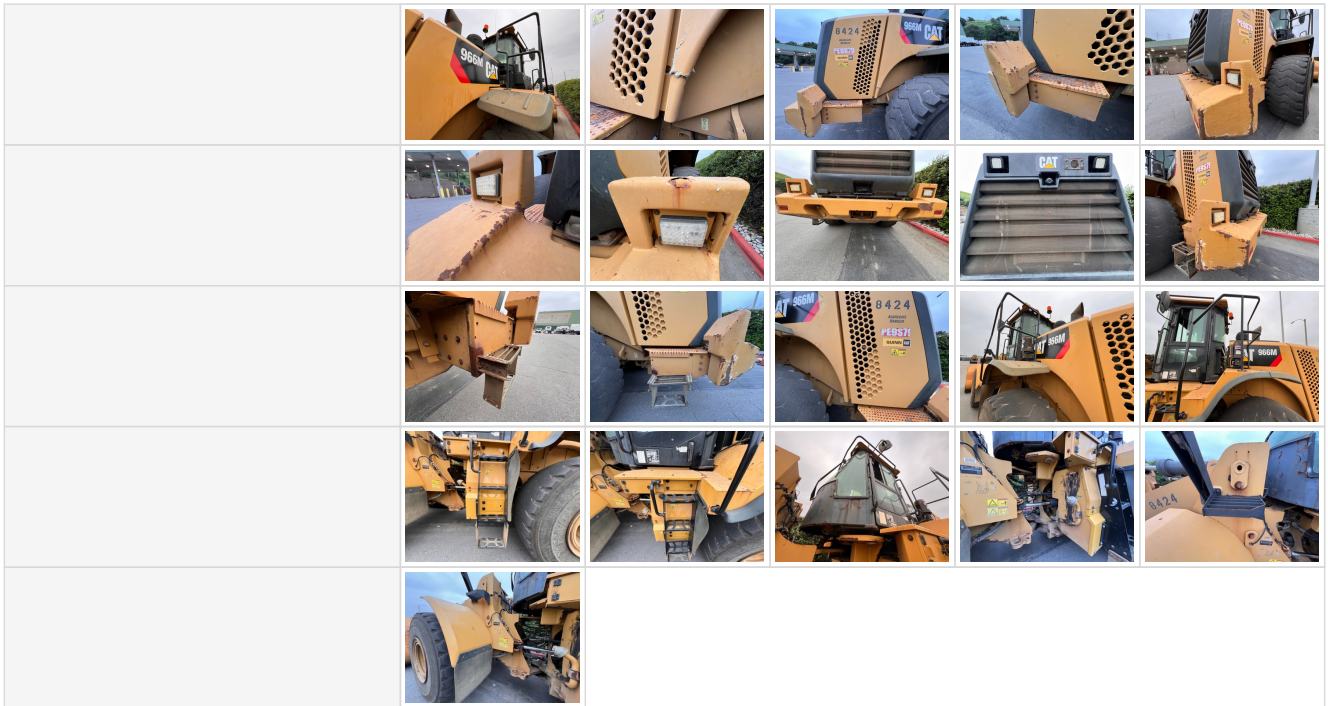
Close-up Exterior Photos

Steps / Ladders	2 - Above Average Wear & Tear	
Steps / Ladders Condition	Bent or broken steps or rungs	
Handrails	2 - Above Average Wear & Tear	
Handrails Condition	Bent or broken railings	
Glass	1 - Service Required	
Glass Condition	Major chips or cracks observed	
Mirrors	2 - Above Average Wear & Tear	
Mirror Condition	Other (see comments)

Comments	Mirror mounts rusted
Exterior Lights	2 - Above Average Wear & Tear
Exterior Lights Condition	Other (see comments)
Comments	Fogged lenses
Overall Exterior	2 - Above Average Wear & Tear
Comments	Above average wear and tear due to corrosion rust observed throughout exterior of machine, bent and damaged handrails and step ladders

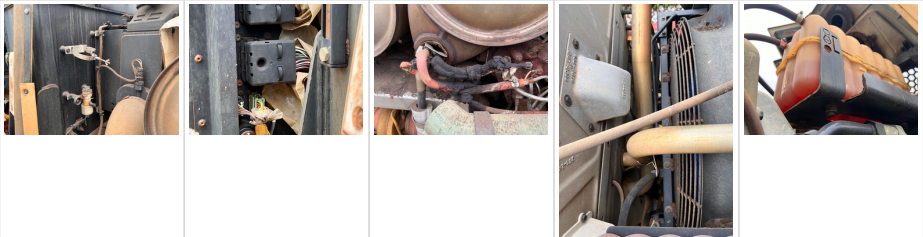
Engine Compartment Photos

Unusual Noises (Upon Start-up, Idle, Shutdown)	Yes
Unusual Noise Notes	Other (see comments)
Comments	Pulley whining noise
Engine Smoke (Upon Start-up, Idle, Shutdown)	No
Engine Exhaust Color	Clear
Battery	3 - Normal Wear & Tear
Battery Condition	Inaccessible, unable to determine condition
Radiator	3 - Normal Wear & Tear
Belts	3 - Normal Wear & Tear
Hoses	2 - Above Average Wear & Tear
Hose Condition	Dried seepages observed
Water Pump	3 - Normal Wear & Tear
Cooling System Leaks	No
Coolant Appearance	3 - Normal Wear & Tear
Oil Leaks	No
Oil Appearance	3 - Normal Wear & Tear
Fuel Leaks	No
Equipped with DPF (Diesel Particulate Filter)	Yes
DPF Condition	2 - Above Average Wear & Tear
DPF Condition Notes	Soot accumulation observed on the DPF outlet face
Requires DEF (Diesel Exhaust Fluid)	Yes
DEF Tank	3 - Normal Wear & Tear
Overall Engine Rating	2 - Above Average Wear & Tear
Overall Engine Appearance	Areas of dried seepage seen on engine hoses & components, Very dirty

Overall Engine Comments	Above average wear and tear due to dried seepage, found throughout engine compartment and engine compartment full of debris
