## Inspection Report (Telehandler)

B&B Stock Number	A8106911
Year	2005
Make	Caterpillar
Model	TH330B
Serial Number	CATTH330ESLB00889
Serial Plate Photo

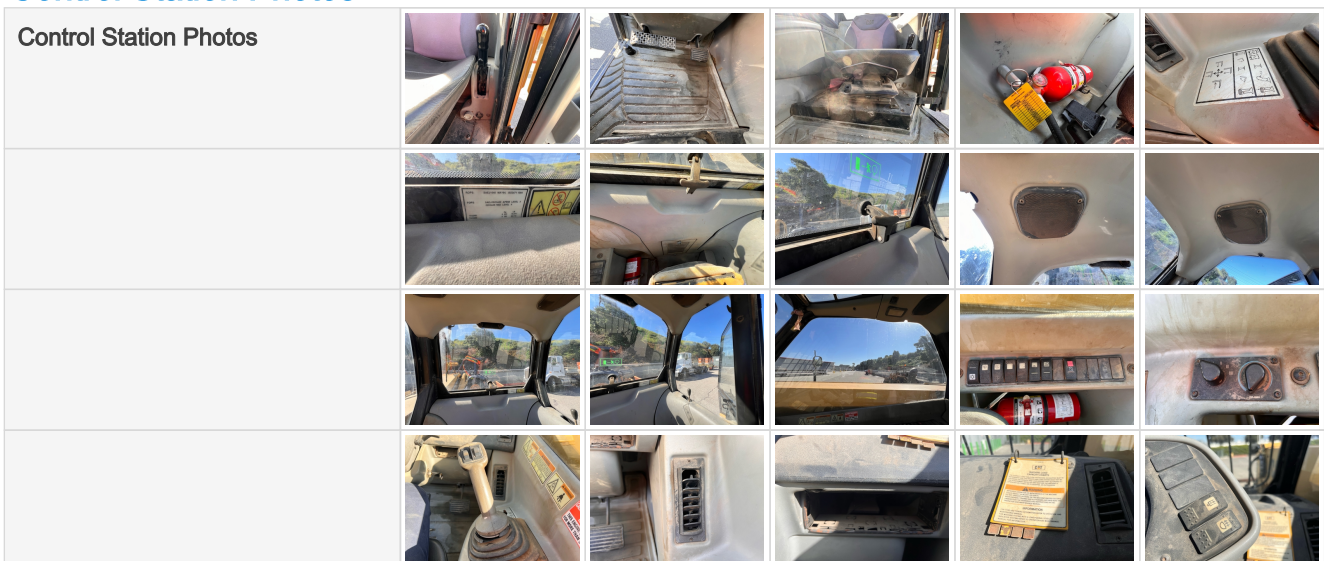
#### Control Station Photos

<b>Control Station Type</b>	Enclosed Cab (EROPS)
<b>Control Type</b>	Pilot Controls
<b>Control Configuration</b>	N/A
<b>Seat</b>	2 - Above Average Wear & Tear
<b>Seat Condition</b>	Seat(s) is damaged due to sun exposure; fading, cracking observed, Seat adjustment controls move through full range of travel, Seat belt secures properly
<b>Cabin Lights</b>	3 - Normal Wear & Tear
<b>Cabin Lights Condition</b>	Cabin lights are installed with all light covers in place, bulbs are installed and working properly
<b>Safety Lock Out / Stop</b>	3 - Normal Wear & Tear
<b>Safety Lock Out / Stop Condition</b>	Safety lock out device is present, in good condition, and functional
<b>Controls &amp; Switches</b>	3 - Normal Wear & Tear
<b>Controls &amp; Switches Condition</b>	All switches are installed and functional
<b>Hour Meter Activity</b>	3 - Normal Wear & Tear
<b>Hour Meter Condition</b>	Hour meter is functional and in good condition

<b>Other Gauge Activity</b>	3 - Normal Wear & Tear
<b>Other Gauge Condition</b>	All cockpit gauges are functional and in good condition
<b>Heater &amp; A/C</b>	2 - Above Average Wear & Tear
<b>Heater &amp; A/C Condition</b>	Heater and A/C work as expected, Other (see comments)
<b>Comments</b>	May need charge
<b>Travel Alarm</b>	0

Horn	3 - Normal Wear & Tear
Backup Camera	0
Control Station Overall Rating	3 - Normal Wear & Tear
Control Station Overall Condition	Minor cosmetic wear to cabin surfaces, floors, panels, and ceiling

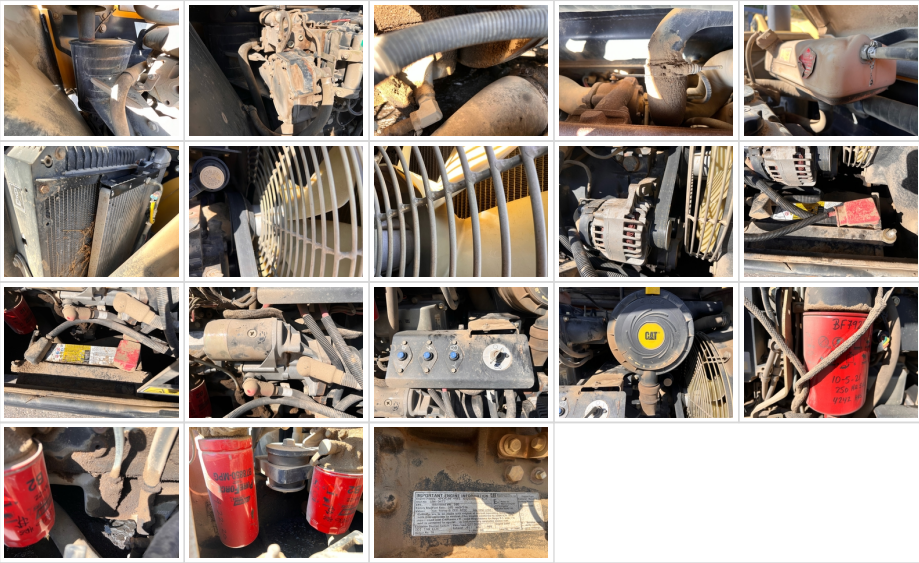
Engine Compartment Photos

Engine Smoke (Upon Start-up, Idle, Shutdown)	Yes
Engine Smoke Notes	Engine smoke observed upon start up
Engine Exhaust Color	White
Battery	2 - Above Average Wear & Tear
Battery Condition	Dusty & dirty appearance
Radiator	3 - Normal Wear & Tear
Belts	3 - Normal Wear & Tear
Hoses	2 - Above Average Wear & Tear
Hose Condition	Cracking, stiff, or charred hoses
Water Pump	3 - Normal Wear & Tear
Water Pump Condition	No unusual pump noises heard
Cooling System Leaks	No
Coolant Appearance	3 - Normal Wear & Tear
Coolant Appearance Notes	Normal Translucent appearance, no visual signs of contamination
Oil Leaks	No
Oil Appearance	3 - Normal Wear & Tear
Fuel Leaks	No
Equipped with DPF (Diesel Particulate Filter)	No
Requires DEF (Diesel Exhaust Fluid)	No
Overall Engine Rating	2 - Above Average Wear & Tear
Overall Engine Appearance	Areas of dried seepage seen on engine hoses & components, Active leaks/pooling observed in & around engine compartment

Overall Engine Comments	Above average wear and tear dried seepage noticed throughout engine compartment Could not the source of the seepage or what type of fluid it may be

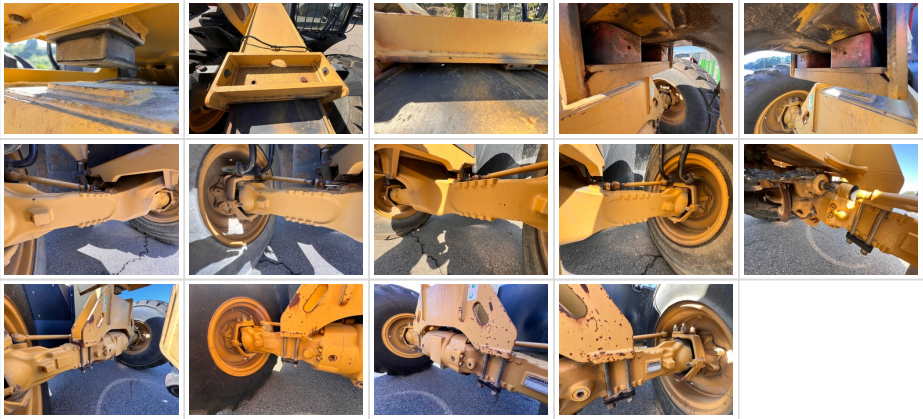
Chassis Photos

Frame	3 - Normal Wear & Tear
Stance	3 - Normal Wear & Tear
Oscillating Pin Appearance	0
Boom Condition	3 - Normal Wear & Tear
Chain / Tensioners	3 - Normal Wear & Tear
Rollers & Guides	3 - Normal Wear & Tear
Boom Wear Guides	2 - Above Average Wear & Tear
Comments	Missing wear pads
Overall Chassis	3 - Normal Wear & Tear

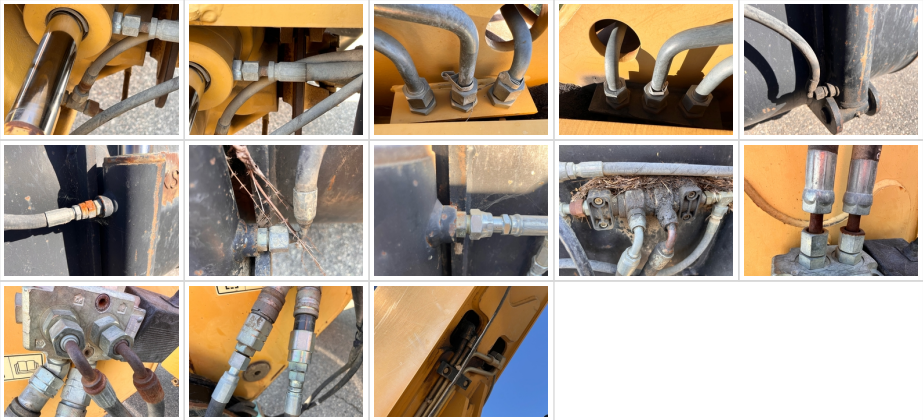
Hydraulic System Photos

Wet or Damp Hydraulic Lines / Fittings	Yes
Hydraulic Lines/Fittings	2 - Above Average Wear & Tear
Hydraulic Lines / Fittings Condition	Dried seepages observed
Hydraulic Pump(s)	3 - Normal Wear & Tear
Unusual Noises	No

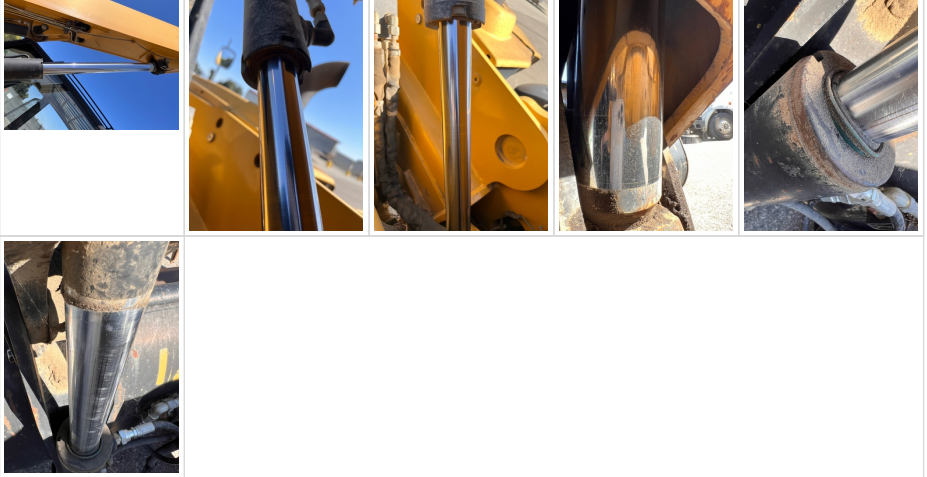
Hydraulic Cylinder Photos

Mounting Pins	3 - Normal Wear & Tear
Cylinder Oil Leaks	No
Hydraulic System Overall	3 - Normal Wear & Tear
Comments	Dried seepage noticed on hard lines under boom

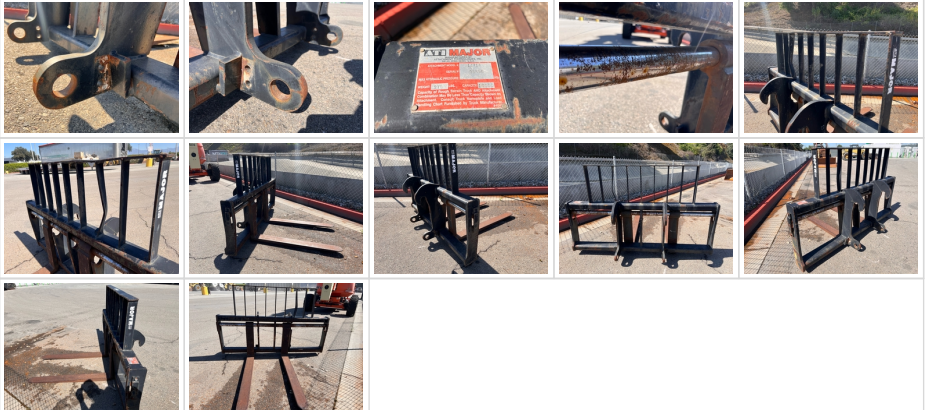
Attachment Type	Fork and carriage
Attachment Make	Ati major / model 11714 / serial 95896
Attachment Size / Specs	975lbs / capacity 10000lbs / 75" wide / 4' forks
Attachment Condition	2 - Above Average Wear & Tear
Comments	Surface rust observed on fork bar, bent backrest
Attachment Photos
