Inspection Report (Wheel Loader)

General Info		
B&B Stock Number	A5756739	
Year	2005	
Make	Caterpillar	
Model	966F	
Serial Number	4YG75001	
Serial Plate Photo	CATERPILLAR CERTIFIED 4/TU /5001 AL FUTURE DEPATIFICATION OP THIS UNIT TO CATERPILLAR SHOULD BE REFERENCED BY NUMBER DISPLAYED AT TOP OF THIS PLATE THIS MACHINE REMANUFACTURED BY IN CONFORMITY WITH THE CATERPILLAR CERTIFIED REBUILD PROCESS PRODUCT DENTIFICATION NUMBER CATERPILLAR CATERPILLAR CATERPILLAR SHOULD BE SH-5034	
Hour Meter Reading	8311	
Single Photo	302-5812 HOURS CAT®	
Previous Application (e.g., earth moving, mining, demolition, etc)	Sanitation district

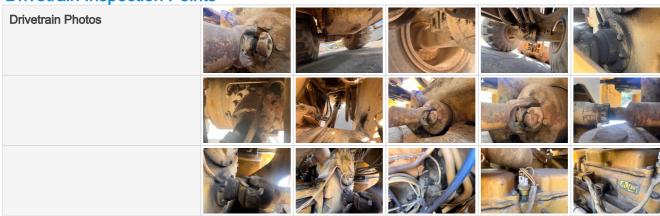
Hydrostatic Transmission?	No
Drive Type	4WD
Transmission Components	3 - Normal Wear & Tear
Parking Brake	3 - Normal Wear & Tear
Overall Drivetrain Rating	3 - Normal Wear & Tear
Overall Drivetrain Comments	Normal wear and tear no major issues to report
