Inspection Report (Excavator)

B&B Stock Number	A2758803
Year	2016
Make	Hyundai
Model	220LC-9A
Serial Number	HHKHZ610HF0000331
Serial Plate Photo

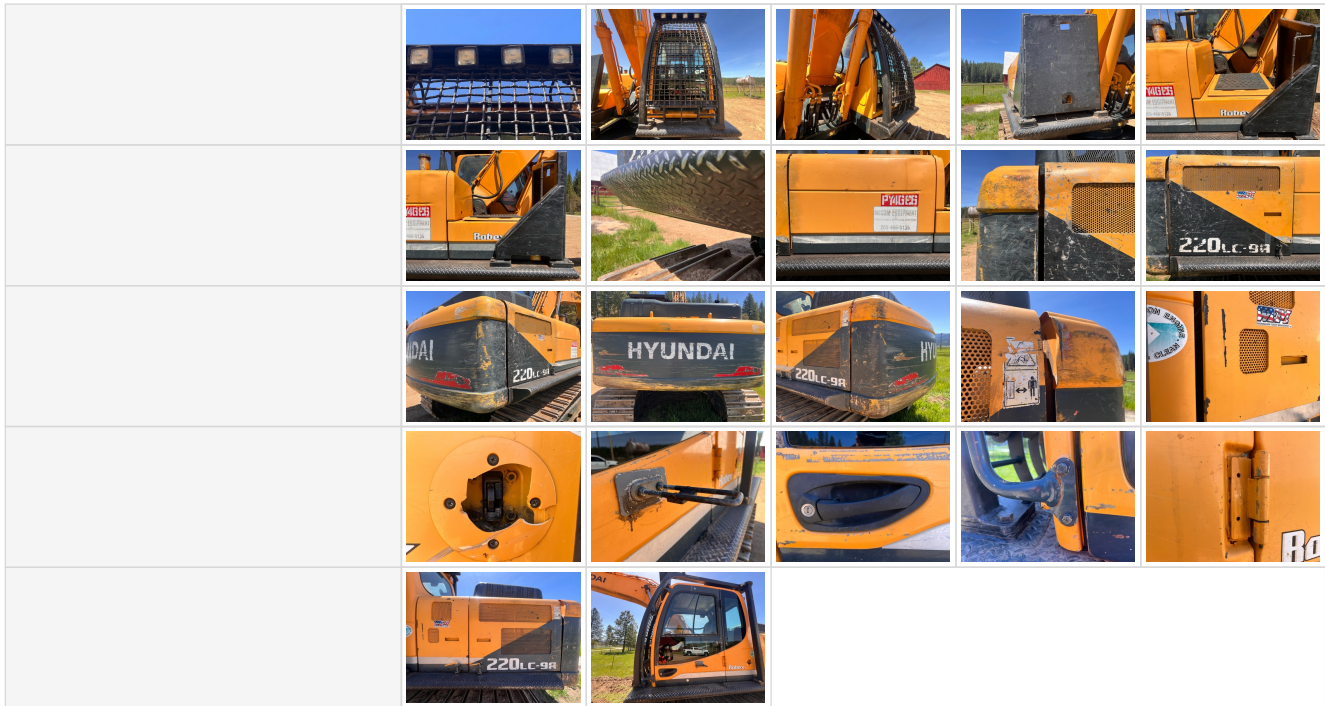
Close-up Exterior Photos	 
--------------------------	--

Mirrors	0
Exterior Lights	3 - Normal Wear & Tear
Exterior Lights Condition	No visible damage, lighting system is operational
Overall Exterior	2 - Above Average Wear & Tear
Comments	Above average wear and tear to exterior of machine due to bent panels and chipped paint

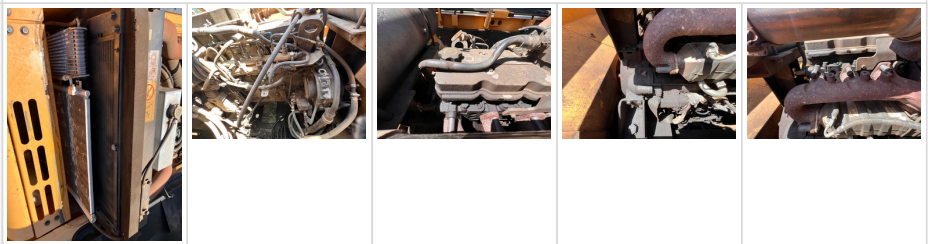
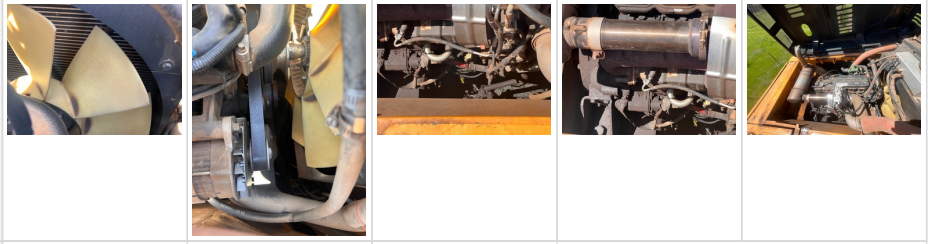
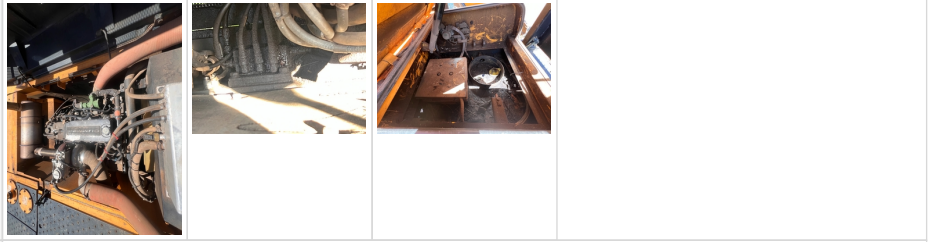
<p>Engine Compartment Photos</p>

Emissions Tier	Undetermined
Engine Fuel Type	Diesel
Blow-by (Visual Observation Check)	No
Unusual Noises (Upon Start-up, Idle, Shutdown)	No
Engine Smoke (Upon Start-up, Idle, Shutdown)	No
Engine Exhaust Color	Clear
Battery	3 - Normal Wear & Tear
Battery Condition	Dusty & dirty appearance
Radiator	3 - Normal Wear & Tear
Belts	3 - Normal Wear & Tear
Hoses	3 - Normal Wear & Tear
Water Pump	3 - Normal Wear & Tear
Cooling System Leaks	No
Coolant Appearance	3 - Normal Wear & Tear
Oil Leaks	No
Oil Appearance	3 - Normal Wear & Tear
Fuel Leaks	No
Equipped with DPF (Diesel Particulate Filter)	Yes
DPF Condition	3 - Normal Wear & Tear
DPF Condition Notes	Filter housing is intact with no signs of damage or malfunction, DPF indicator is not illuminated
Requires DEF (Diesel Exhaust Fluid)	No
Overall Engine Rating	2 - Above Average Wear & Tear
Overall Engine Appearance	Active leaks/pooling observed in & around engine compartment, Areas of dried seepage seen on engine hoses & components

Overall Engine Comments	Above average wear and tear to the engine compartment due to the dried seepage throughout engine compartment, as well as areas of fluid pooling at the base of the engine compartment

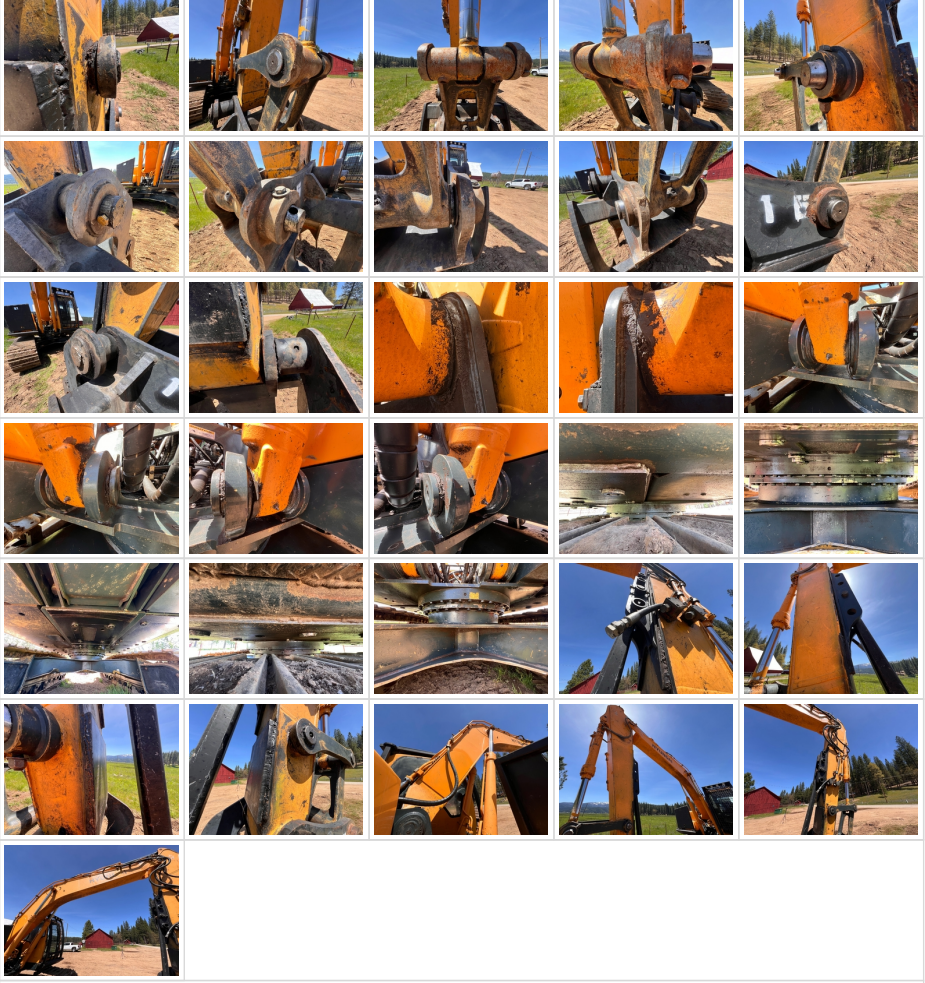
Chassis Photos

Boom Condition	3 - Normal Wear & Tear
Stick Condition	3 - Normal Wear & Tear
Boom Base Pin & Bushings	3 - Normal Wear & Tear
Boom to Stick Pin & Bushings	3 - Normal Wear & Tear
Stick to Bucket Pin & Bushings	3 - Normal Wear & Tear
Turntable Bearing	3 - Normal Wear & Tear

Bottom Covers	4 - Very Light or Minimal Wear
Comments	Mastication package
Overall Chassis	3 - Normal Wear & Tear
Overall Chassis Comments	Normal wear and tear no major issues to report

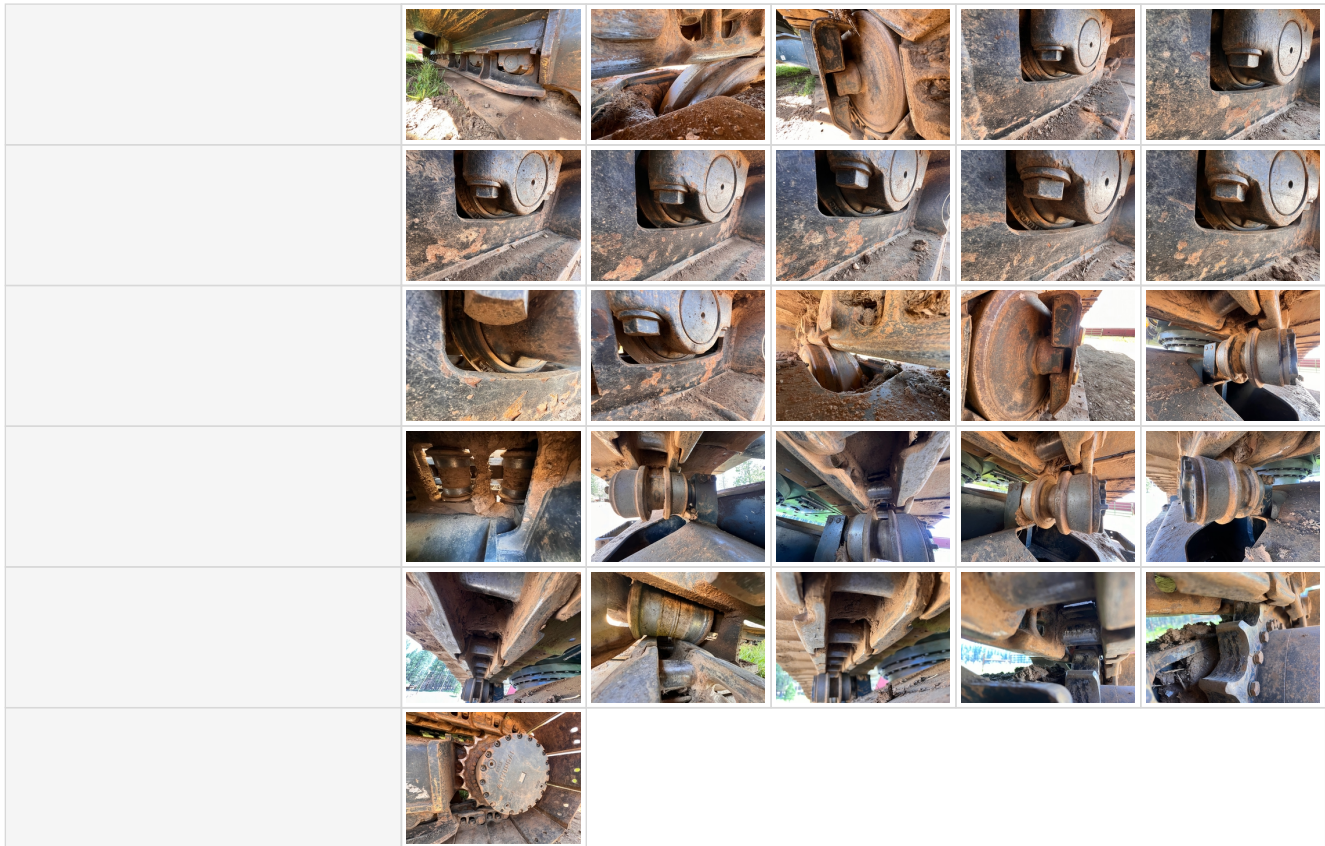
Undercarriage Photos

Sprocket Teeth	3 - Normal Wear & Tear
Track Bushings	3 - Normal Wear & Tear
Track Frames	3 - Normal Wear & Tear
Pivot Shafts	0
Equalizer Bar & Joints	0
Front Idler	2 - Above Average Wear & Tear
Comments	Worn
Track Tensioner	2 - Above Average Wear & Tear
Comments	At max tension
Track links	3 - Normal Wear & Tear
Bottom Rollers	3 - Normal Wear & Tear
Carrier Rollers	3 - Normal Wear & Tear
Overall Undercarriage	2 - Above Average Wear & Tear
Overall Percent Estimate	30%
Overall Undercarriage Comments	Above average wear and tear due to worn front idlers and track tensioner at or near max capacity
