## Inspection Report (Excavator)

B&B Stock Number	A6388732
Year	2015
Make	Kubota
Model	KX040-4
Serial Number	22676
Serial Plate Photo

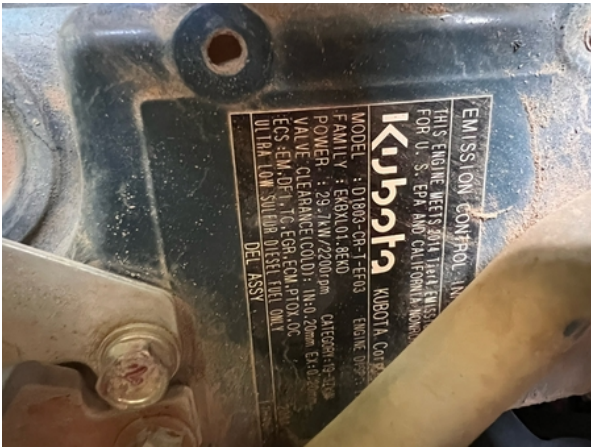
Engine Data Plate

Engine Type (Make, Model, Cylinders, Hp)	Kubota				
Emissions Tier	Undetermined				
Engine Serial Number	Unable to verify				
Engine Fuel Type	Diesel				
Blow-by (Visual Observation Check)	No				
Unusual Noises (Upon Start-up, Idle, Shutdown)	No				
Engine Smoke (Upon Start-up, Idle, Shutdown)	No				
Engine Exhaust Color	Clear				
Battery	3 - Normal Wear & Tear				
Battery Condition	Clean & dry appearance, tight connections				
Radiator	3 - Normal Wear & Tear				
Radiator Condition	Radiator fins & components appear to be in good working order, no signs of damage or leaks				
Belts	2 - Above Average Wear & Tear				
Belt Condition	Other (see comments)

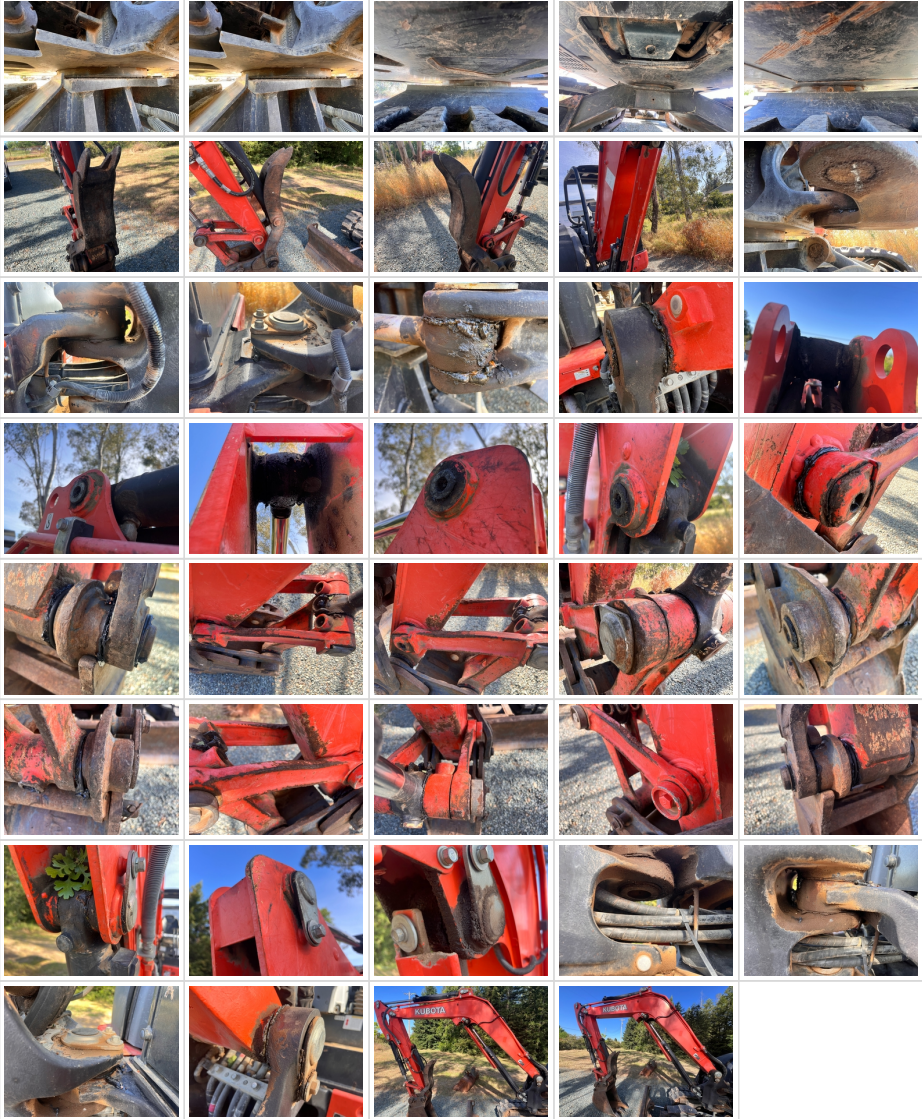
Chassis Photos

Boom Condition	3 - Normal Wear & Tear
Stick Condition	3 - Normal Wear & Tear
Boom Base Pin & Bushings	3 - Normal Wear & Tear
Boom to Stick Pin & Bushings	3 - Normal Wear & Tear
Stick to Bucket Pin & Bushings	3 - Normal Wear & Tear
Turntable Bearing	3 - Normal Wear & Tear
Bottom Covers	3 - Normal Wear & Tear
Overall Chassis	3 - Normal Wear & Tear
Overall Chassis Comments	Area of concern: bucket tilt cylinder linkages worn

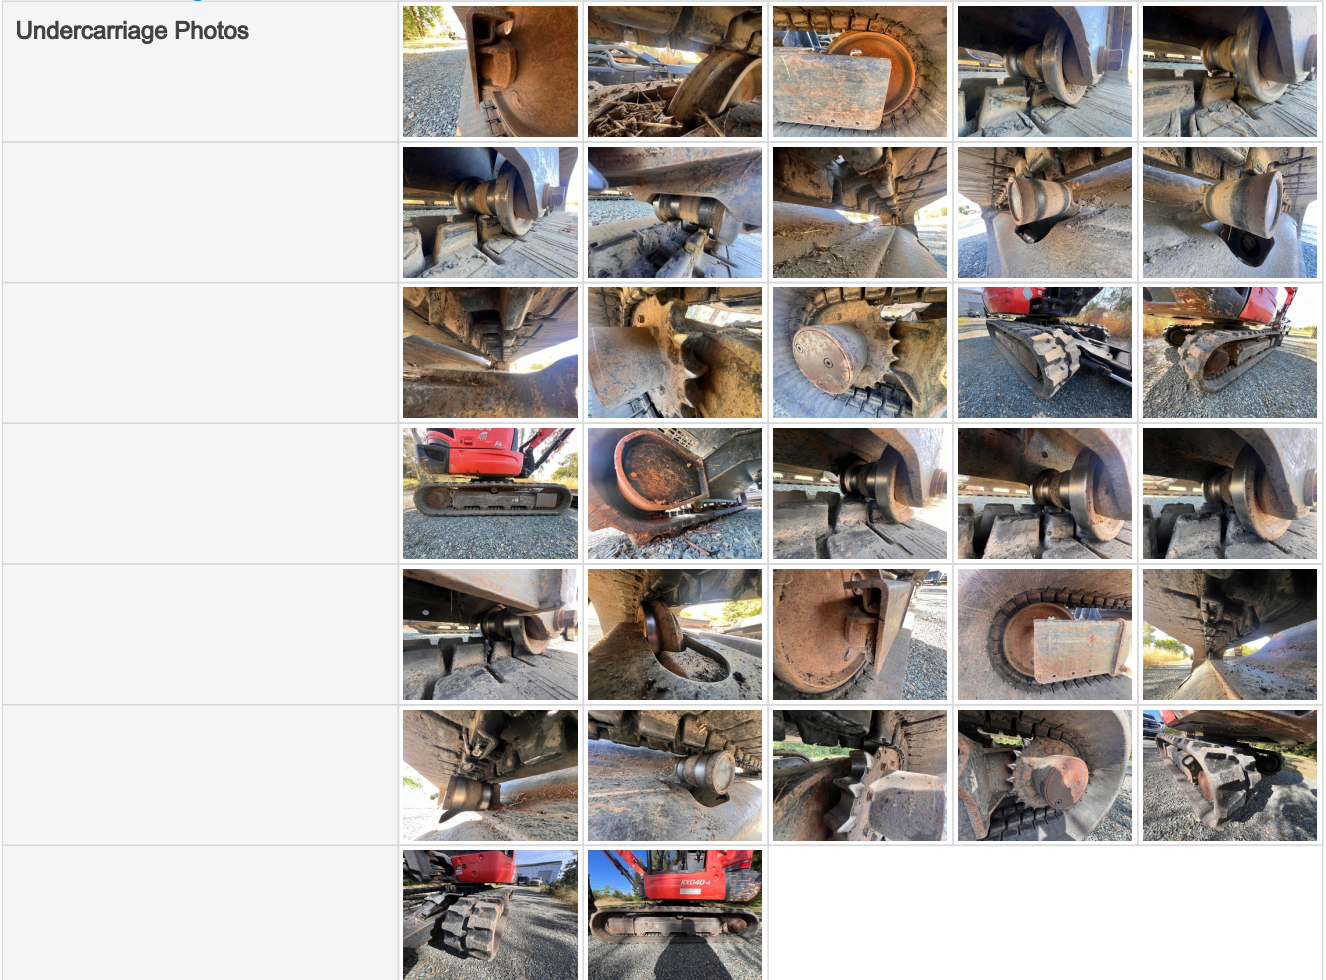
#### Undercarriage Photos

Track Width (inches)	14"
Track Length (inches)	38"
Roller Frames	3 - Normal Wear & Tear
Track Belt	4 - Very Light or Minimal Wear
Rubber Belt Drive Lugs	4 - Very Light or Minimal Wear
Track Tensioners	3 - Normal Wear & Tear
Front Idlers	3 - Normal Wear & Tear
Rear Idlers	0
Track Rollers	3 - Normal Wear & Tear
Sprockets	3 - Normal Wear & Tear
Overall Undercarriage Rating	3 - Normal Wear & Tear

Left Track Belt - Percent Remaining Estimate	90%
Right Track Belt - Percent Remaining Estimate	70%
Overall Comments	Normal wear and tear no major issues to report
