## Inspection Report (Bulldozer)

B&B Stock Number	A8501217
Year	2006
Make	Caterpillar
Model	D5G XL
Serial Number	CAT00D5GCWGB03429
Serial Plate Photo

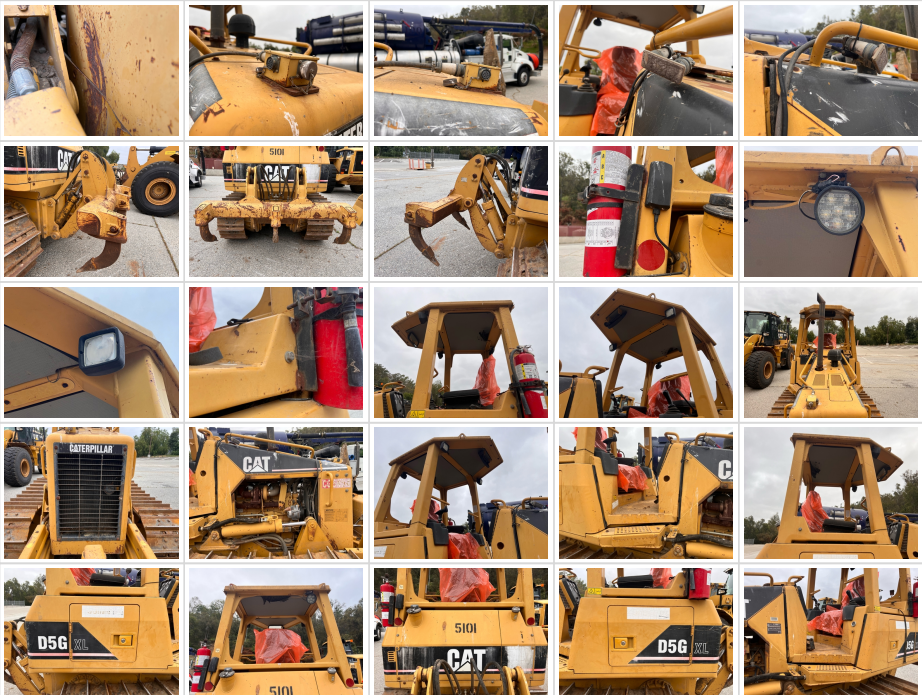
Close-up Exterior Photos

Handrails Condition	Handrails are fully intact and appear structurally sound	
Glass	0	
Mirrors	3 - Normal Wear & Tear	
Exterior Lights	3 - Normal Wear & Tear	
Overall Exterior	2 - Above Average Wear & Tear	
Comments	Above average wear and tear due to surface rust observed and dented panels

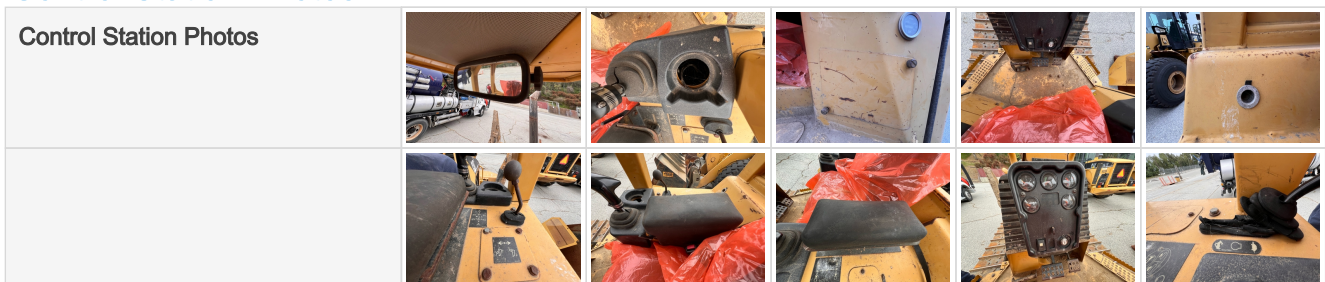
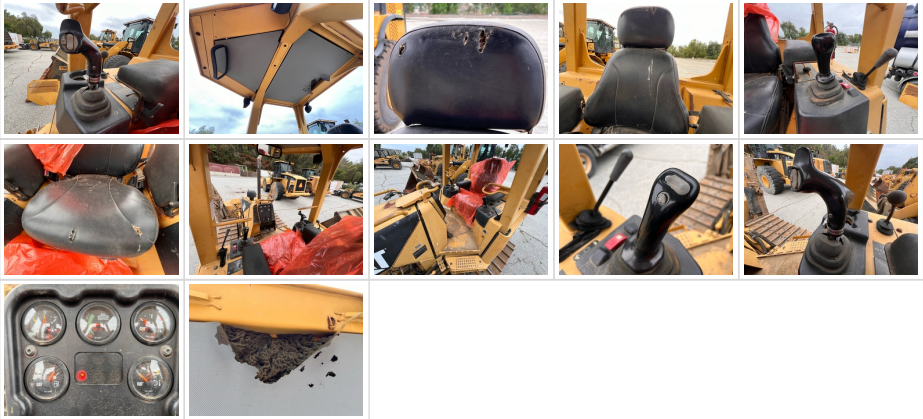
#### Control Station Photos

<b>Control Station Type</b>	Open Cab (OROPS)
<b>Control Type</b>	Lever Controls
<b>Control Configuration</b>	N/A
<b>Seat</b>	2 - Above Average Wear & Tear
<b>Seat Condition</b>	Seat(s) have minor surface staining or small tears, Seat belt secures properly
<b>Cabin Lights</b>	0
<b>Safety Lock Out / Stop</b>	3 - Normal Wear & Tear
<b>Safety Lock Out / Stop Condition</b>	Safety lock out device is present, in good condition, and functional
<b>Controls &amp; Switches</b>	2 - Above Average Wear & Tear
<b>Controls &amp; Switches Condition</b>	Switches have good functionality, minor cosmetic damage observed
<b>Hour Meter Activity</b>	3 - Normal Wear & Tear
<b>Other Gauge Activity</b>	3 - Normal Wear & Tear
<b>Heater &amp; A/C</b>	0
<b>Travel Alarm</b>	0
<b>Horn</b>	3 - Normal Wear & Tear
<b>Backup Camera</b>	0
<b>Control Station Overall Rating</b>	2 - Above Average Wear & Tear
<b>Control Station Overall Condition</b>	Significant wear and tear to cabin floor, panels, and ceiling

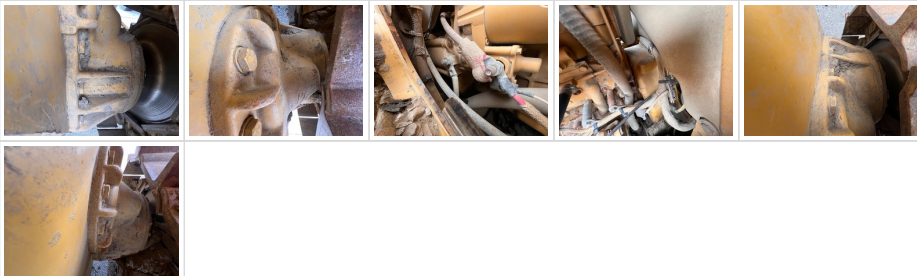
Drivetrain Photos

Hydrostatic Transmission?	Yes				
Speeds	Variable Speed				
Drive Type	N/A (Track Undercarriage)				
Transmission Components	0				
Drive Motors	3 - Normal Wear & Tear				
Parking Brake	0				
Overall Drivetrain Rating	3 - Normal Wear & Tear				
Overall Drivetrain Comments	Normal wear and tear no major issues to report

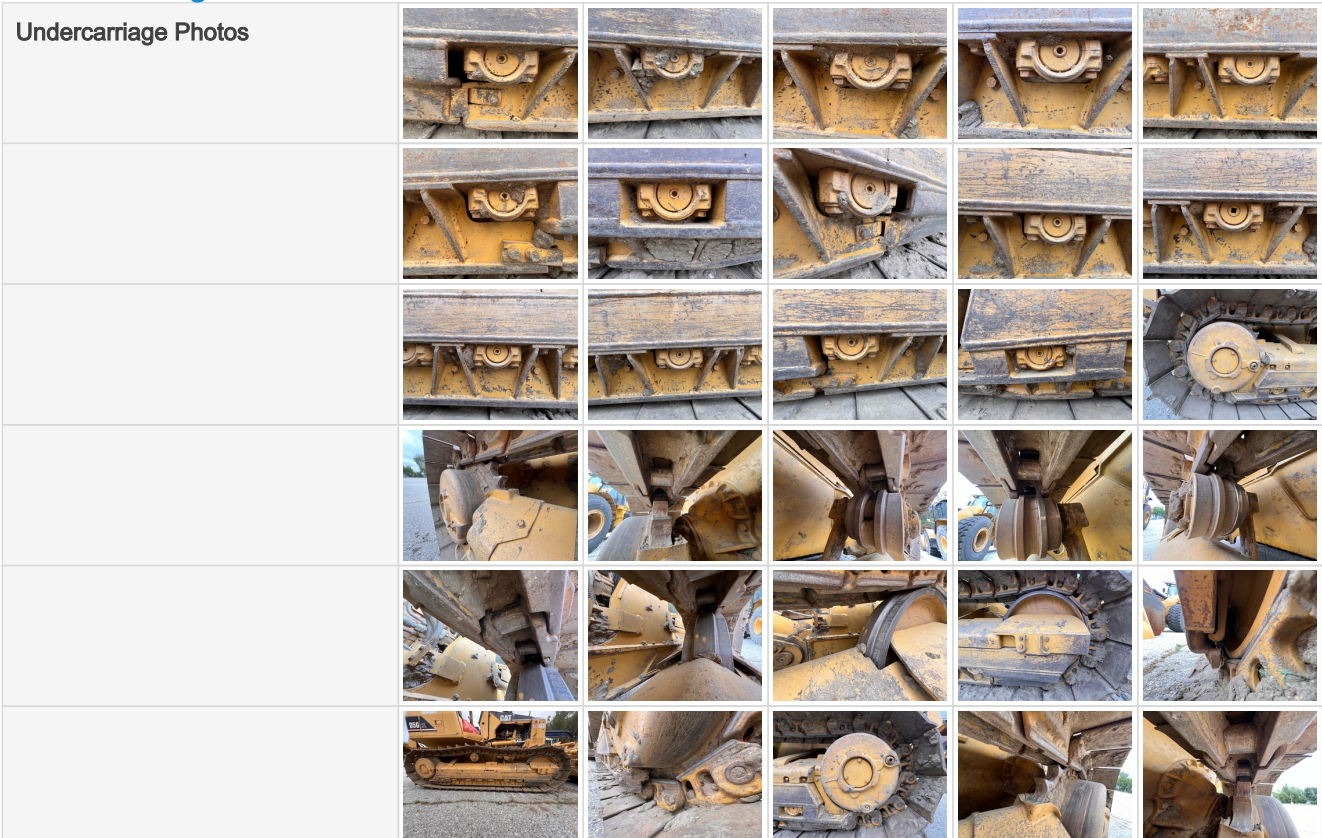
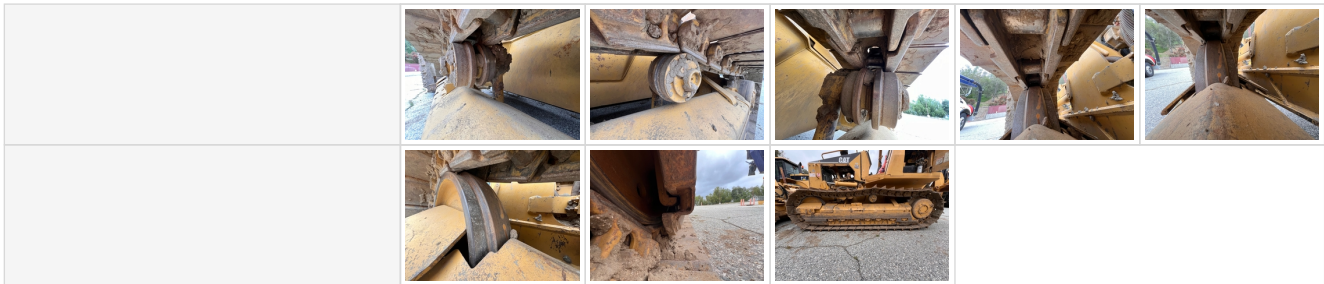
#### Undercarriage Photos

Sprocket Teeth	3 - Normal Wear & Tear
Track Bushings	3 - Normal Wear & Tear
Track Frames	3 - Normal Wear & Tear
Pivot Shafts	0
Equalizer Bar & Joints	0
Front Idler	3 - Normal Wear & Tear
Track Tensioner	3 - Normal Wear & Tear
Track links	3 - Normal Wear & Tear
Bottom Rollers	3 - Normal Wear & Tear
Carrier Rollers	3 - Normal Wear & Tear
Overall Undercarriage	3 - Normal Wear & Tear
Overall Percent Estimate	50%
Overall Undercarriage Comments	Normal wear and tear no major issues to report

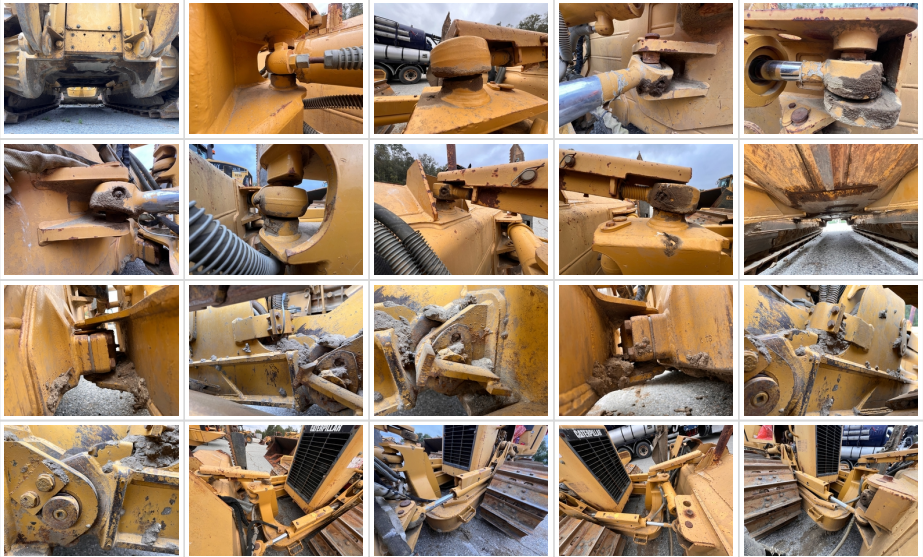
Chassis Photos

Push Arm / C-Frame Condition	3 - Normal Wear & Tear
Push Arm Pivot / C-Frame Trunnions Condition	3 - Normal Wear & Tear

Tilt Linkage Pin & Bushings	3 - Normal Wear & Tear
Angle Linkage Pin & Bushings	3 - Normal Wear & Tear
Blade Trunnions / Bushings	3 - Normal Wear & Tear
Frame Condition	3 - Normal Wear & Tear
Overall Chassis	3 - Normal Wear & Tear
Overall Chassis Comments	Normal wear and tear no major issues to report

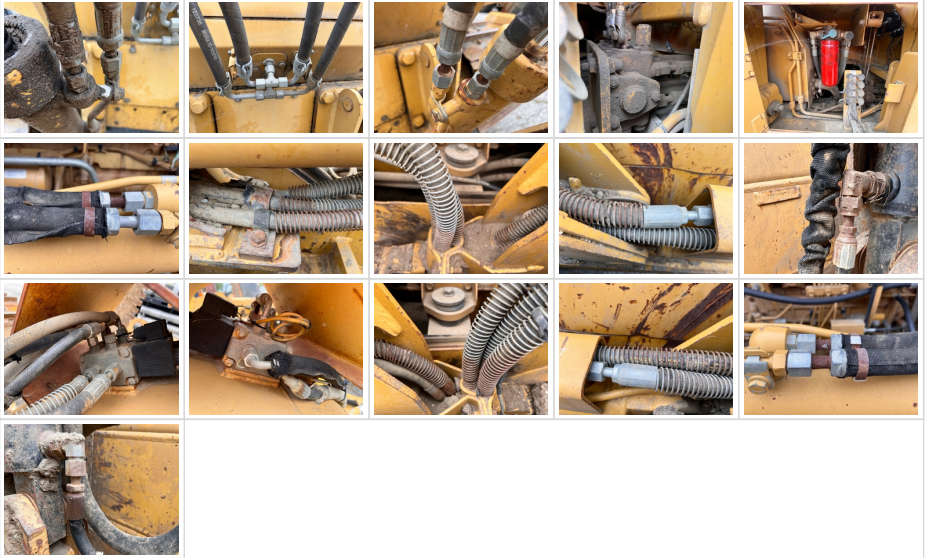
Hydraulic System Photos

Wet or Damp Hydraulic Lines / Fittings	No
Hydraulic Lines/Fittings	2 - Above Average Wear & Tear
Hydraulic Lines / Fittings Condition	Worn, cut, or damaged hose covering
Hydraulic Pump(s)	3 - Normal Wear & Tear
Unusual Noises	No
Hydraulic Pump Notes	No unusual noises heard during operation

Mounting Pins	2 - Above Average Wear & Tear
Cylinder Oil Leaks	No
Comments	Rear left ripper cylinder had dried seeping around wiper seal
Hydraulic System Overall	2 - Above Average Wear & Tear
Comments	Above average where to hydraulic system due to brittle hydraulic lines and dried seepage found at rear left ripper cylinder wiper seal
