# 1999 CHEVROLET C7500 / 0

Job #: 71495 / VIN: 1GBM7H1C2XJ105054

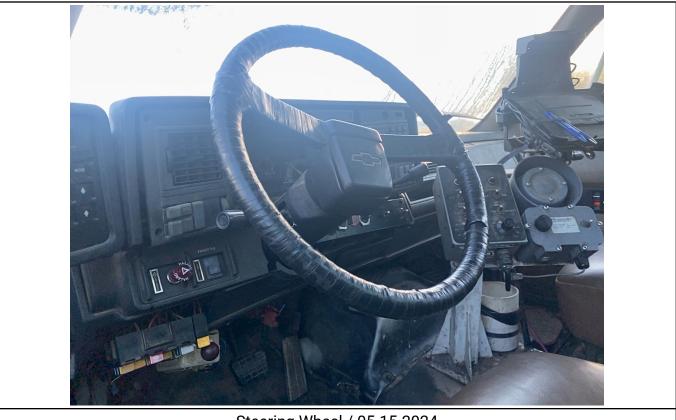
Steering Wheel / 05-15-2024

| Year1999MakeChevroletModelC7500Date of Inspection05/14/2024Location of Inspection5112 E University Dr , Denton, TX,<br>76208, USAVIN1GBM7H1C2XJ105054GVWR33,000Odometer146,300Engine Hours25,099EMS Warning LightsNo Active WarningsCab InteriorSee NotesDriver's SeatNo Damages ObservedPassenger's SeatNo Damages ObservedFloorboardNo Damages ObservedFloorboardNo Damages ObservedRadioYesA/CYesSwitches and ControlsSee NotesPower MirrorsNoHeated MirrorsNoSteering WheelSee NotesMirrorsNo Damages ObservedStepsSee NotesMirrorsNo Damages ObservedEngine CompartmentNo Damages ObservedEngine CompartmentNo Damages ObservedEngine CompartmentObstructedObstructedObstructed | Specifications | |
|---|---|---|
| Steps See Notes Handrails No Damages Observed Exhaust Pipe See Notes Engine Compartment No Damages Observed Engine Serial Plate Obstructed | Steering Wheel | See Notes |

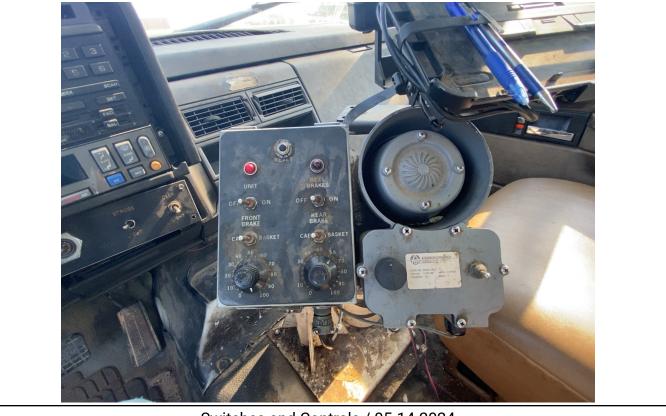
Switches and Controls / 05-14-2024

| Year1999MakeChevroletModelC7500Date of Inspection05/14/2024Location of Inspection5112 E University Dr , Denton, TX,<br>76208, USAVIN1GBM7H1C2XJ105054GVWR33,000Odometer146,300Engine Hours25,099EMS Warning LightsNo Active WarningsCab InteriorSee NotesDriver's SeatNo Damages ObservedPassenger's SeatNo Damages ObservedFloorboardNo Damages ObservedFloorboardNo Damages ObservedRadioYesA/CYesSwitches and ControlsSee NotesPower MirrorsNoHeated MirrorsNoSteering WheelSee NotesMirrorsNo Damages ObservedStepsSee NotesMirrorsNo Damages ObservedEngine CompartmentNo Damages ObservedEngine CompartmentNo Damages ObservedEngine CompartmentObstructedObstructedObstructed | Specifications | |
|---|---|---|
| Heated MirrorsNoSteering WheelSee NotesMirrorsNo Damages ObservedStepsSee NotesHandrailsNo Damages ObservedExhaust PipeSee NotesEngine CompartmentNo Damages ObservedEngine Serial PlateObstructed | Switches and Controls | See Notes |

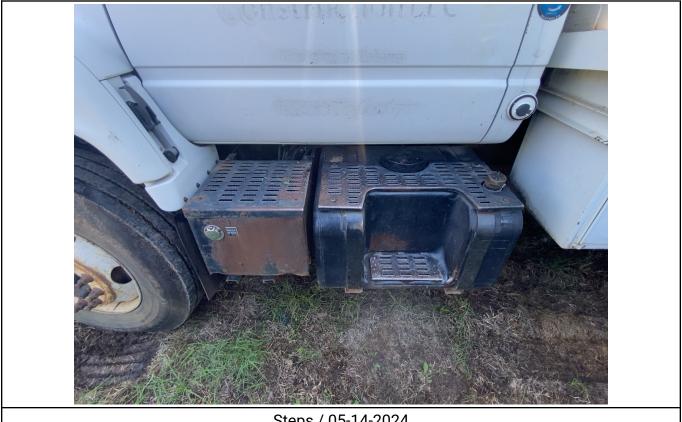
Steps / 05-14-2024

| Year1999MakeChevroletModelC7500Date of Inspection05/14/2024Location of Inspection5112 E University Dr , Denton, TX,<br>76208, USAVIN1GBM7H1C2XJ105054GVWR33,000Odometer146,300Engine Hours25,099EMS Warning LightsNo Active WarningsCab InteriorSee NotesDriver's SeatNo Damages ObservedPassenger's SeatNo Damages ObservedFloorboardNo Damages ObservedFloorboardNo Damages ObservedRadioYesA/CYesSwitches and ControlsSee NotesPower MirrorsNoHeated MirrorsNoSteering WheelSee NotesMirrorsNo Damages ObservedStepsSee NotesMirrorsNo Damages ObservedEngine CompartmentNo Damages ObservedEngine CompartmentNo Damages ObservedEngine CompartmentObstructedObstructedObstructed | Specifications | |
|---|---|---|
| Exhaust PipeSee NotesEngine CompartmentNo Damages ObservedEngine Serial PlateObstructed | Steps | See Notes |

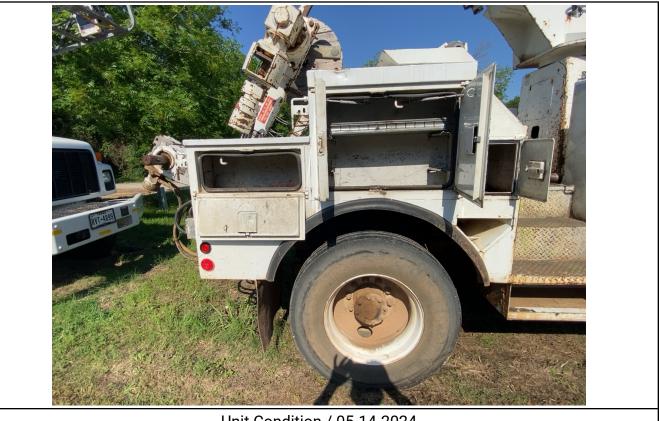
Unit Condition / 05-14-2024

The unit runs and drives. The engine information was acquired via a VIN decoder software. The front bumper is rusty. The front bumper is modified. The bed of unit is rusty. The wire roll holder is rusty. The dash is broken. The EMS panel is broken. The windshield is cracked. The steering wheel is taped up. The driver's seat is torn. The dash has wires hanging from it. The interior is dirty. The beacon light is broken. The control panel for boom is faded and missing screws. The right door paint is chipping. The left step is bent and rusty. The muffler is bent. The storage box is bent. Steering gearbox may be leaking oil. The right and left rear cylinders may be leaking. The undercarriage is rusty. The right rear drive hub is leaking oil. The rear diff may be leaking. The brake can dust caps are missing.

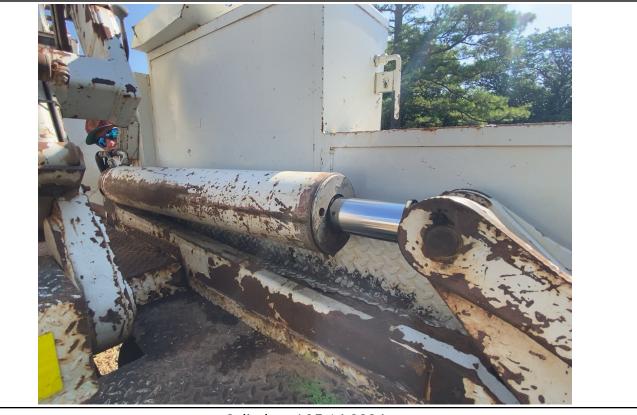
Cylinders / 05-14-2024

| Year1999MakeChevroletModelC7500Date of Inspection05/14/2024Location of Inspection5112 E University Dr , Denton, TX,<br>76208, USAVIN1GBM7H1C2XJ105054GVWR33,000Odometer146,300Engine Hours25,099EMS Warning LightsNo Active WarningsCab InteriorSee NotesDriver's SeatNo Damages ObservedPassenger's SeatNo Damages ObservedFloorboardNo Damages ObservedFloorboardNo Damages ObservedRadioYesA/CYesSwitches and ControlsSee NotesPower MirrorsNoHeated MirrorsNoSteering WheelSee NotesMirrorsNo Damages ObservedStepsSee NotesMirrorsNo Damages ObservedEngine CompartmentNo Damages ObservedEngine CompartmentNo Damages ObservedEngine CompartmentObstructedObstructedObstructed | Specifications | |
|---|---|---|
| Cylinders See Notes | Cylinders | See Notes |
