Inspection Report (Excavator)

B&B Stock Number	A6388732
Year	2015
Make	Kubota
Model	KX040-4
Serial Number	22676
Serial Plate Photo

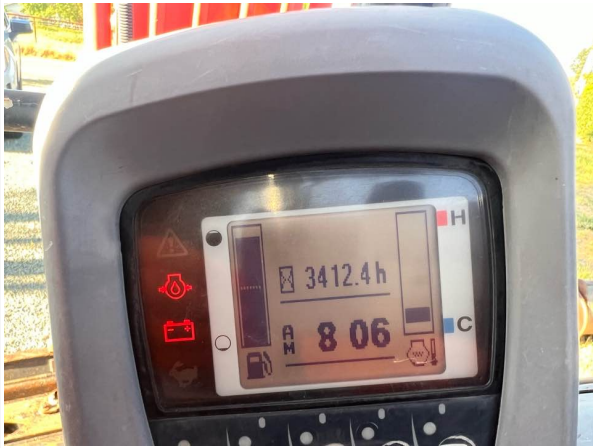
Hour Meter Reading	3412.4
Hour Meter Photo

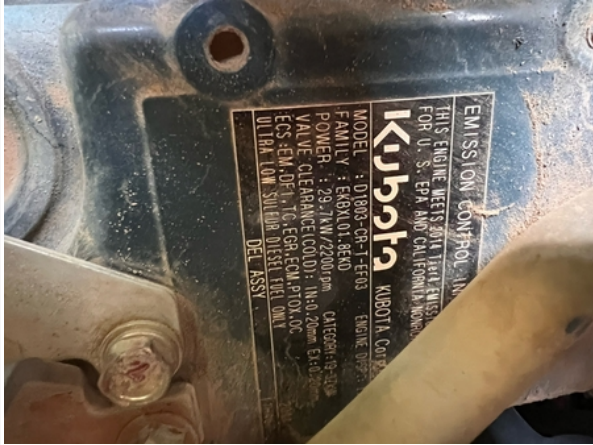
Engine Data Plate

Engine Type (Make, Model, Cylinders, Hp)	Kubota
Emissions Tier	Undetermined
Engine Serial Number	Unable to verify
Engine Fuel Type	Diesel
Blow-by (Visual Observation Check)	No
Unusual Noises (Upon Start-up, Idle, Shutdown)	No
Engine Smoke (Upon Start-up, Idle, Shutdown)	No
Engine Exhaust Color	Clear
Battery	3 - Normal Wear & Tear
Battery Condition	Clean & dry appearance, tight connections
Radiator	3 - Normal Wear & Tear
Radiator Condition	Radiator fins & components appear to be in good working order, no signs of damage or leaks
Belts	2 - Above Average Wear & Tear
Belt Condition	Other (see comments)
