Inspection Report (Skid Steer/Track Loader)

B&B Stock Number	A5067887
Year	2018
Make	Caterpillar
Model	249D
Serial Number	CAT0249DEGWR02723
Serial Plate Photo

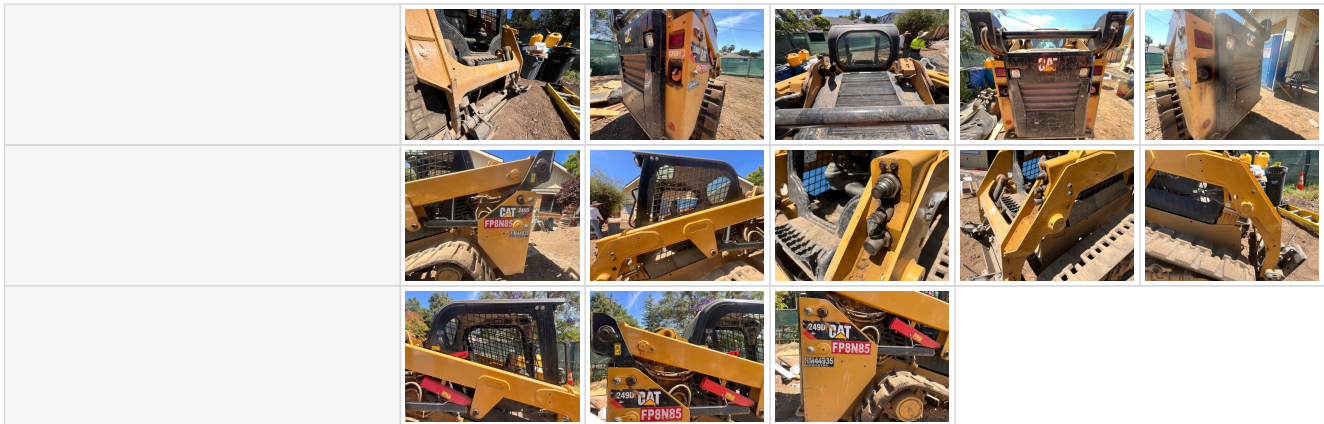
Close-up Exterior Photos	 
--------------------------	--

Inspection Rating Criteria	Rating Scale	Explanation
	1 - Service Required	Requires immediate repairs to function as expected.
	2 - Above Average Wear & Tear	Exhibits greater wear than expected given age and usage. While operable, further diagnosis may be needed.
	3 - Normal Wear & Tear	Exhibits wear that is consistent with age and usage. Operation is normal, and as expected.
	4 - Very Light or Minimal Wear	Exhibits very minimal wear. Operation is better than expected given age and usage.
	5 - Like New, Recently Replaced	Excellent condition, free of visible wear or damage. Operation is within factory specifications.
Body Panels	2 - Above Average Wear & Tear	
Body Panel Condition	Visible chipped paint or dents, Areas of surface rust observed	
Doors / Canopy Latches	0	
Steps / Ladders	3 - Normal Wear & Tear	
Handrails	2 - Above Average Wear & Tear	
Handrails Condition	Bent or broken railings	
Comments	Bent left hand rail

Glass	3 - Normal Wear & Tear	
Mirrors	3 - Normal Wear & Tear	
Exterior Lights	1 - Service Required	
Exterior Lights Condition	One or more exterior lights are non-operational	
Comments	Top right light damaged	
Overall Exterior	2 - Above Average Wear & Tear	
Comments	Above average wear and tear due to bent hand rail, areas of surface rust observed at rear of machine and scratches and dents to rear of machine

What Needs Work	The things that need work on this machine are that left-hand railing, top right light and bent manual release levers for bucket.	
Date/Time	05-30-2024	
Inspector Name	Javier Bocanegra

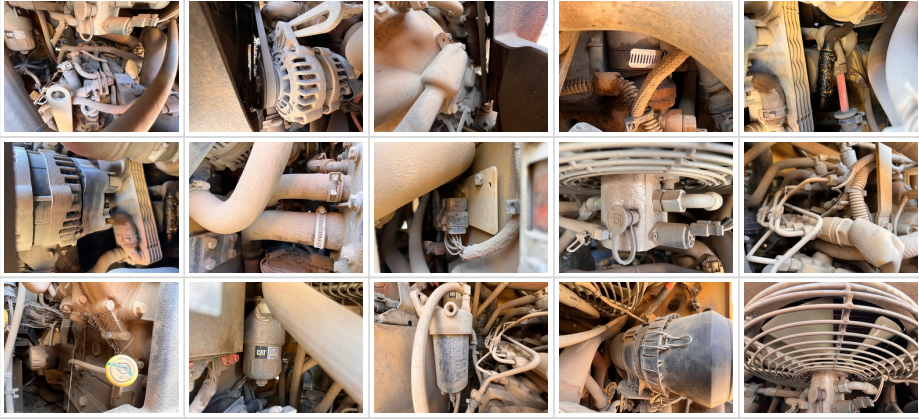
Engine Compartment Photos

Unusual Noises (Upon Start-up, Idle, Shutdown)	No
Engine Smoke (Upon Start-up, Idle, Shutdown)	No
Engine Exhaust Color	Clear
Battery	3 - Normal Wear & Tear
Radiator	3 - Normal Wear & Tear
Belts	3 - Normal Wear & Tear
Hoses	3 - Normal Wear & Tear
Water Pump	3 - Normal Wear & Tear
Cooling System Leaks	No
Coolant Appearance	3 - Normal Wear & Tear
Oil Leaks	No
Oil Appearance	3 - Normal Wear & Tear
Fuel Leaks	No
Equipped with DPF (Diesel Particulate Filter)	No
Requires DEF (Diesel Exhaust Fluid)	No
Overall Engine Rating	3 - Normal Wear & Tear
Overall Engine Appearance	Areas of dried seepage seen on engine hoses & components, Very dirty
Overall Engine Comments	Normal wear and tear no major issues to report

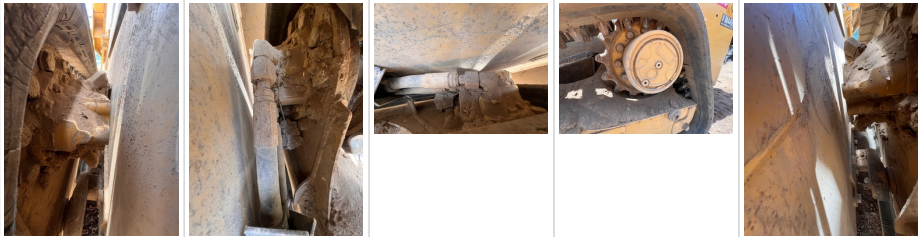
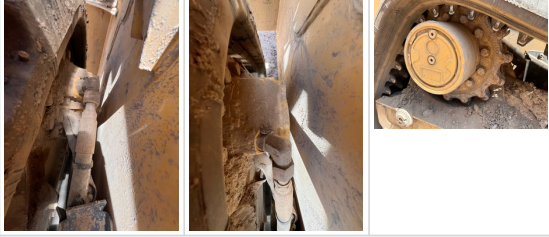
Drivetrain Photos

Speeds	Variable Speed
Drive Type	N/A (Track Undercarriage)
Transmission Components	0
Drive Motors	3 - Normal Wear & Tear
Parking Brake	0
Overall Drivetrain Rating	3 - Normal Wear & Tear
Overall Drivetrain Comments	Normal wear and tear no major issues to report
