Inspection Report (Skid Steer/Track Loader)

B&B Stock Number	A9490757
Year	2022
Make	Case
Model	TV450B
Serial Number	JAFTV450KMM405299
Serial Plate Photo

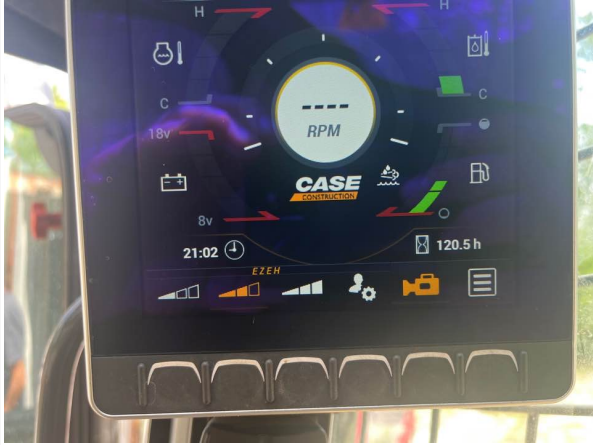
Hour Meter Reading	120.5
Hour Meter Photo

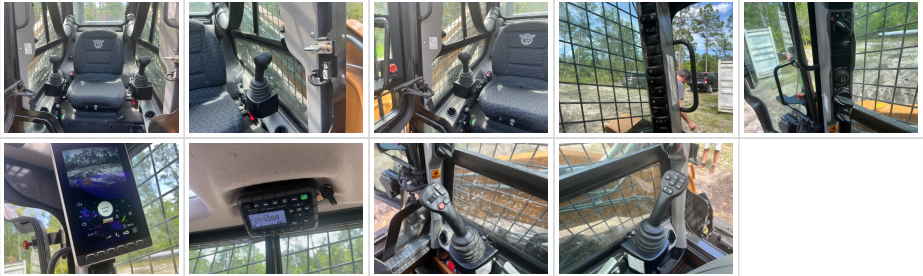
Control Station Photos

Control Station Type	Enclosed Cab (EROPS)
Control Type	Pilot Controls
Control Configuration	Configurable (SAE and ISO)
Seat	5 - Like New, Recently Replaced
Cabin Lights	5 - Like New, Recently Replaced
Safety Lock Out / Stop	5 - Like New, Recently Replaced
Controls & Switches	5 - Like New, Recently Replaced
Hour Meter Activity	5 - Like New, Recently Replaced

Hour Meter Condition	Hour meter is functional and in good condition
Other Gauge Activity	5 - Like New, Recently Replaced
Heater & A/C	5 - Like New, Recently Replaced
Travel Alarm	5 - Like New, Recently Replaced
Horn	5 - Like New, Recently Replaced
Backup Camera	5 - Like New, Recently Replaced
Control Station Overall Rating	5 - Like New, Recently Replaced

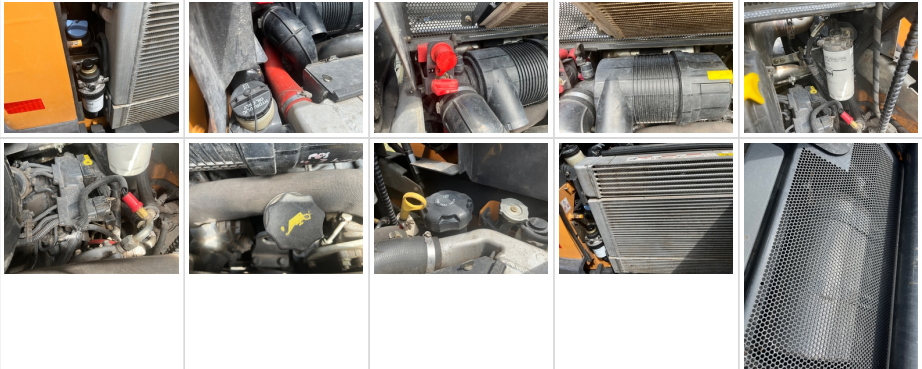
Engine Compartment Photos

Engine Type (Make, Model, Cylinders, Hp)	Fiat 3.4 liter
Emissions Tier	Tier 4F
Engine Serial Number	No tag
Engine Fuel Type	Diesel
Blow-by (Visual Observation Check)	No
Unusual Noises (Upon Start-up, Idle, Shutdown)	No
Engine Smoke (Upon Start-up, Idle, Shutdown)	No
Engine Exhaust Color	Clear
Battery	5 - Like New, Recently Replaced
Battery Condition	Clean & dry appearance, tight connections
Radiator	5 - Like New, Recently Replaced
Radiator Condition	Radiator fins & components appear to be in good working order, no signs of damage or leaks
Belts	5 - Like New, Recently Replaced
Belt Condition	Belts appear in good condition & alignment with proper tension
Hoses	5 - Like New, Recently Replaced
Hose Condition	Firm, pliant hoses with no signs of wear or leaks
Water Pump	5 - Like New, Recently Replaced
Water Pump Condition	No unusual pump noises heard
Cooling System Leaks	No
Coolant Appearance	5 - Like New, Recently Replaced

Coolant Appearance Notes	Normal Translucent appearance, no visual signs of contamination
Oil Leaks	No
Oil Appearance	5 - Like New, Recently Replaced
Oil Appearance Notes	Clean oil appearance, no signs of cross contamination
Fuel Leaks	No
Equipped with DPF (Diesel Particulate Filter)	No
Requires DEF (Diesel Exhaust Fluid)	Yes
DEF Tank	5 - Like New, Recently Replaced
DEF Tank Condition	Area around DEF tank cap is clean, fluid is clear & appears free of contaminants
Overall Engine Rating	5 - Like New, Recently Replaced
Overall Engine Appearance	Clean & dry

Overall Engine Comments	No issues
-------------------------	-----------

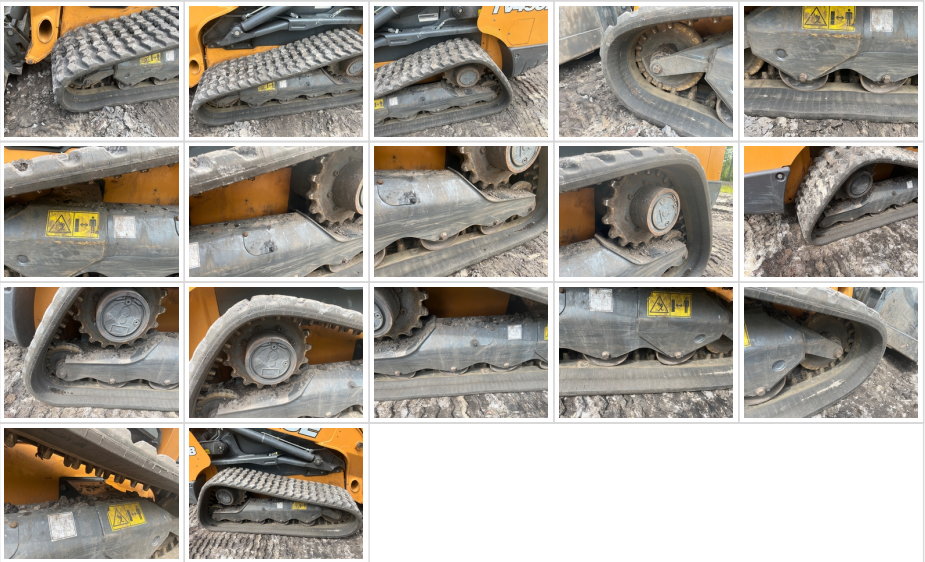
Drivetrain Photos

Drive Type	N/A (Track Undercarriage)
Transmission Components	5 - Like New, Recently Replaced
Transmission Condition	Good forward and reverse function
Parking Brake	5 - Like New, Recently Replaced
Overall Drivetrain Rating	5 - Like New, Recently Replaced
Overall Drivetrain Comments	No issues

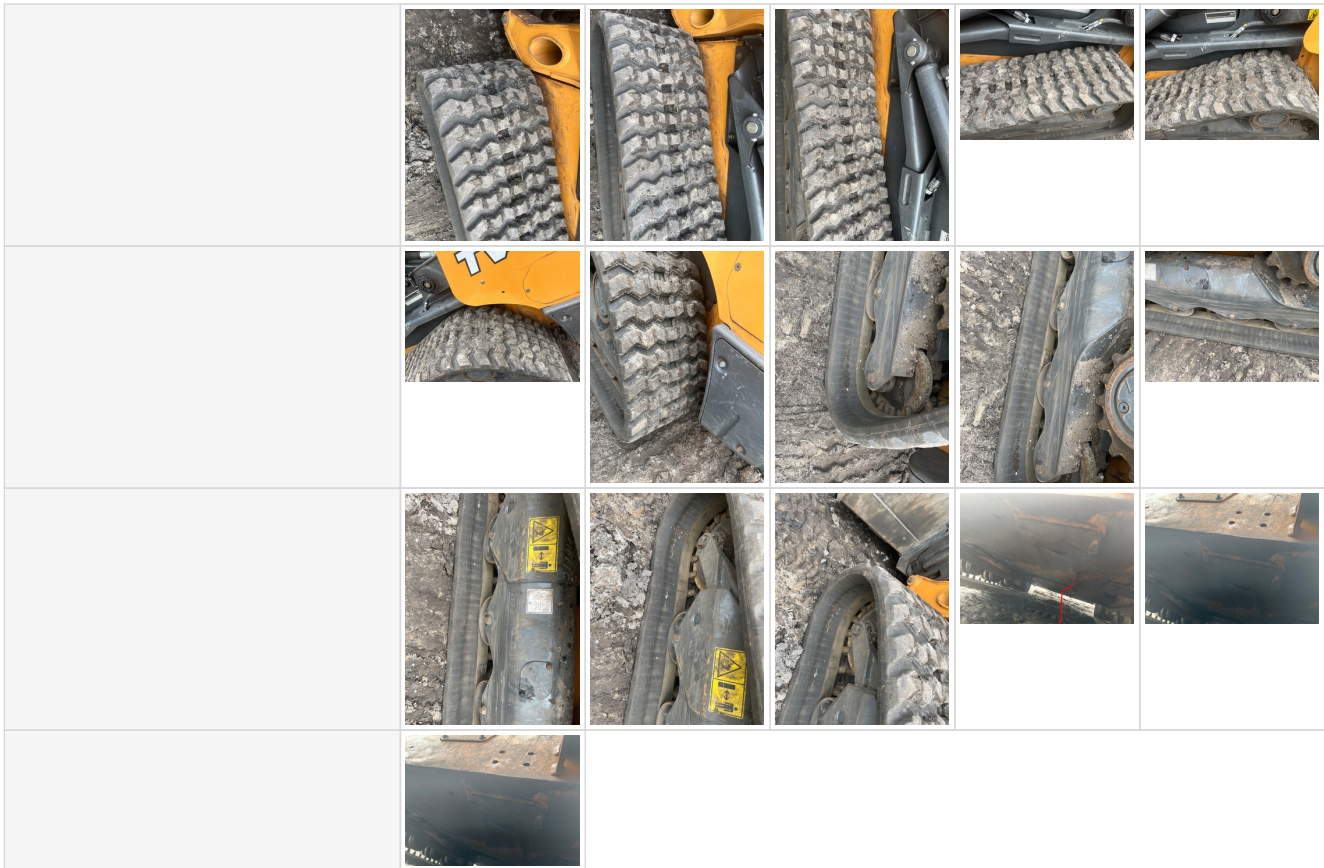
Undercarriage Photos	 
----------------------	--

Track Width (inches)	1 foot and 6 inches
Track Length (inches)	64.5 inches on ground
Roller Frames	5 - Like New, Recently Replaced
Track Belt	5 - Like New, Recently Replaced
Rubber Belt Drive Lugs	5 - Like New, Recently Replaced
Track Tensioners	5 - Like New, Recently Replaced
Front Idlers	5 - Like New, Recently Replaced
Rear Idlers	5 - Like New, Recently Replaced
Track Rollers	5 - Like New, Recently Replaced
Overall Undercarriage Rating	5 - Like New, Recently Replaced
Left Track Belt - Percent Remaining Estimate	90%
Right Track Belt - Percent Remaining Estimate	90%
Overall Comments	No issues

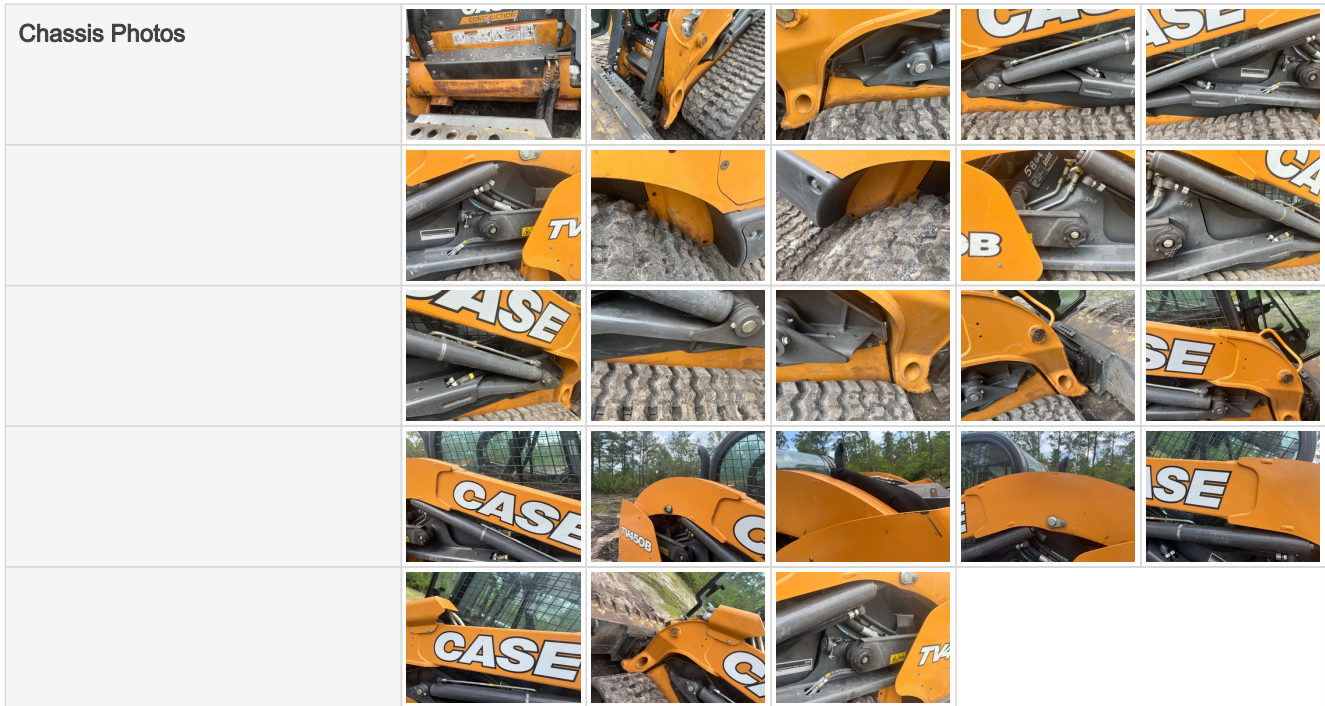
Chassis Photos

Frame	5 - Like New, Recently Replaced
Stance	5 - Like New, Recently Replaced
Lift Arms	5 - Like New, Recently Replaced
Chassis to Arm Pins	5 - Like New, Recently Replaced
Quick Coupler	5 - Like New, Recently Replaced
Quick Coupler to Arms Pins	5 - Like New, Recently Replaced
Overall Chassis	5 - Like New, Recently Replaced
Overall Chassis Comments	No issues

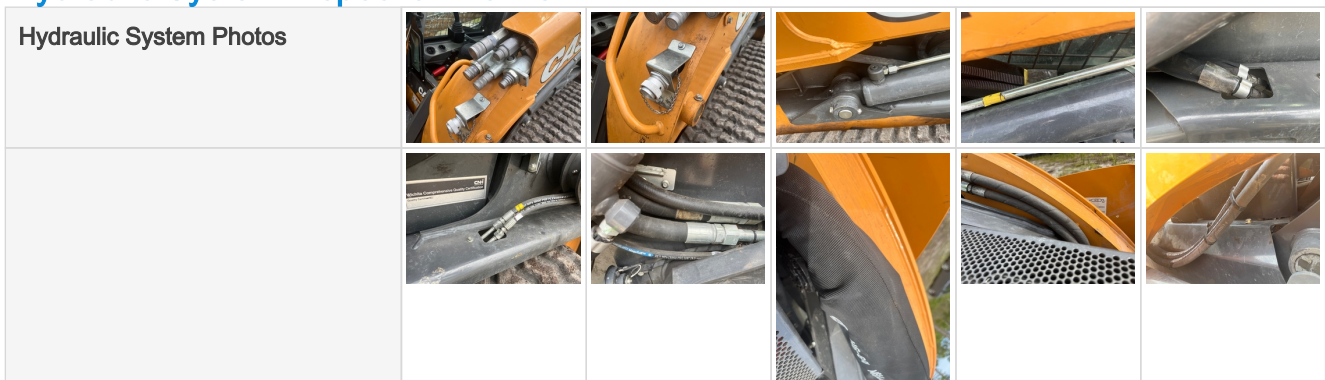
Hydraulic System Inspection Points

Wet or Damp Hydraulic Lines / Fittings	No				
Hydraulic Lines/Fittings	5 - Like New, Recently Replaced				
Hydraulic Lines / Fittings Condition	Hydraulic lines & fittings are clean and in good condition				
Hydraulic Pump(s)	5 - Like New, Recently Replaced				
Unusual Noises	No				
Hydraulic Pump Notes	No unusual noises heard during operation
