## Inspection Report (On-Highway Service Truck)

B&B Stock Number	A3608076
Year	2007
Make	International
Model	4300
Serial Number	1HTMMAAN68H417399
Serial Plate

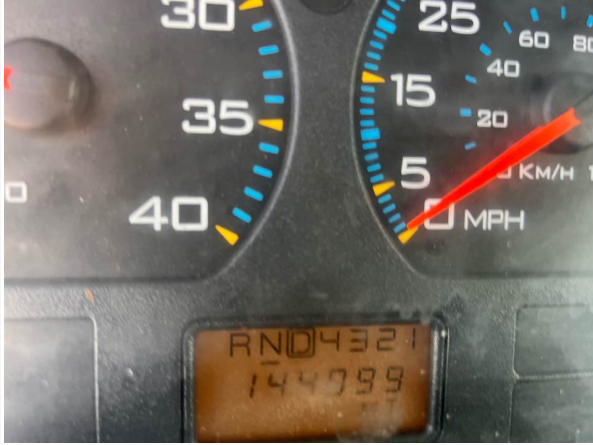
Odometer Reading	144099
Odometer

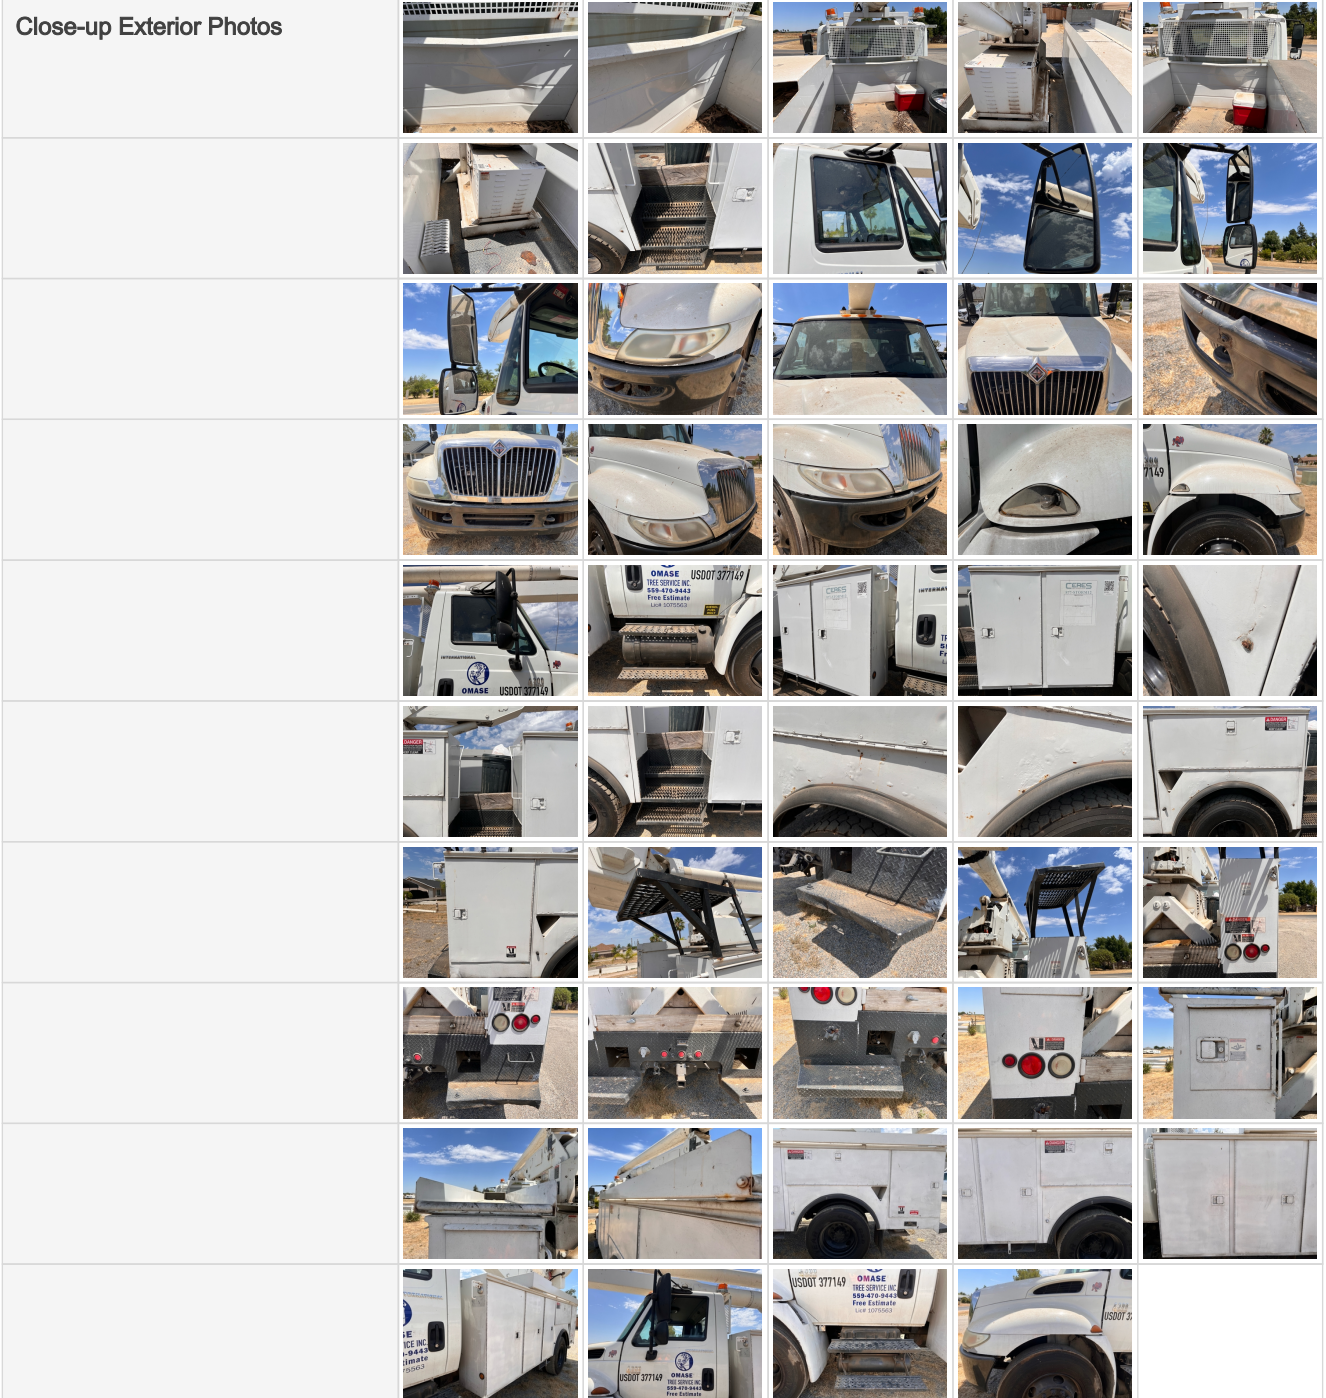
### General Appearance Photos

Body Panels	2 - Above Average Wear & Tear
Body Panel Condition	Large dents or cracks, Areas of surface rust observed
Doors / Canopy Latches	3 - Normal Wear & Tear
Doors / Canopy Latches Condition	No visible damage
Steps / Ladders	2 - Above Average Wear & Tear
Steps / Ladders Condition	Bent or broken steps or rungs
Handrails	3 - Normal Wear & Tear
Handrails Condition	Handrails are fully intact and appear structurally sound
Glass	3 - Normal Wear & Tear
Glass Condition	Glass intact, no visible damage
Mirrors	2 - Above Average Wear & Tear
Mirror Condition	Major chips or cracks observed
Exterior Lights	2 - Above Average Wear & Tear
Exterior Lights Condition	Major chip or cracks seen on light casings
Overall Exterior	2 - Above Average Wear & Tear
Comments	Above average wear and tear due to best steps, cracked passenger side mirror, Passenger side ember lens missing and areas of surface rust observed near rear right tire

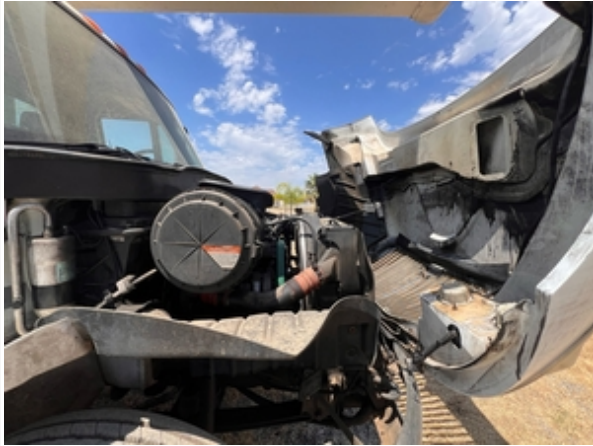
Engine Data Plate

Engine Type (Make, Model, Cylinders, Hp)	Unable to verify
Emissions Tier	Undetermined
Engine Fuel Type	Diesel
Blow-by (Visual Observation Check)	No
Unusual Noises (Upon Start-up, Idle, Shutdown)	No
Engine Smoke (Upon Start-up, Idle, Shutdown)	Yes
Engine Smoke Notes	Other (see comments)
Comments	Smell of burning oil during operation
Engine Exhaust Color	Black
Battery	3 - Normal Wear & Tear
Radiator	2 - Above Average Wear & Tear
Radiator Condition	Other (see comments)
Comments	Oil and debris all over component
Belts	2 - Above Average Wear & Tear
Belt Condition	Other (see comments)
Comments	Belts covered in oil
Hoses	2 - Above Average Wear & Tear
Hose Condition	Other (see comments)
Water Pump	2 - Above Average Wear & Tear
Cooling System Leaks	No
Coolant Appearance	3 - Normal Wear & Tear
Oil Leaks	Yes
Oil Leak Notes	Active dripping and/or oil pooling observed

Fuel Leaks	No
Equipped with DPF (Diesel Particulate Filter)	No
Requires DEF (Diesel Exhaust Fluid)	No
Overall Engine Rating	1 - Service Required
Overall Engine Appearance	Active leaks/pooling observed in & around engine compartment
Overall Engine Comments	Major oil leak in engine compartment, oil all over hoses belts, and other major components in the engine compartment
