Inspection Report (Wheel Loader)

B&B Stock Number	A5676528
Year	2015
Make	Caterpillar
Model	962M
Serial Number	CAT0962MHEJB00301
Serial Plate Photo

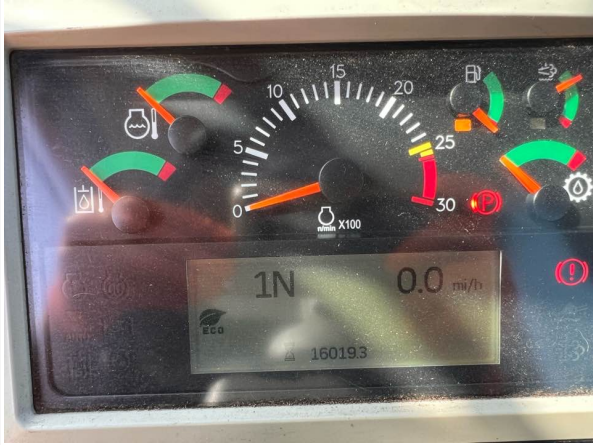
Hour Meter Reading	16019.3
Single Photo

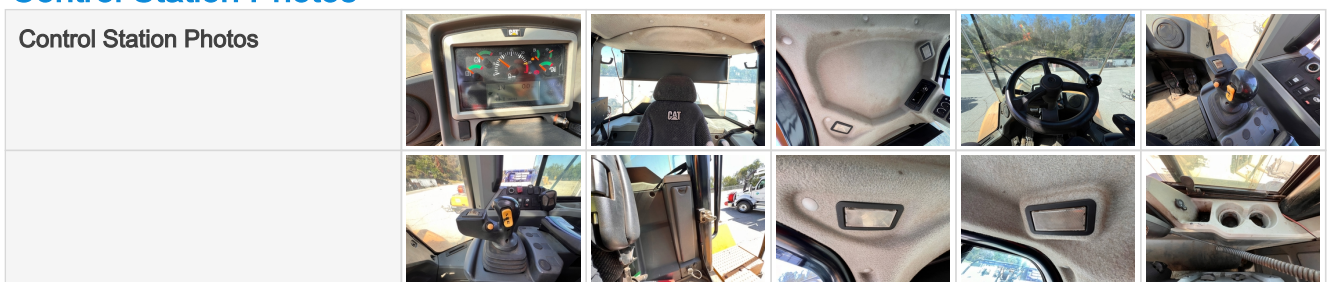
Control Station Photos

Control Station Type	Enclosed Cab (EROPS)
Control Type	Pilot Controls
Control Configuration	N/A
Seat	3 - Normal Wear & Tear
Cabin Lights	1 - Service Required
Cabin Lights Condition	Cabin light system is not operational
Safety Lock Out / Stop	3 - Normal Wear & Tear
Controls & Switches	3 - Normal Wear & Tear
Hour Meter Activity	3 - Normal Wear & Tear
Other Gauge Activity	3 - Normal Wear & Tear
Heater & A/C	3 - Normal Wear & Tear
Travel Alarm	0
Horn	3 - Normal Wear & Tear
Backup Camera	3 - Normal Wear & Tear
Control Station Overall Rating	3 - Normal Wear & Tear

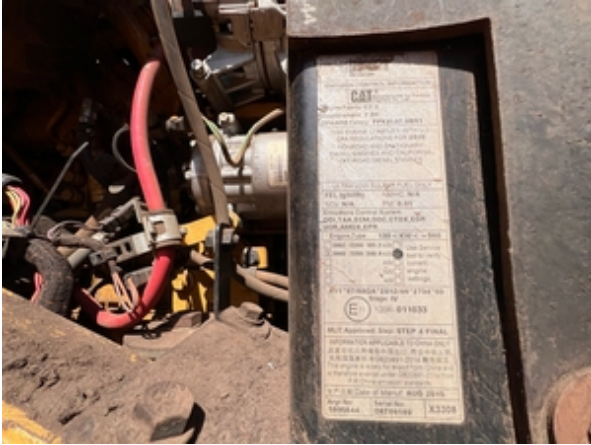
Engine Data Plate

Engine Type (Make, Model, Cylinders, Hp)	CAT C7.1				
Emissions Tier	Undetermined				
Engine Serial Number	D8T09189				
Engine Fuel Type	Diesel				
Blow-by (Visual Observation Check)	No				
Unusual Noises (Upon Start-up, Idle, Shutdown)	No				
Engine Smoke (Upon Start-up, Idle, Shutdown)	No

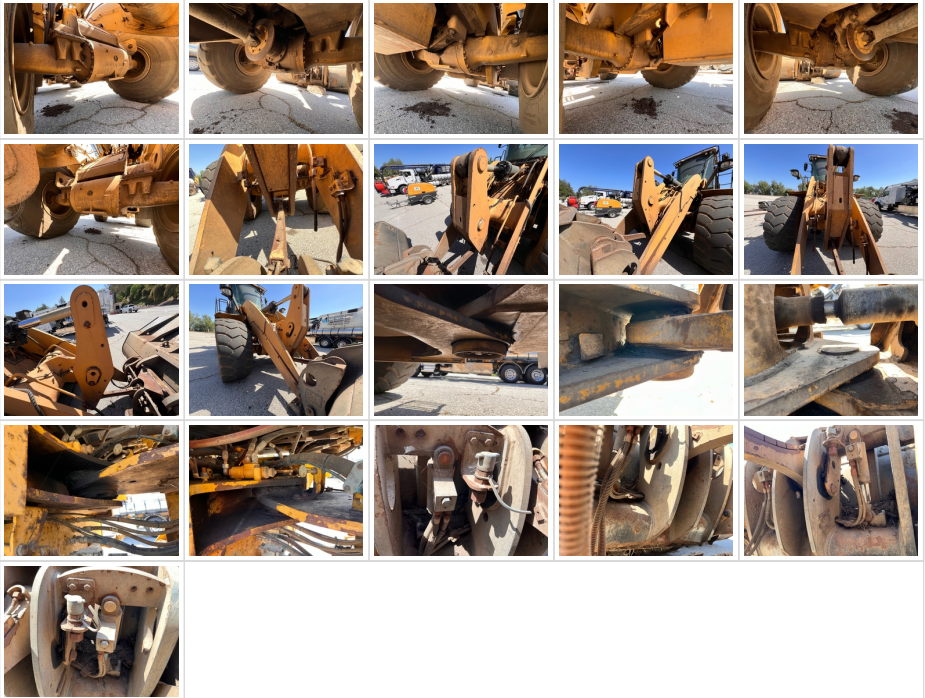
Chassis Photos

Frame	3 - Normal Wear & Tear
Stance	3 - Normal Wear & Tear
Front Axle Appearance	3 - Normal Wear & Tear
Rear Axle Appearance	3 - Normal Wear & Tear
Articulating Center Pin Appearance	3 - Normal Wear & Tear
Lift Arm	3 - Normal Wear & Tear
Chassis to Arm Pins	3 - Normal Wear & Tear
Tilt Linkage	3 - Normal Wear & Tear
Tilt Linkage Pins and Bushings	3 - Normal Wear & Tear
Quick Coupler	3 - Normal Wear & Tear
Quick Coupler to Arms Pins	3 - Normal Wear & Tear
Overall Chassis	3 - Normal Wear & Tear
