General Into	
B&B Stock Number	A6753886
Year	2013
Make	Caterpillar
Model	140M2
Serial Number	M9D01452
Serial Plate Photo	CATERPILAR BRASIL LTDA The distribution was the second process of
Hour Meter Reading	8942
Hour Meter Photo	5
Previous Application (e.g., earth moving, mining, demolition, etc)	Marana,Az

Inspection Report (Motor Grader)

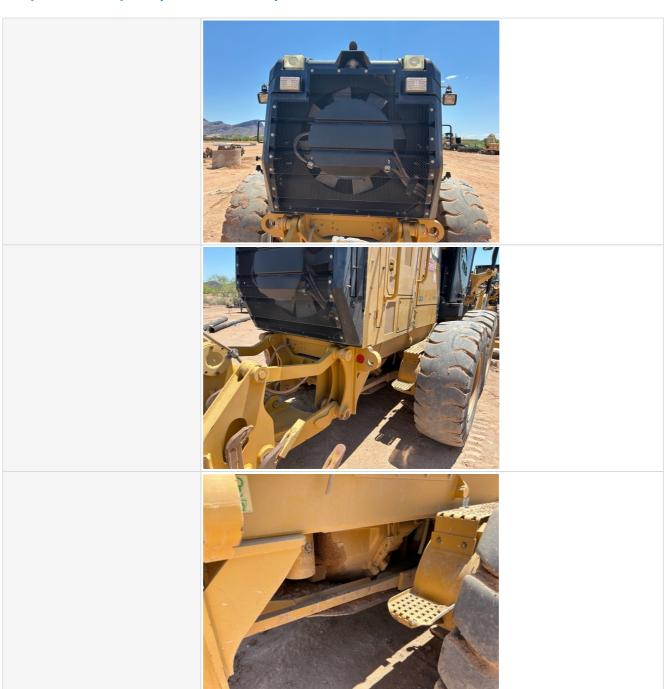
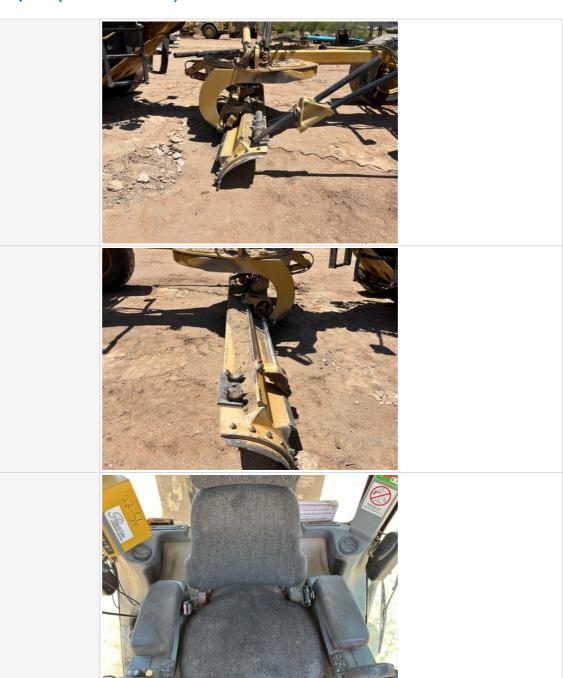
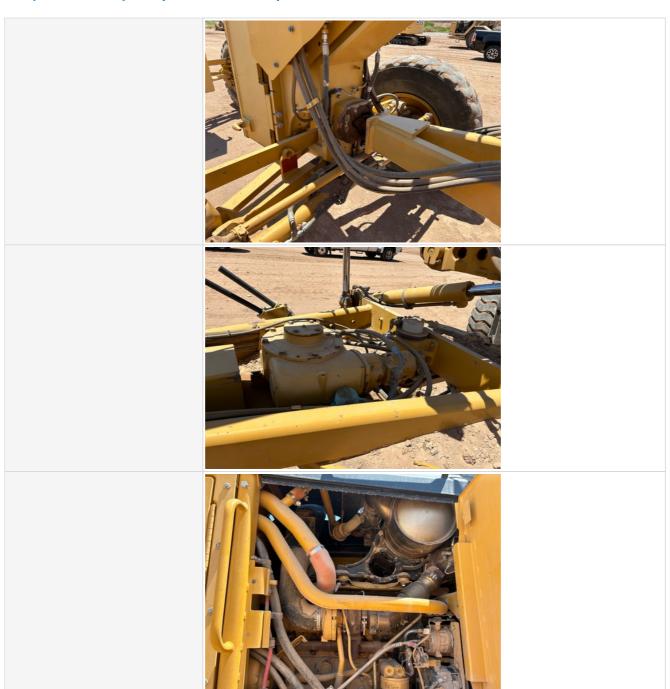
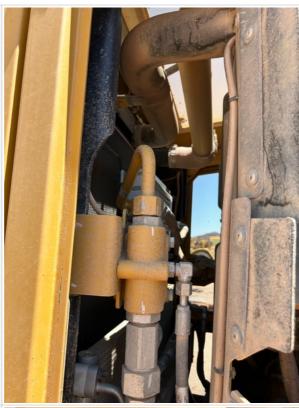
General Appearance Photos

Glass intact, no visible damage
rors 3 - Normal Wear & Tear
ror Condition Mirrors present and intact, no visible damage
erior Lights 3 - Normal Wear & Tear
rerior Lights Condition No visible damage, lighting system is operational
erall Exterior 3 - Normal Wear & Tear
mments Good

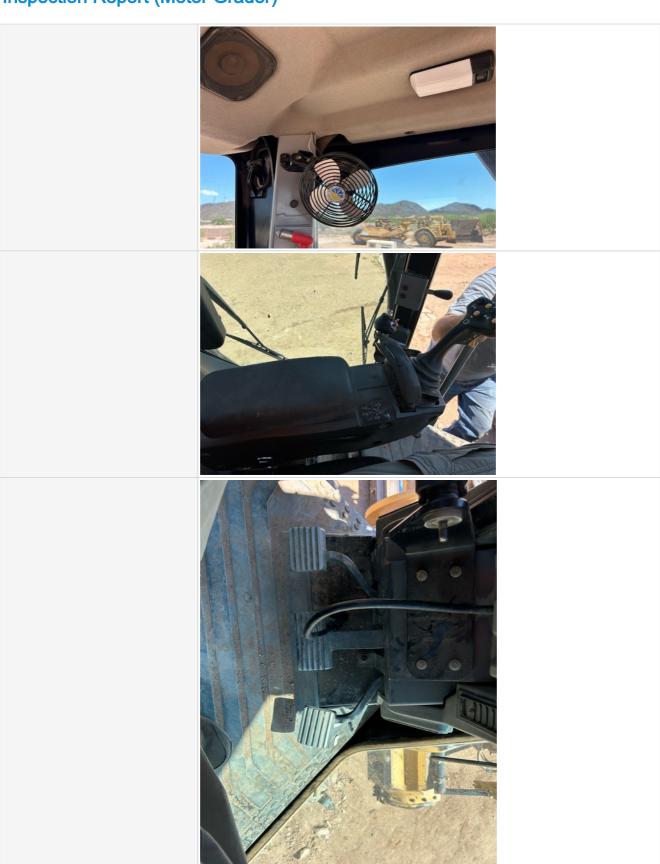
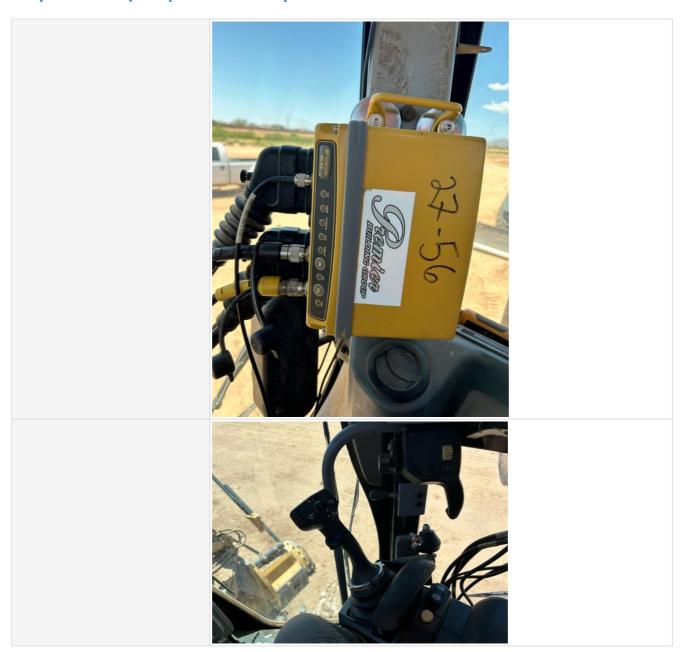
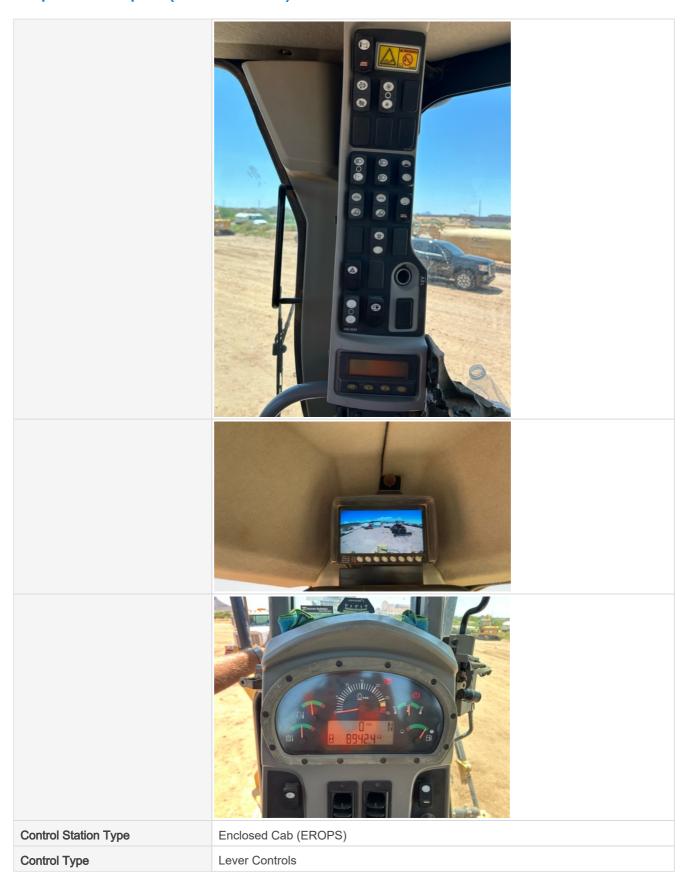
Control Station Photos

Control Configuration	Other
Seat	3 - Normal Wear & Tear
Seat Condition	Seat(s) in good condition, no stains or tears in upholstery
Cabin Lights	3 - Normal Wear & Tear
Cabin Lights Condition	Cabin lights are installed with all light covers in place, bulbs are installed and working properly
Safety Lock Out / Stop	3 - Normal Wear & Tear
Safety Lock Out / Stop Condition	Safety lock out device is present, in good condition, and functional
Controls & Switches	3 - Normal Wear & Tear
Controls & Switches Condition	All switches are installed and functional
Hour Meter Activity	3 - Normal Wear & Tear
Hour Meter Condition	Hour meter is functional and in good condition
Other Gauge Activity	3 - Normal Wear & Tear
Other Gauge Condition	All cockpit gauges are functional and in good condition
Heater & A/C	3 - Normal Wear & Tear
Heater & A/C Condition	Heater and A/C work as expected
Horn	3 - Normal Wear & Tear
Horn Condition	Horn is installed and functioning as expected

Backup Camera	3 - Normal Wear & Tear
Backup Camera Condition	Back up camera is installed and functioning as expected
Control Station Overall Rating	3 - Normal Wear & Tear

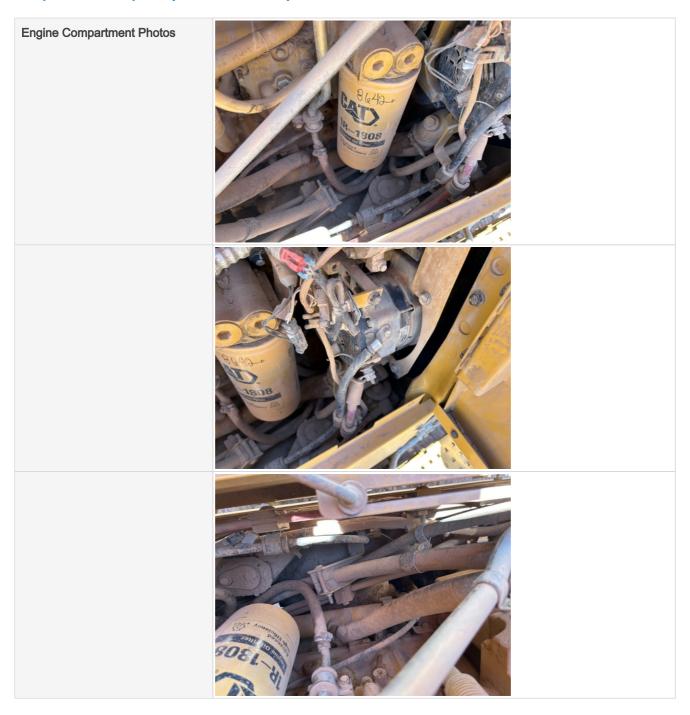
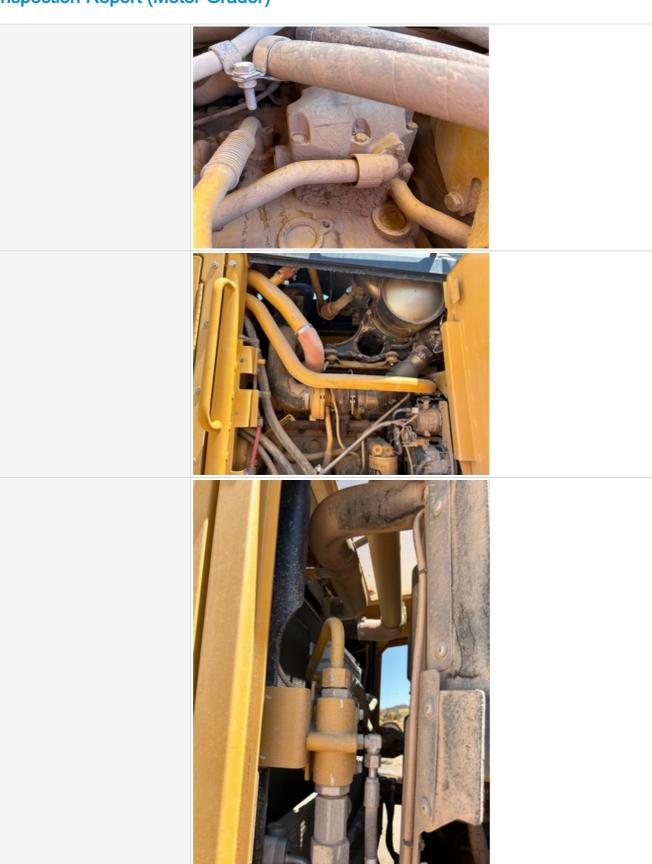
Engine Compartment Photos

Engine Type (Make, Model, Cylinders, Hp)	C-9.3 Acert
Emissions Tier	Tier 4i
Engine Fuel Type	Diesel
Blow-by (Visual Observation Check)	No
Unusual Noises (Upon Start-up, Idle, Shutdown)	No
Engine Smoke (Upon Start-up, Idle, Shutdown)	No
Engine Exhaust Color	Clear
Battery	3 - Normal Wear & Tear
Battery Condition	Clean & dry appearance, tight connections
Radiator	3 - Normal Wear & Tear
Radiator Condition	Radiator fins & components appear to be in good working order, no signs of damage or leaks
Belts	3 - Normal Wear & Tear
Belt Condition	Belts appear in good condition & alignment with proper tension
Hoses	3 - Normal Wear & Tear

Hose Condition	Firm, pliant hoses with no signs of wear or leaks
Cooling System Leaks	No
Coolant Appearance	3 - Normal Wear & Tear
Coolant Appearance Notes	Normal Translucent appearance, no visual signs of contamination
Oil Appearance	3 - Normal Wear & Tear
Oil Appearance Notes	Appropriate oil level
Fuel Leaks	No
Equipped with DPF (Diesel Particulate Filter)	No
Requires DEF (Diesel Exhaust Fluid)	No
Overall Engine Rating	3 - Normal Wear & Tear
Overall Engine Appearance	Dusty & dry
Overall Engine Comments	Good

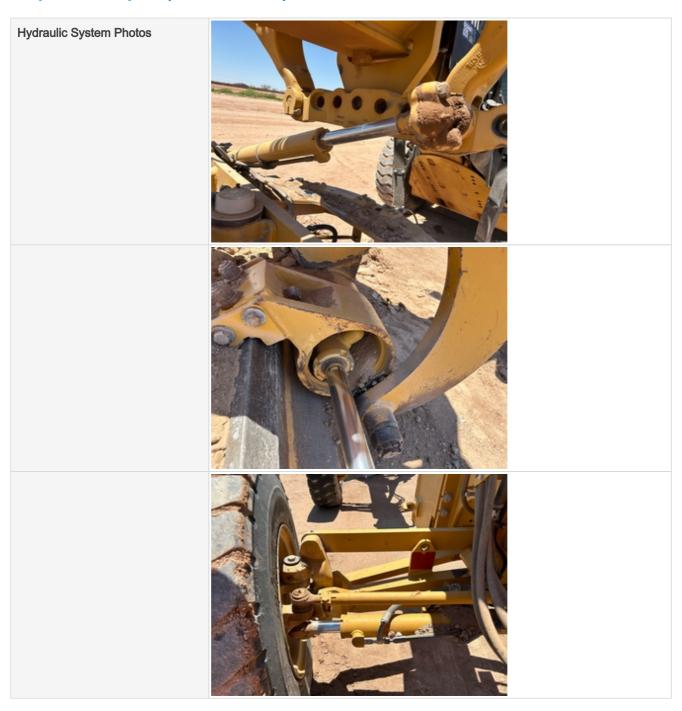
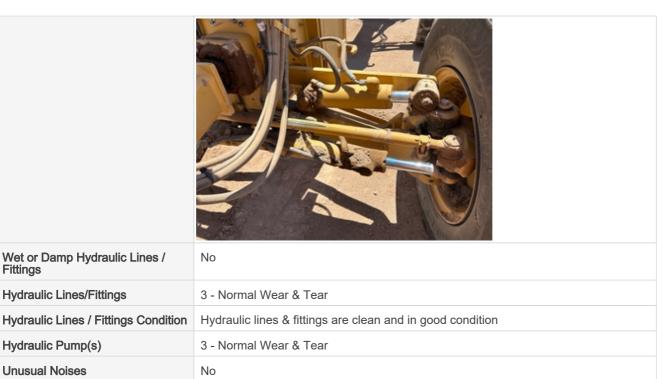
Hydraulic System Inspection Points

No unusual noises heard during operation

Mounting Pins	3 - Normal Wear & Tear
Cylinder Oil Leaks	No
Comments	Good
Hydraulic System Overall	3 - Normal Wear & Tear
