B&B Stock Number	A3796101
Year	2001
Make	Pettibone
Model	8044 Extendo
Serial Number	224
	Market and the state of the sta

Date Submitted: 08-13-2024 03:05 PM

Inspection Report (Telehandler)

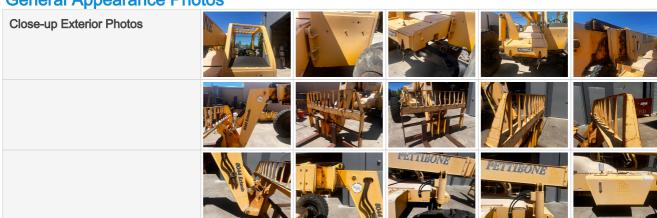
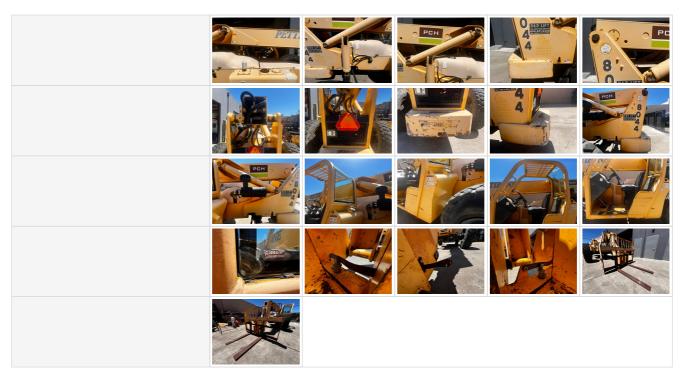
General Appearance Photos

Inspection Rating Criteria	Rating Scale	Explanation
	1 - Service Required	Requires immediate repairs to function as expected.
	2 - Above Average Wear & Tear	Exhibits greater wear than expected given age and usage. While operable, further diagnosis may be needed.
	3 - Normal Wear & Tear	Exhibits wear that is consistent with age and usage. Operation is normal, and as expected.
	4 - Very Light or Minimal Wear	Exhibits very minimal wear. Operation is better than expected given age and usage.
	5 - Like New, Recently Replaced	Excellent condition, free of visible wear or damage. Operation is within factory specifications.
Body Panels	2 - Above Average Wear 8	Tear
Body Panel Condition	Visible chipped paint or de	nts, Areas of surface rust ob
Doors / Canopy Latches	0	
Steps / Ladders	3 - Normal Wear & Tear	
Handrails	3 - Normal Wear & Tear	
Glass	2 - Above Average Wear 8	Tear
Glass Condition	Minor chips or cracks obse	erved

Mirrors	3 - Normal Wear & Tear	
Exterior Lights	0	
Overall Exterior	3 - Normal Wear & Tear	
Comments	Normal wear and tear no n	najor issues to report

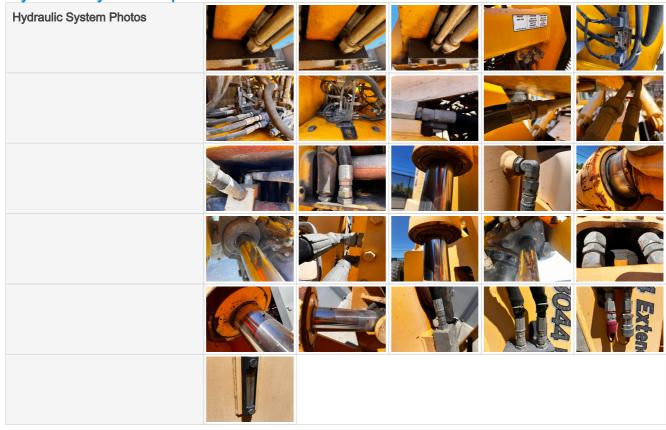
Hydraulic System Inspection Points

Wet or Damp Hydraulic Lines / Fittings	No
Hydraulic Lines/Fittings	3 - Normal Wear & Tear
Hydraulic Pump(s)	3 - Normal Wear & Tear
Unusual Noises	No
Hydraulic Pump Notes	No unusual noises heard during operation
