Inspection Report (On-Highway Truck Cab + Chassis)

B&B Stock Number	A7538858
Year	2003
Make	International
Model	Pro star
Serial Number	3HSDJSJRXD156803
Serial Plate	 
Odometer Reading	202423
Odometer	 
Current Inspection / State Cert / DOT	2023
Previous Application (e.g., earth moving, mining, demolition, etc)	Inner city hauling

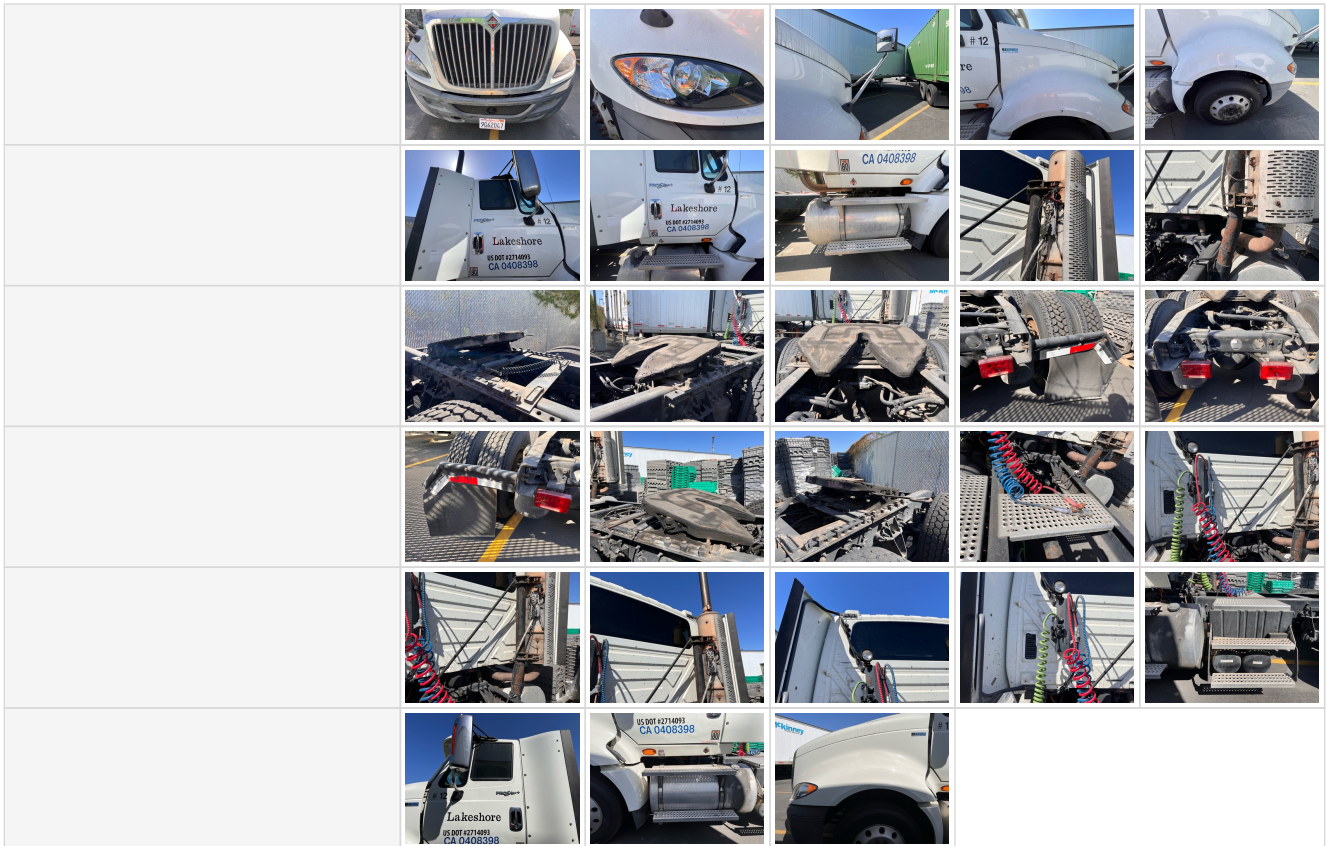
Inspection Rating Criteria	Rating Scale	Explanation
	1 - Service Required	Requires immediate repairs to function as expected.
	2 - Above Average Wear & Tear	Exhibits greater wear than expected given age and usage. While operable, further diagnosis may be needed.
	3 - Normal Wear & Tear	Exhibits wear that is consistent with age and usage. Operation is normal, and as expected.
	4 - Very Light or Minimal Wear	Exhibits very minimal wear. Operation is better than expected given age and usage.
	5 - Like New, Recently Replaced	Excellent condition, free of visible wear or damage. Operation is within factory specifications.
Body Panels	3 - Normal Wear & Tear	
Doors / Canopy Latches	3 - Normal Wear & Tear	
Steps / Ladders	3 - Normal Wear & Tear	
Handrails	3 - Normal Wear & Tear	
Glass	3 - Normal Wear & Tear	
Mirrors	3 - Normal Wear & Tear	
Exterior Lights	3 - Normal Wear & Tear	
Overall Exterior	3 - Normal Wear & Tear

Comments	Normal wear and tear no major issues to report

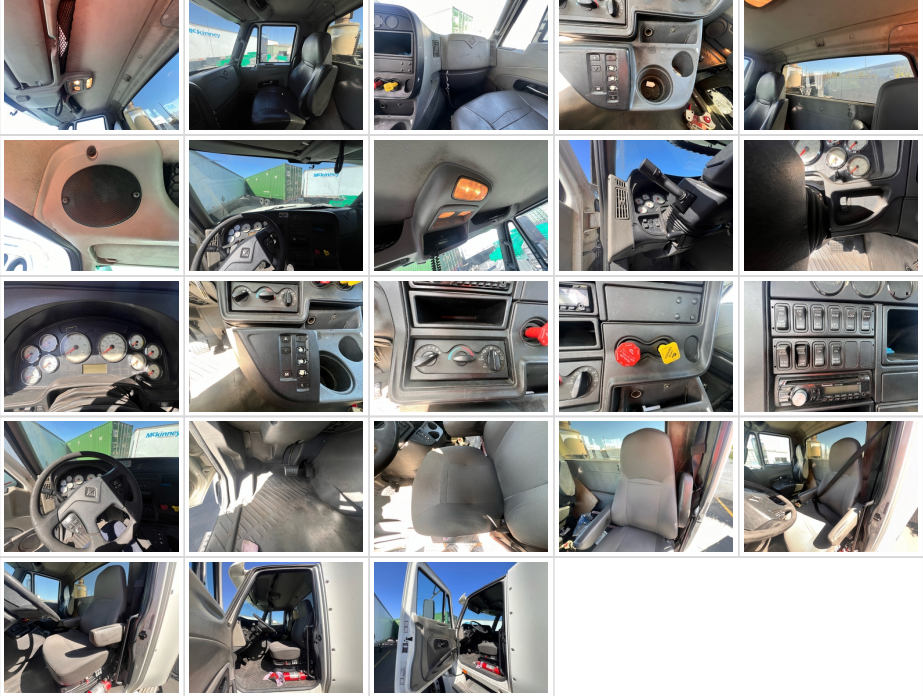
Cab Interior Photos

Odometer Activity	3 - Normal Wear & Tear
Controls/Switches/Gauges	3 - Normal Wear & Tear
Brake System Type	Air Brakes
Air Brakes Build Correct Pressure	Yes
Clutch	0
Horn	3 - Normal Wear & Tear
Reverse Alarm / Backup Camera	0
Heater & A/C	3 - Normal Wear & Tear
Heat & A/C	Heater and A/C work as expected
Interior Lights	4 - Very Light or Minimal Wear
Seats/Seat Belts	3 - Normal Wear & Tear
Cab Interior Overall	3 - Normal Wear & Tear

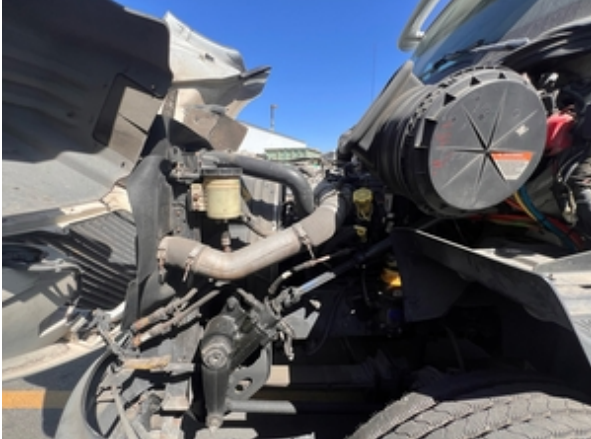
Engine Data Plate

Engine Type (Make, Model, Cylinders, Hp)	Unable to verify
Emissions Tier	Undetermined
Engine Fuel Type	Diesel
Blow-by (Visual Observation Check)	No
Unusual Noises (Upon Start-up, Idle, Shutdown)	No
Engine Smoke (Upon Start-up, Idle, Shutdown)	No
Engine Exhaust Color	Clear
Battery	3 - Normal Wear & Tear
Radiator	3 - Normal Wear & Tear
Belts	3 - Normal Wear & Tear
Hoses	3 - Normal Wear & Tear
Water Pump	3 - Normal Wear & Tear

Cooling System Leaks	No
Coolant Appearance	3 - Normal Wear & Tear
Oil Leaks	No
Oil Appearance	3 - Normal Wear & Tear
Fuel Leaks	No
Equipped with DPF (Diesel Particulate Filter)	Yes
DPF Condition	3 - Normal Wear & Tear
DPF Condition Notes	Filter housing is intact with no signs of damage or malfunction, DPF indicator is not illuminated
Requires DEF (Diesel Exhaust Fluid)	No
Overall Engine Rating	2 - Above Average Wear & Tear
Overall Engine Appearance	Areas of dried seepage seen on engine hoses & components
Overall Engine Comments	Engine shows sign of above average wear and tear due to dried seepage on engine components

What Needs Work	The thing that needs work on this truck is the dried seepage on a few of the components in the engine compartment	
Date/Time	06-25-2024	
Inspector Name	Javier Bocanegra
