## Inspection Report (Wheel Loader)

B&B Stock Number	A5676528
Year	2015
Make	Caterpillar
Model	962M
Serial Number	CAT0962MHEJB00301
Serial Plate Photo

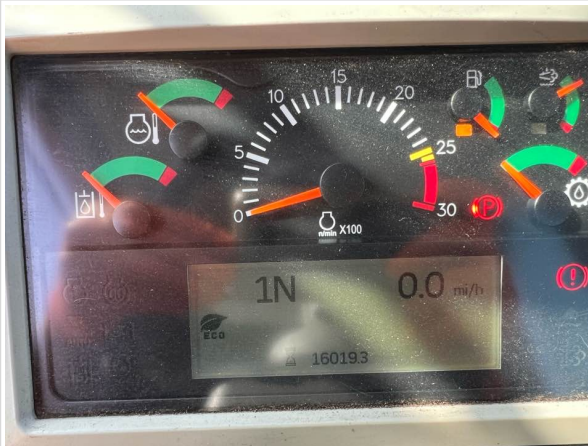
Hour Meter Reading	16019
Single Photo

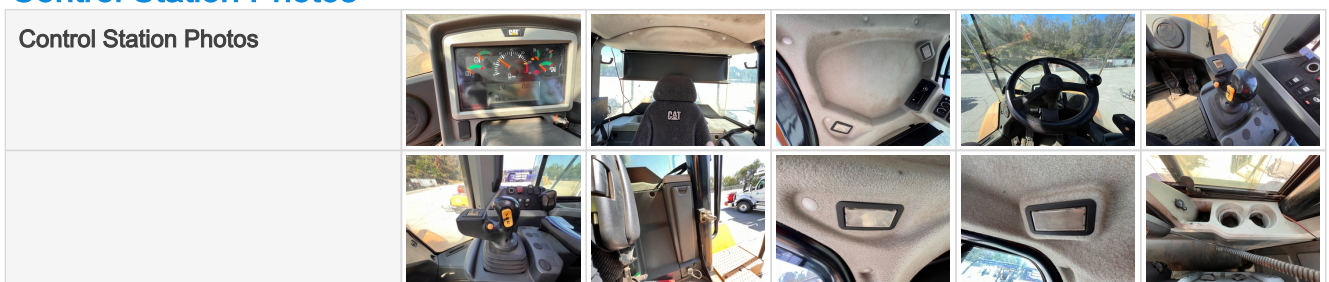
#### Control Station Photos

Control Station Type	Enclosed Cab (EROPS)				
Control Type	Pilot Controls				
Control Configuration	N/A				
Seat	3 - Normal Wear & Tear				
Cabin Lights	1 - Service Required				
Cabin Lights Condition	Cabin light system is not operational				
Safety Lock Out / Stop	3 - Normal Wear & Tear				
Controls & Switches	3 - Normal Wear & Tear				
Hour Meter Activity	3 - Normal Wear & Tear				
Other Gauge Activity	3 - Normal Wear & Tear				
Heater & A/C	3 - Normal Wear & Tear				
Travel Alarm	0				
Horn	3 - Normal Wear & Tear				
Backup Camera	3 - Normal Wear & Tear				
Control Station Overall Rating	3 - Normal Wear & Tear

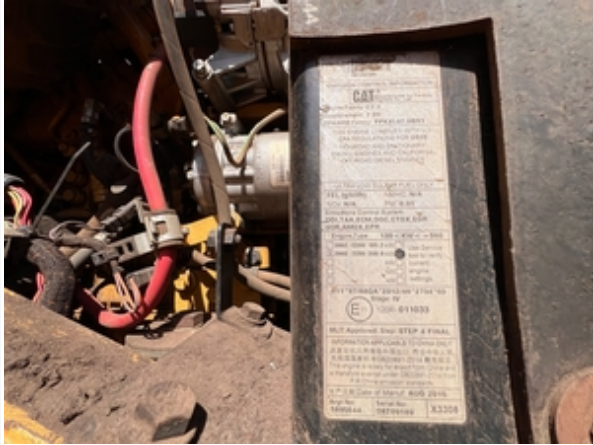
Engine Data Plate

Engine Type (Make, Model, Cylinders, Hp)	CAT C7.1
Emissions Tier	Undetermined
Engine Serial Number	D8T09189
Engine Fuel Type	Diesel
Blow-by (Visual Observation Check)	No
Unusual Noises (Upon Start-up, Idle, Shutdown)	No
Engine Smoke (Upon Start-up, Idle, Shutdown)	No
