Inspection Report (Trailer)

B&B Stock Number	A3830712
Year	2022
Make	AM
Model	AM360 2000GN
Serial Number	SN#PL200330 VIN#2M9FGH2A8PL200330
Serial Plate Photo	 
Current Inspection / State Cert / DOT	NA
Previous Application (e.g., earth moving, mining, demolition, etc)	Forestry

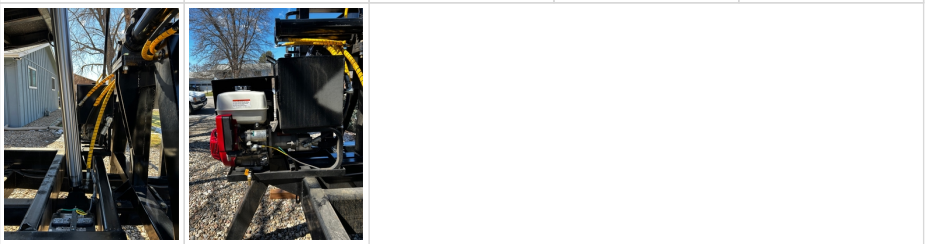
Hydraulic System Photos

Wet or Damp Hydraulic Lines / Fittings	No
Hydraulic Lines/Fittings	4 - Very Light or Minimal Wear
Hydraulic Lines / Fittings Condition	Hydraulic lines & fittings are clean and in good condition
Hydraulic Pump(s)	4 - Very Light or Minimal Wear
Unusual Noises	No
Hydraulic Pump Notes	No unusual noises heard during operation

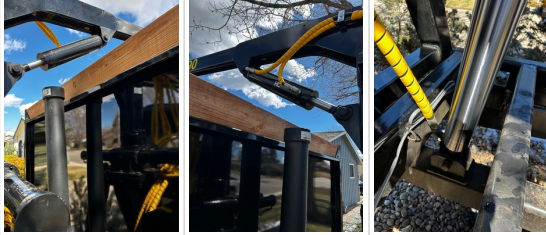
Hydraulic Cylinder Photos

Mounting Pins	4 - Very Light or Minimal Wear	
Cylinder Oil Leaks	No	
Comments	Entire unit is dry with no seepage seen. Only visible oil is seen below engine from changing oil of engine	
Hydraulic System Overall	4 - Very Light or Minimal Wear	
Comments	Seller added hydraulic hose protection after the trailer was purchased. No hose damage or seepage can be seen
