### **General Info**

B&B Shock NumberAdd23375Year2015MakeDodgeModelRan 4500VIN NumberSoftwareSarlai or VIN PlateImage: Sarlai or VIN PlateOcometer Reading1299Cometer Reading1299	General IIIIO	
MakeDodgeModelRm 4500VIN NumberGrWRLFL7FG589073Serial or VIN PlateImage: Constant of the series of the ser	B&B Stock Number	A4025375
ModelRam 4500VIN Number3c7/VRLFL/FG589073Serial or VIN PlateImage: Constant of the second o	Year	2015
N1 Number       5:7/WELFL7EG589073         Serial or VIN Plate       Image: Constant of the plane o	Make	Dodge
Sorial or VIN Plate       Image: Constant of VIN Plate         Odometer Reading       21293         Odometer Reading       Image: Constant of VIN Plate         Odometer       Image: Constant of VIN Plate	Model	Ram 4500
Odometer Reading1293Odometer Reading21293	VIN Number	
Odometer	Serial or VIN Plate	ALLER and Address 12 million and Address 12 million and Address 12 million and Address 12 million address 12

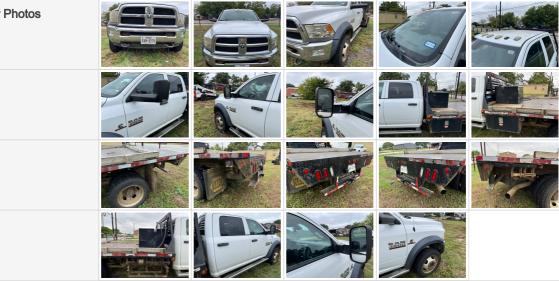
Close-up Exterior Photos

Inspection Rating Criteria	Rating Explanation		
	5	Light or minimal wear for its age	
	4	Expected wear and tear for its age, operates as expected	
	3	Above average wear and tear for its age, still operates as expected	
	2	Heavy wear, is operable but needs attention	
	1	Requires repair(s) to function as expected	
Body Panels	4 - Expec	ted Wear - Fully Operable	
Body Panel Condition	Good paint condition and panel fitment		
Doors / Canopy Latches	4 - Expected Wear - Fully Operable		
Doors / Canopy Latches Condition	No visible	e damage	
Steps / Ladders	4 - Expec	ted Wear - Fully Operable	
Handrails	4 - Expec	ted Wear - Fully Operable	
Glass	3 - Notab	le Wear - Fully Operable	
Glass Condition	Minor chi	ps or cracks observed	
Mirrors	4 - Expected Wear - Fully Operable		
Exterior Lights	5 - Very Light or Minimal Wear		
Overall Exterior	4 - Expected Wear - Fully Operable		
Comments	Exterior is in good overall condition. Crack and chip on the windshield is only item note.
