## Inspection Report (Trailer)

B&B Stock Number	A9648646
Year	2021
Make	BigTex
Model	22gn-25bk+5mr
Serial Number	16v3f3820n6148483
Serial Plate Photo

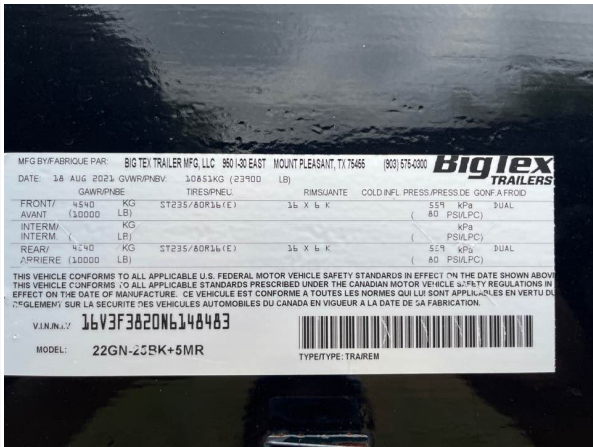
VIN Number	16v3f3820n6148483
VIN Plate Photo

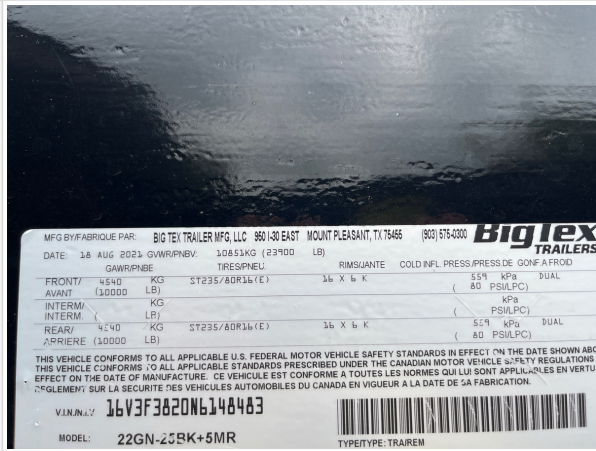
Data Plate Photo

Length (ft and inches)	Spec
Width (ft and inches)	102", bed 97"
Max Height (ft and inches)	88"
Dock Height (ft and inches)	35"
GVWR (lbs)	23900
GAWR (lbs)	10,000 front/rear

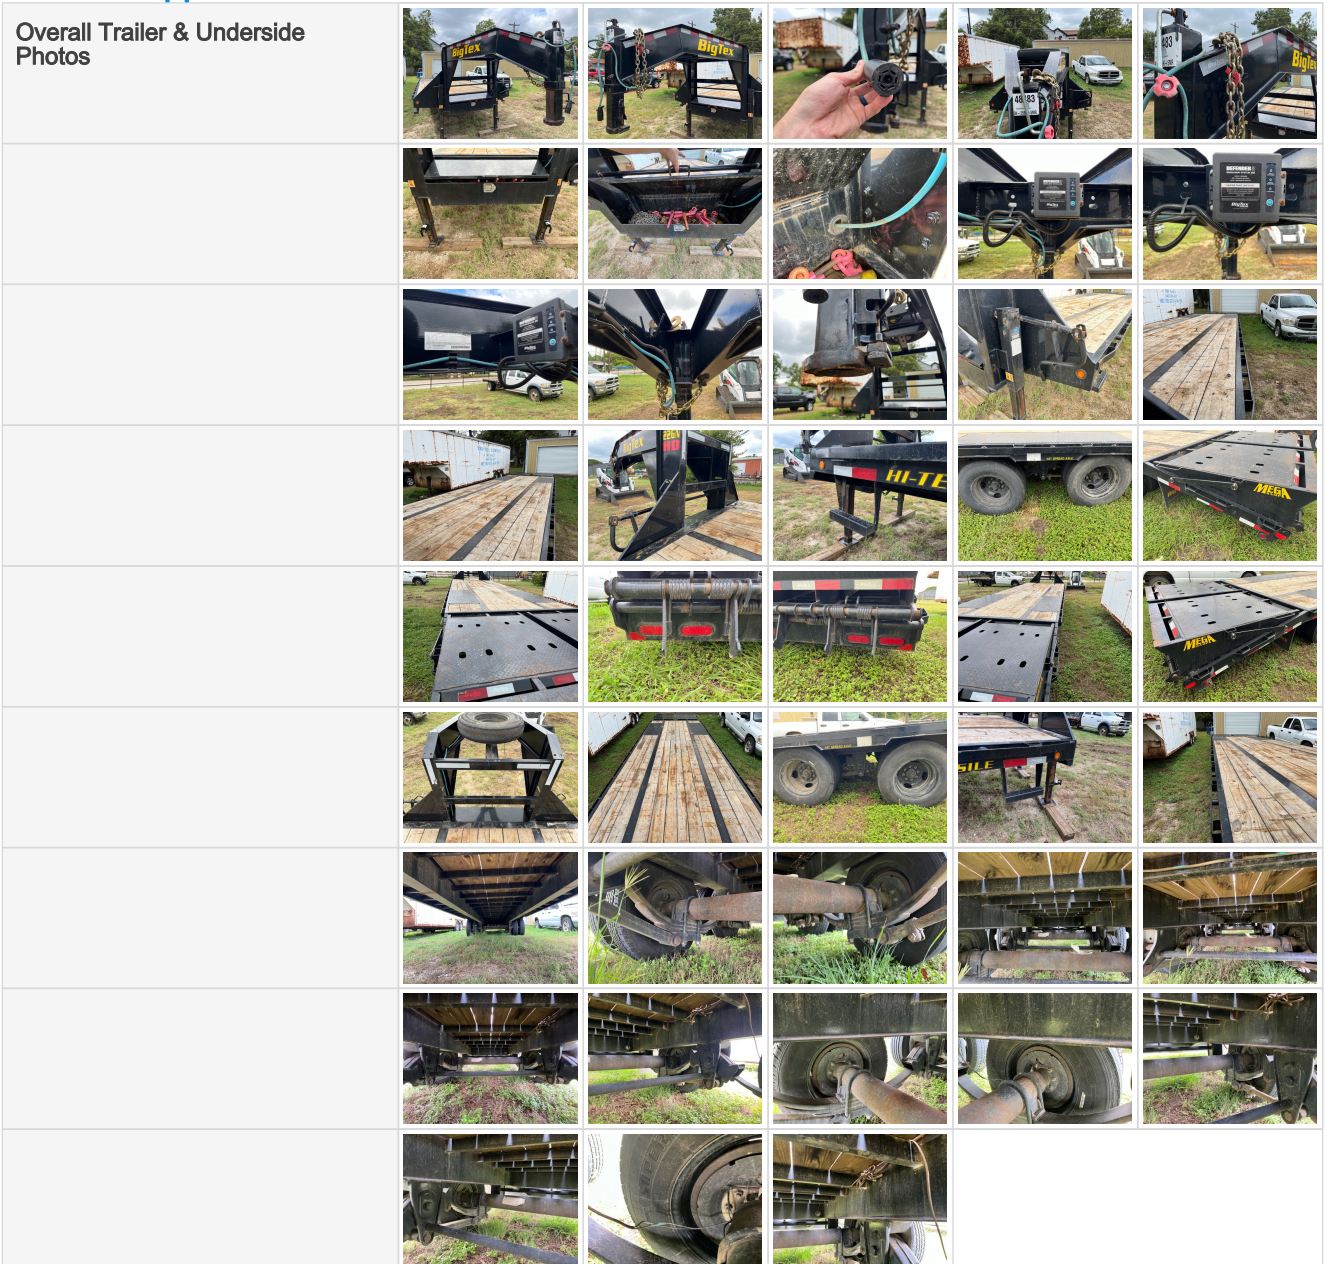
Overall Trailer & Underside Photos

Frame Condition	5 - Very Light or Minimal Wear
Deck	4 - Expected Wear - Fully Operable
