Inspection Report (Forklift)

B&B Stock Number	A4166689
Year	2021
Make	Doosan
Model	G25n-7
Serial Number	Fga14-1290-06897
Serial Plate Photo

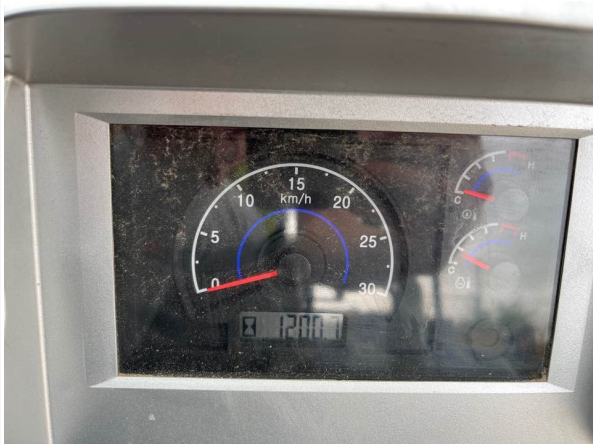
Engine Hour Meter Reading	1200
Engine Hour Meter Photo

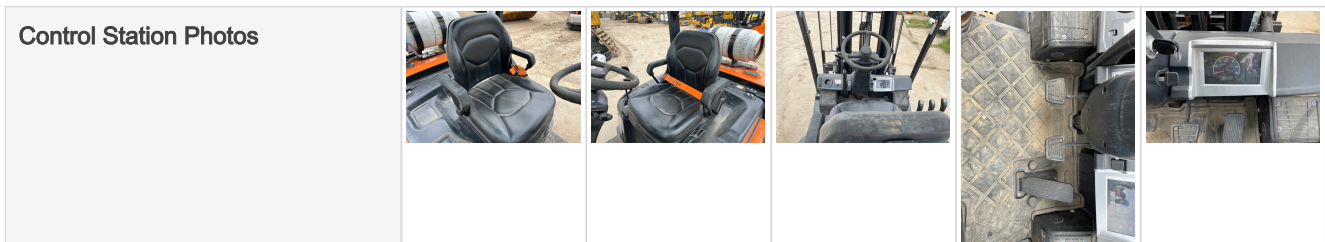
Control Station Photos

Control Station Type	Open Cab (OROPS)
Control Type	Other
Control Configuration	N/A
Seat	4 - Expected Wear - Fully Operable
Seat Condition	Seat in good condition, no stains or tears in upholstery
Cabin Lights	0
Safety Lock Out / Stop	4 - Expected Wear - Fully Operable
Controls & Switches	4 - Expected Wear - Fully Operable
Hour Meter Activity	4 - Expected Wear - Fully Operable
Other Gauge Activity	4 - Expected Wear - Fully Operable
Heater & A/C	0
Travel Alarm	4 - Expected Wear - Fully Operable
Horn	4 - Expected Wear - Fully Operable
Backup Camera	0
Control Station Overall Rating	4 - Expected Wear - Fully Operable

29.771249, -95.174225
Control Station Overall Condition	Good cabin appearance, solid floors, panels, and ceiling

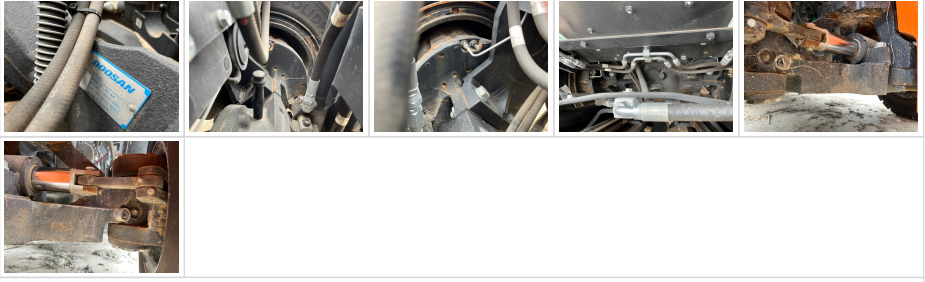
Drivetrain Photos

Hydrostatic Transmission?	No
Transmission Info (Make/Model/Speeds)	Doosan - see photos
Drive Type	2WD
Differential Lock	No
Transmission Components	4 - Expected Wear - Fully Operable
Parking Brake	4 - Expected Wear - Fully Operable
Overall Drivetrain Rating	4 - Expected Wear - Fully Operable
Overall Drivetrain Comments	Drive train in good shape
Front Axle	4 - Expected Wear - Fully Operable
Rear Axle	4 - Expected Wear - Fully Operable

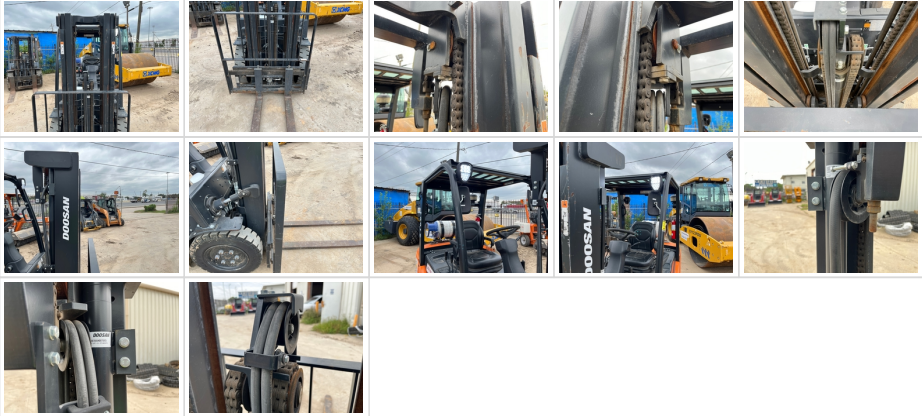
Chassis Photos

Frame	4 - Expected Wear - Fully Operable
Stance	4 - Expected Wear - Fully Operable
Carriage Appearance	4 - Expected Wear - Fully Operable
Mast Condition	4 - Expected Wear - Fully Operable
Chain / Tensioners	4 - Expected Wear - Fully Operable
Rollers & Guides	4 - Expected Wear - Fully Operable
Overall Chassis	4 - Expected Wear - Fully Operable

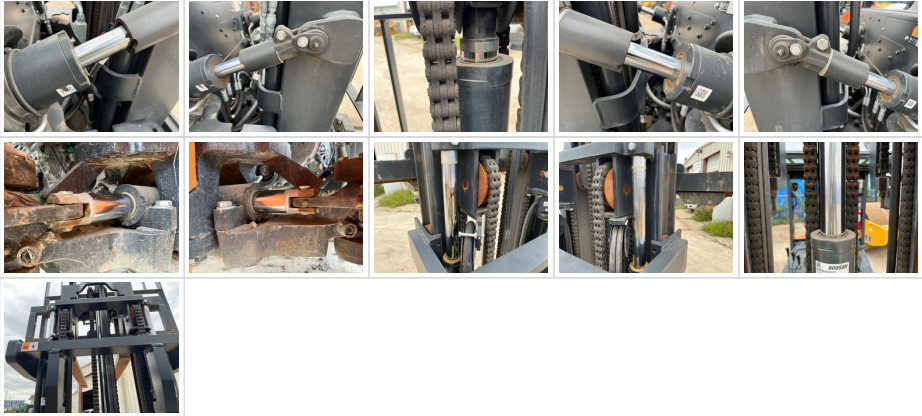
Hydraulic Cylinder Photos

Mounting Pins	4 - Expected Wear - Fully Operable				
Cylinder Oil Leaks	No				
Hydraulic System Overall	4 - Notable Wear - Fully Operable				
Comments	Dry and operates smoothly
