Inspection Report (Forklift)

| B&B Stock Number | A3029199 |
| Make | Doosan |
| Model | G25E-7 |

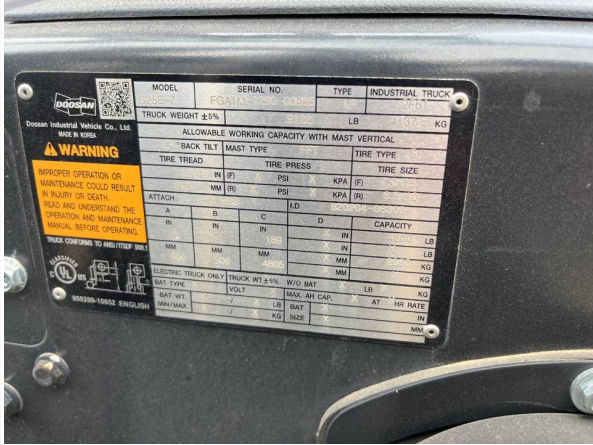
| Serial Plate Photo | |

| Serial Number | Fga1m-1290-00986 |

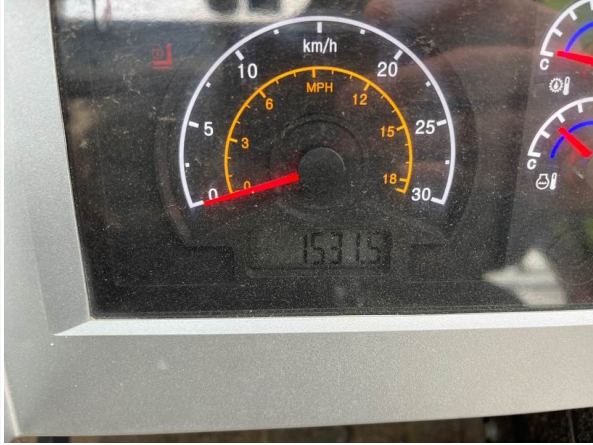
| Engine Hour Meter Photo | |

| Engine Hour Meter Reading | 1531 |

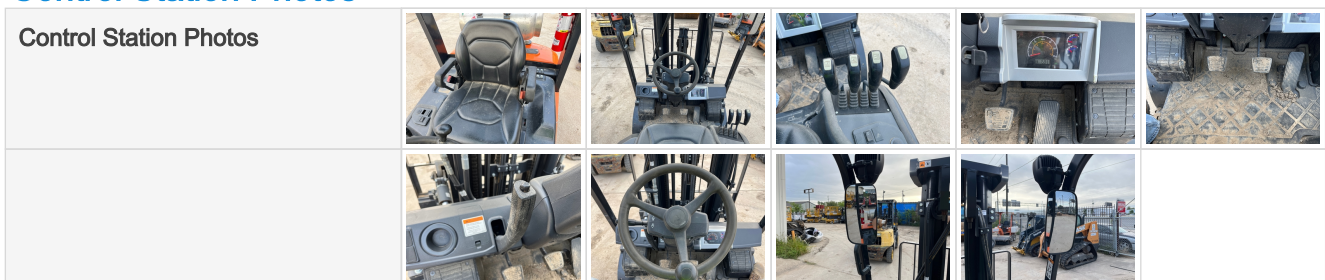
Control Station Photos

| Control Station Overall Rating | 4 - Expected Wear - Fully Operable |
| Control Station Overall Condition | Good cabin appearance, solid floors, panels, and ceiling |

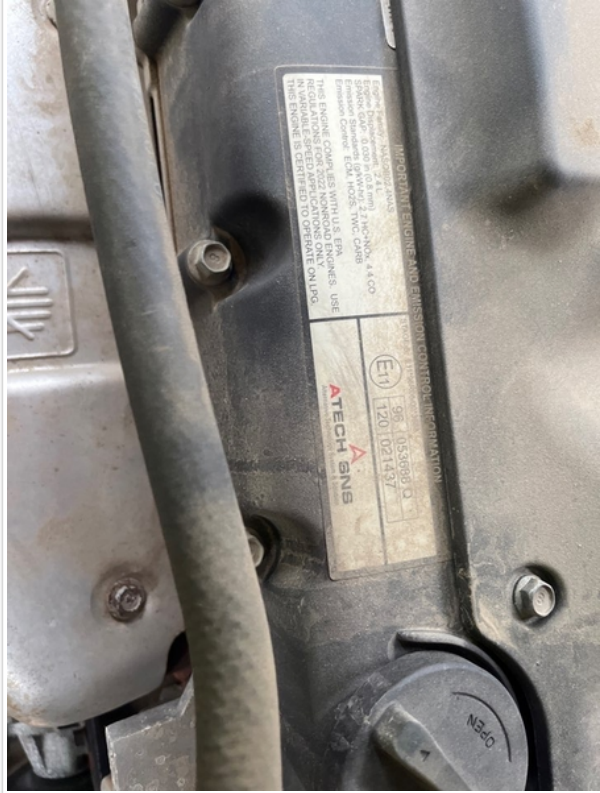
| Engine Data Plate | | | | | |

| Overall Engine Rating | 4 - Expected Wear - Fully Operable |
| Overall Engine Appearance | Clean & dry |
| Overall Engine Comments | Engine appears to run smoothly with no audible or visual issues. |

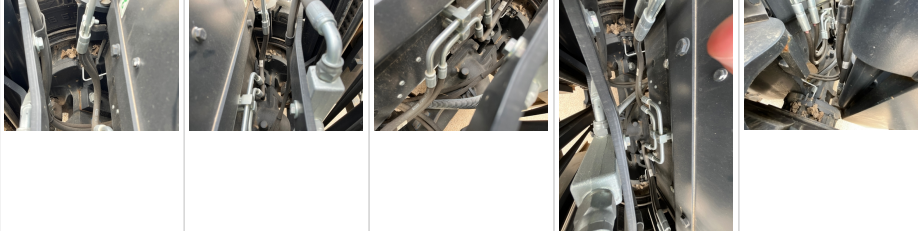
| Drivetrain Photos | |

| Transmission Condition | Good forward and reverse function |
| Overall Drivetrain Rating | 4 - Expected Wear - Fully Operable |
| Overall Drivetrain Comments | Appears to be in good working order. |

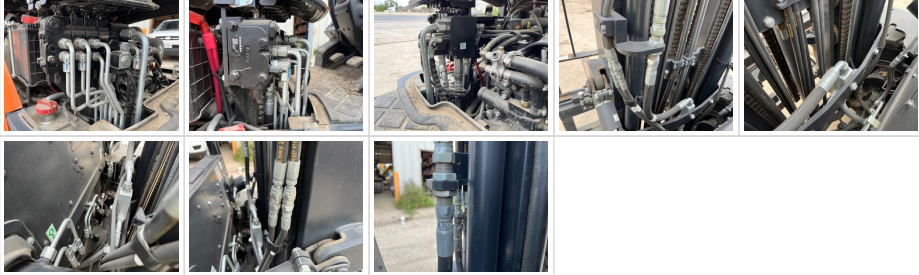
| Hydraulic System Photos | |

| Hydraulic Lines / Fittings Condition | Hydraulic lines & fittings are clean and in good condition |
| Hydraulic Pump Notes | No unusual noises heard during operation |

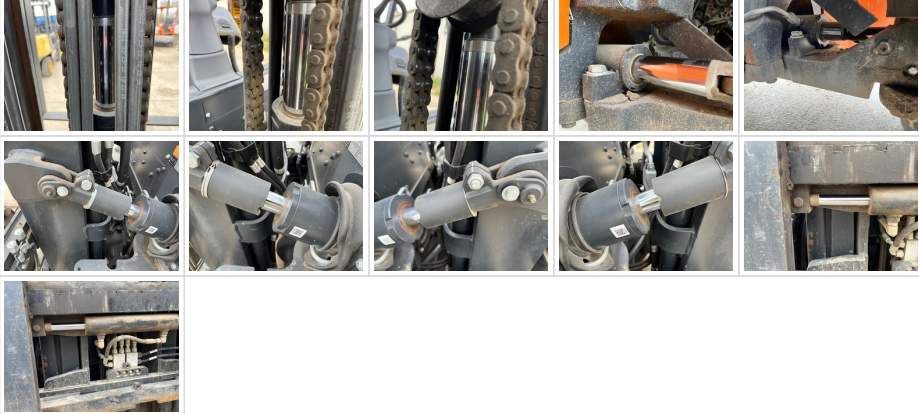
| Hydraulic Cylinder Photos | |

| Mounting Pins | 4 - Expected Wear - Fully Operable |
| Cylinder Oil Leaks | No |
| Hydraulic System Overall | 4 - Notable Wear - Fully Operable |

| Comments | Operates smoothly |
