## Inspection Report (Excavator)

B&B Stock Number	A1442432
Year	2021
Make	Sany
Model	SY365C LC
Serial Number	SY036MCA00388
Serial Plate Photo

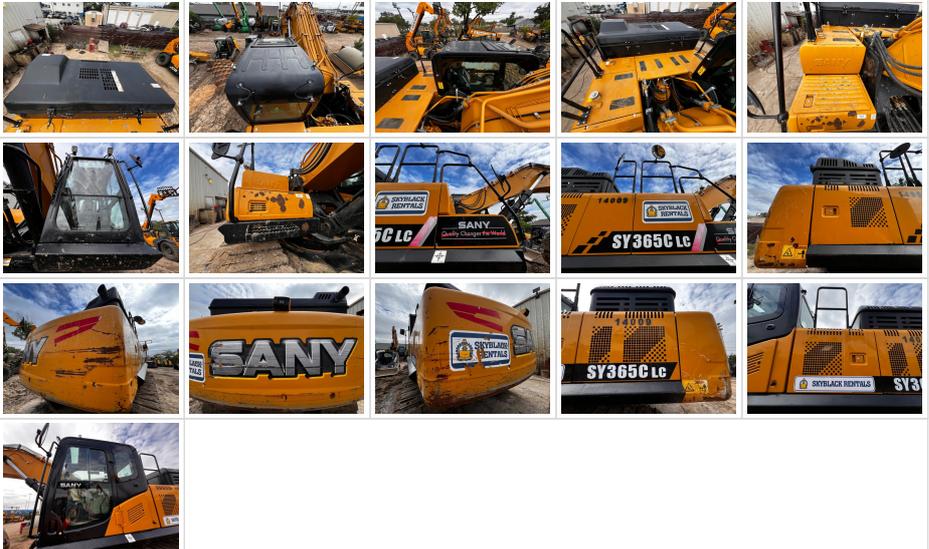
Close-up Exterior Photos

Inspection Rating Criteria	Rating	Explanation
	5	Light or minimal wear for its age
	4	Expected wear and tear for its age, operates as expected
	3	Above average wear and tear for its age, still operates as expected
	2	Heavy wear, is operable but needs attention
	1	Requires repair(s) to function as expected
Body Panels	4 - Expected Wear - Fully Operable	
Body Panel Condition	Expected chipped paint or dents for its age.	
Doors / Canopy Latches	5 - Very Light or Minimal Wear	
Steps / Ladders	4 - Expected Wear - Fully Operable	
Handrails	5 - Very Light or Minimal Wear	
Glass	5 - Very Light or Minimal Wear	
Mirrors	5 - Very Light or Minimal Wear	
Exterior Lights	5 - Very Light or Minimal Wear	
Overall Exterior	5 - Very Light or Minimal Wear	
Comments	Light to minimal wear due to age of machine no major issues to report

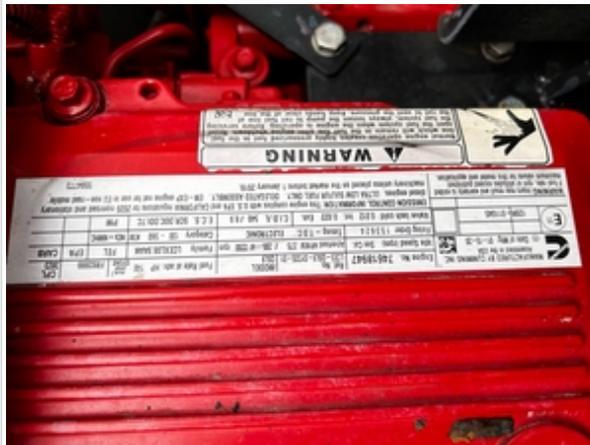
Engine Data Plate

<b>Engine Type (Make, Model, Cylinders, Hp)</b>	Cummins, QSL9
<b>Emissions Tier</b>	Tier 4F
<b>Engine Serial Number</b>	74618947
<b>Engine Fuel Type</b>	Diesel
<b>Blow-by (Visual Observation Check)</b>	No
<b>Unusual Noises (Upon Start-up, Idle, Shutdown)</b>	No
<b>Engine Smoke (Upon Start-up, Idle, Shutdown)</b>	No
<b>Engine Exhaust Color</b>	Clear
<b>Battery</b>	5 - Very Light or Minimal Wear
<b>Radiator</b>	5 - Very Light or Minimal Wear
<b>Belts</b>	4 - Expected Wear - Fully Operable
<b>Hoses</b>	5 - Very Light or Minimal Wear
<b>Water Pump</b>	5 - Very Light or Minimal Wear
<b>Cooling System Leaks</b>	No
<b>Coolant Appearance</b>	4 - Expected Wear - Fully Operable
<b>Oil Leaks</b>	No
<b>Oil Appearance</b>	4 - Expected Wear - Fully Operable
<b>Fuel Leaks</b>	No
<b>Equipped with DPF (Diesel Particulate Filter)</b>	Yes
<b>DPF Condition</b>	5 - Very Light or Minimal Wear
<b>DPF Condition Notes</b>	Filter housing is intact with no signs of damage or malfunction, DPF indicator is not illuminated

Overall Engine Appearance	Areas of dried seepage seen on engine hoses & components
Overall Engine Comments	Expected wear and tear due to machines age no major issues to report

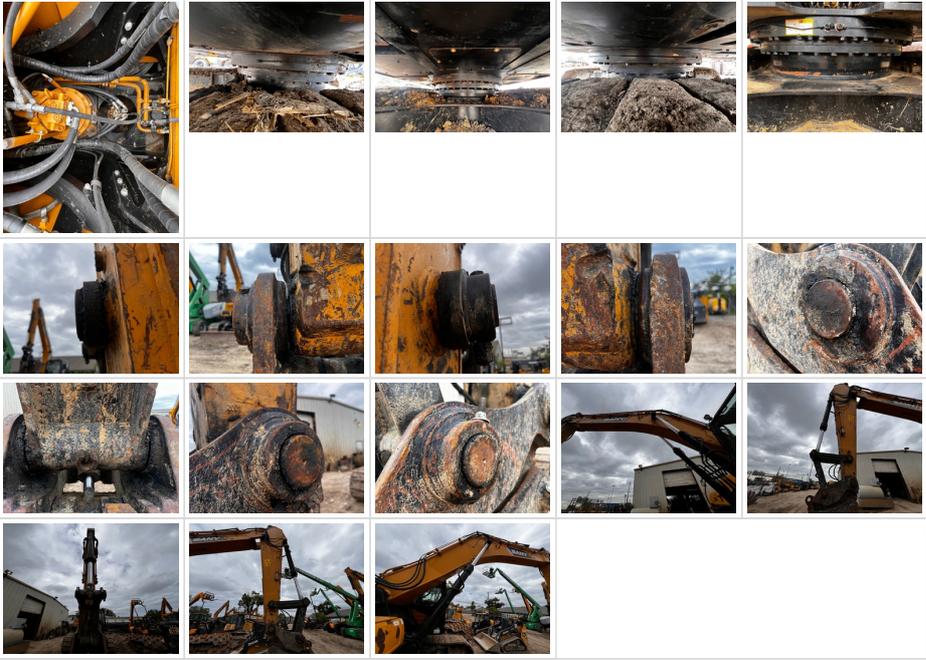
Chassis Photos

Boom Condition	5 - Very Light or Minimal Wear
Stick Condition	5 - Very Light or Minimal Wear
Boom Base Pin & Bushings	4 - Expected Wear - Fully Operable
Boom to Stick Pin & Bushings	4 - Expected Wear - Fully Operable

Stick to Bucket Pin & Bushings	4 - Expected Wear - Fully Operable
Turntable Bearing	5 - Very Light or Minimal Wear
Bottom Covers	5 - Very Light or Minimal Wear
Overall Chassis	5 - Very Light or Minimal Wear
Overall Chassis Comments	Expected wear and tear for machines age no major issues to report

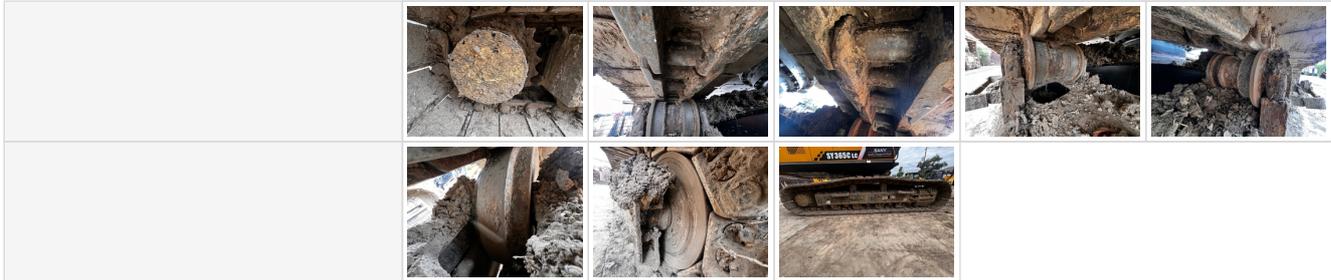
Undercarriage Photos

Sprocket Teeth	4 - Expected Wear - Fully Operable
Track Bushings	4 - Expected Wear - Fully Operable
Track Frames	4 - Expected Wear - Fully Operable
Pivot Shafts	0
Equalizer Bar & Joints	0
Front Idler	4 - Expected Wear - Fully Operable
Track Tensioner	4 - Expected Wear - Fully Operable
Track links	4 - Expected Wear - Fully Operable
Bottom Rollers	4 - Expected Wear - Fully Operable
Carrier Rollers	4 - Expected Wear - Fully Operable
Overall Undercarriage	4 - Expected Wear - Fully Operable
Overall Percent Estimate	70%
Overall Undercarriage Comments	Expected wear and tear due to age of machine no major issues to report
