General Info		
B&B Stock Number	A9940413	
Year	2021	
Make	JCB	
Model	215T	
Serial Number	GE03BWFDLM3075413	
Serial Plate Photo	JCB MANUFACTURING INC. 2000 BAMFORD BOULEVARD POOLER, GA 31322 USA DESIGNATION LOADER DISCHOLING BASS DESIGNATION SS.A. @ 2800 DESIGNATION SS.A. @ 2800 DESIGNATION SS.A. @ 2800 DESIGNATION TEAR OF MANUFACTURE PAXXXX TEAR OF MODEL ASSEMBLED IN USA 3367	
Hour Meter Reading	847.9	
Hour Meter Photo		
Previous Application (e.g., earth moving, mining, demolition, etc)	Construction

Inspection Report (Skid Steer/Track Loader)

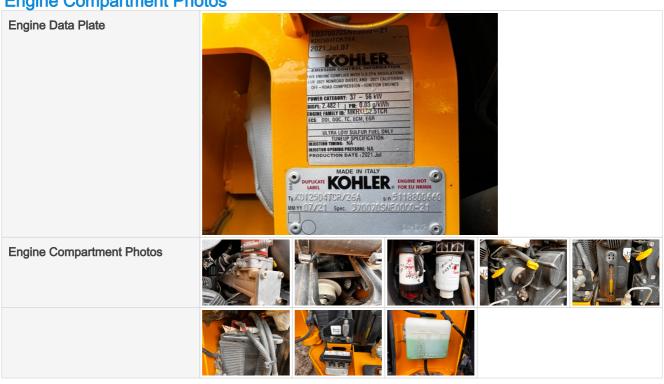
Engine Compartment Photos

Overall Engine Appearance	Clean & dry
Overall Engine Comments	Expected where in tear due to machines age no major issues to report

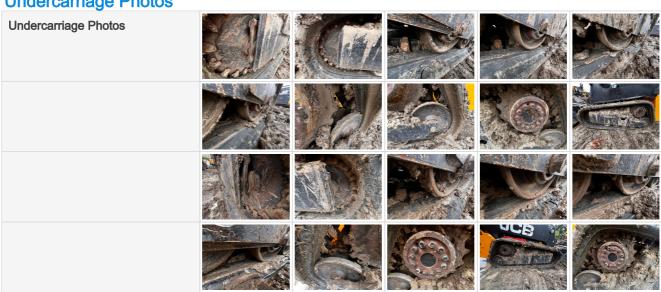
Undercarriage Photos

inspection Points	
Track Width (inches)	13"
Roller Frames	4 - Expected Wear - Fully Operable
Track Belt	3 - Notable Wear - Fully Operable
Rubber Belt Drive Lugs	4 - Expected Wear - Fully Operable
Track Tensioners	4 - Expected Wear - Fully Operable
Front Idlers	4 - Expected Wear - Fully Operable
Rear Idlers	0
Track Rollers	4 - Expected Wear - Fully Operable
Sprockets	4 - Expected Wear - Fully Operable
Overall Undercarriage Rating	4 - Expected Wear - Fully Operable
Left Track Belt - Percent Remaining Estimate	50%
Right Track Belt - Percent Remaining Estimate	50%
Overall Comments	Expected wear and tear due to machines age no major issues to report

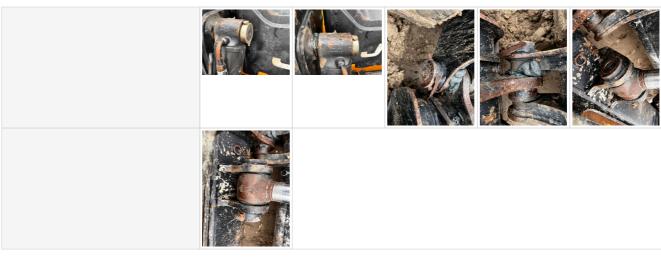
Chassis Photos

Chassis inspection Folitis			
Frame	4 - Expected Wear - Fully Operable		
Stance	4 - Expected Wear - Fully Operable		
Lift Arms	4 - Expected Wear - Fully Operable		
Chassis to Arm Pins	4 - Expected Wear - Fully Operable		
Quick Coupler	4 - Expected Wear - Fully Operable		
Quick Coupler to Arms Pins	4 - Expected Wear - Fully Operable		
Overall Chassis	4 - Expected Wear - Fully Operable		
Overall Chassis Comments	Expected wear and tear due to missing no major issues to report
