Inspection Report (Boom Lift)

B&B Stock Number	A4405315
Year	2013
Make	Genie
Model	S-45
Serial Number	S4513-18117
Serial Plate Photo

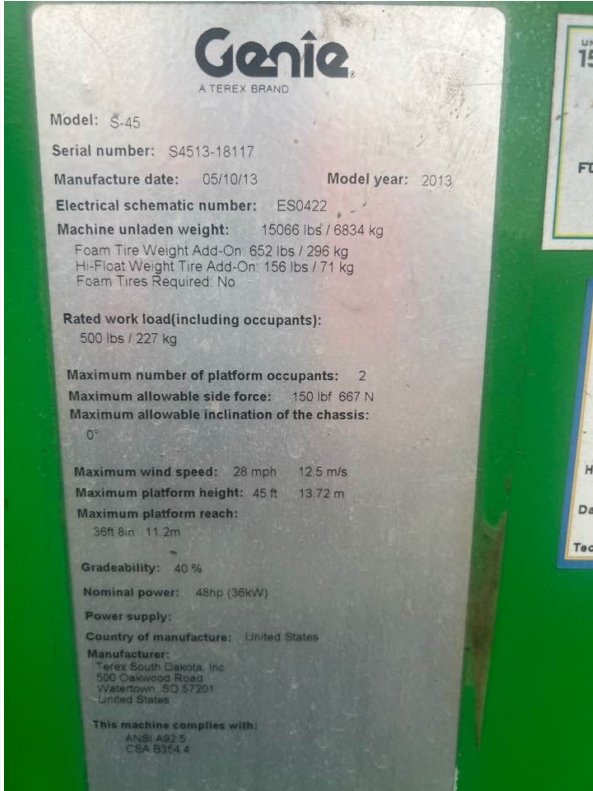
<p> Genie <small>A TEREX BRAND</small> Model: S-45 Serial number: S4513-18117 Manufacture date: 05/10/13 Model year: 2013 Electrical schematic number: ES0422 Machine unladen weight: 15066 lbs / 6834 kg Foam Tire Weight Add-On: 652 lbs / 296 kg Hi-Float Weight Tire Add-On: 156 lbs / 71 kg Foam Tires Required: No Rated work load(including occupants): 500 lbs / 227 kg Maximum number of platform occupants: 2 Maximum allowable side force: 150 lbf 667 N Maximum allowable inclination of the chassis: 0° Maximum wind speed: 28 mph 12.5 m/s Maximum platform height: 45 ft 13.72 m Maximum platform reach: 36ft 8in 11.2m Gradeability: 40 % Nominal power: 48hp (36kW) Power supply: Country of manufacture: United States Manufacturer: Terex South Dakota, Inc. 500 Oakwood Road Watertown, SD 57201 United States This machine complies with: ANSI 462.5 CSA B354.4 </p>

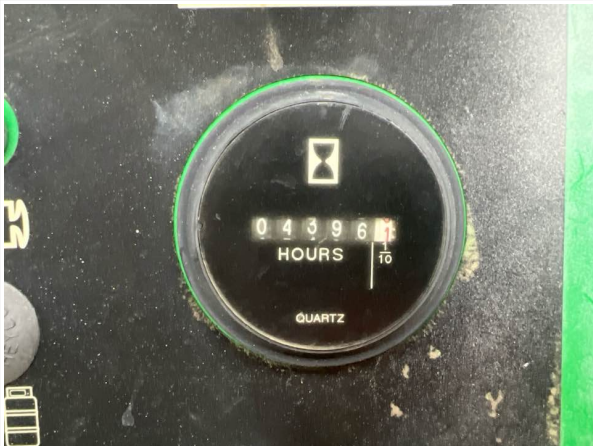
<p> 0 4 3 9 6 . 1 HOURS QUARTZ </p>
Previous Application (e.g., earth moving, mining, demolition, etc)	High reach

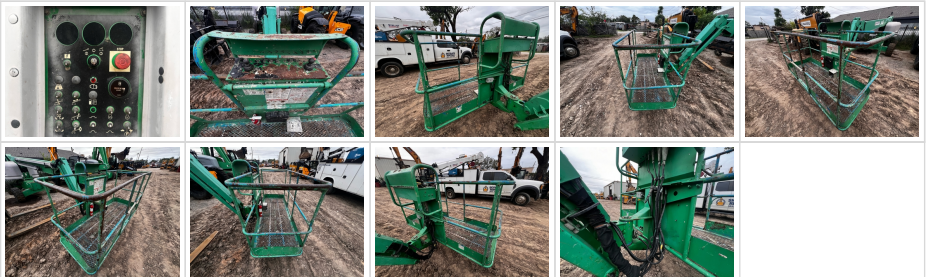
Control Station Photos

Seat	0
Cabin Lights	0
Safety Lock Out / Stop	4 - Expected Wear - Fully Operable
Safety Lock Out / Stop Condition	Safety lock out device is present, in good condition, and functional
Controls & Switches	4 - Expected Wear - Fully Operable
Controls & Switches Condition	Other (see comments)
Comments	Control decal missing
Hour Meter Activity	3 - Notable Wear - Fully Operable
Other Gauge Activity	0
Heater & A/C	0
Travel Alarm	0
Horn	1 - Service Required - Inoperable
Horn Condition	One or more elements of the horn assembly are missing
Backup Camera	0
Control Station Overall Rating	4 - Expected Wear - Fully Operable

29.771599, -95.174227
Control Station Overall Condition	Minor cosmetic wear to cabin surfaces, floors, panels, and ceiling

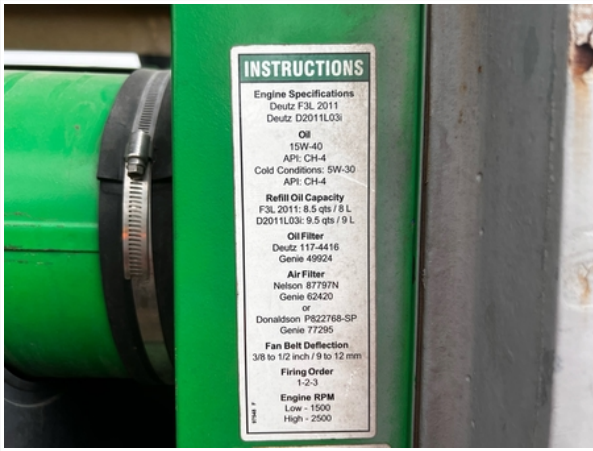
Engine Data Plate

Engine Type (Make, Model, Cylinders, Hp)	Deutz
Emissions Tier	Undetermined
Engine Fuel Type	Diesel
Blow-by (Visual Observation Check)	No
Unusual Noises (Upon Start-up, Idle, Shutdown)	No
Engine Smoke (Upon Start-up, Idle, Shutdown)	No
Engine Exhaust Color	Clear
Battery	4 - Expected Wear - Fully Operable
Radiator	4 - Expected Wear - Fully Operable
Belts	4 - Expected Wear - Fully Operable
Hoses	4 - Expected Wear - Fully Operable
Water Pump	4 - Expected Wear - Fully Operable
Cooling System Leaks	No
Coolant Appearance	4 - Expected Wear - Fully Operable
Oil Leaks	No
Oil Appearance	4 - Expected Wear - Fully Operable
Fuel Leaks	No
Equipped with DPF (Diesel Particulate Filter)	No
Requires DEF (Diesel Exhaust Fluid)	No
Overall Engine Rating	4 - Expected Wear - Fully Operable
Overall Engine Appearance	Clean & dry
Overall Engine Comments	Expected wear and tear due to machines age, no major issues to report

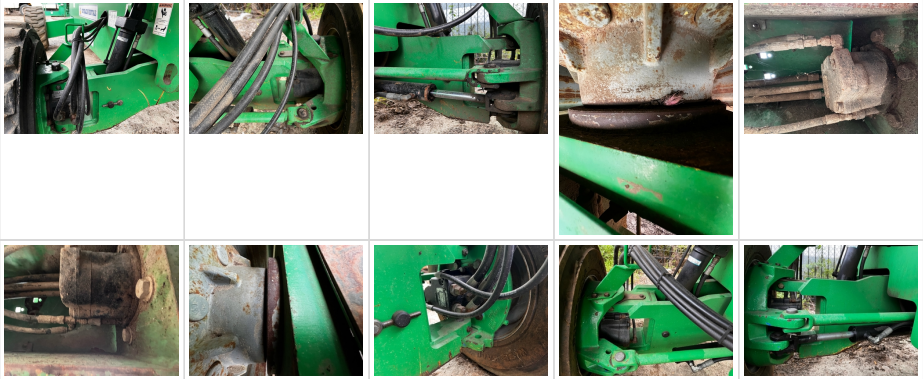
Drivetrain Photos

Hydrostatic Transmission?	Yes
Speeds	2 Speed
Drive Type	2WD
Differential Lock	No
Transmission Components	0
Drive Motors	4 - Expected Wear - Fully Operable
Parking Brake	0
Overall Drivetrain Rating	4 - Expected Wear - Fully Operable
Overall Drivetrain Comments	Expected wear and tear due to age of machine, no major issues to report

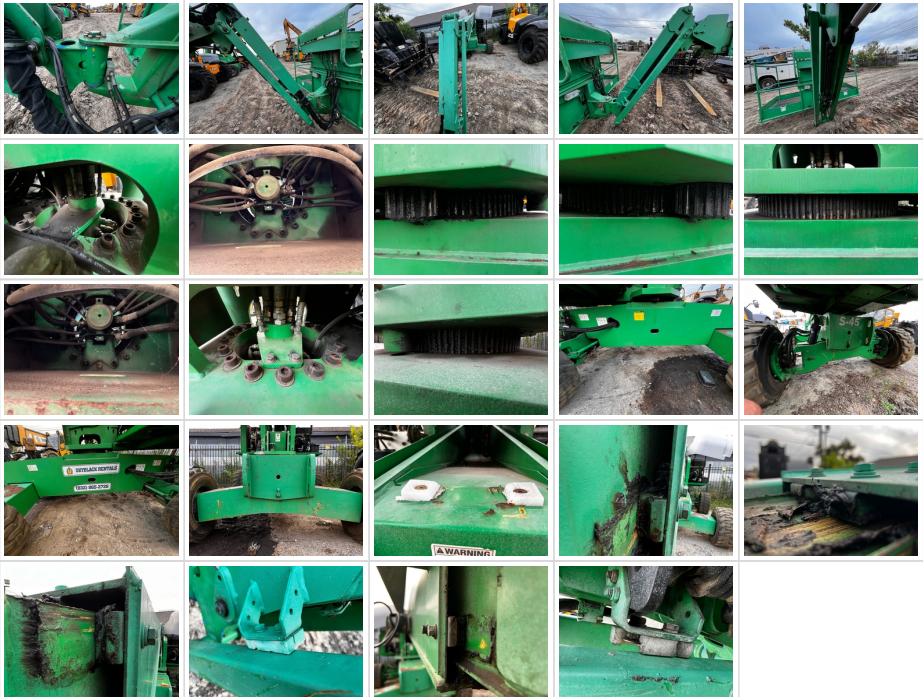
Chassis Photos

Frame	4 - Expected Wear - Fully Operable
Stance	4 - Expected Wear - Fully Operable
Swing Table	4 - Expected Wear - Fully Operable

Boom	4 - Expected Wear - Fully Operable
Boom Wear Guides	2 - Heavy Wear - Needs Attention
Jib	4 - Expected Wear - Fully Operable
Front Axle Appearance	4 - Expected Wear - Fully Operable
Rear Axle Appearance	4 - Expected Wear - Fully Operable
