Inspection Report (Boom Lift)

B&B Stock Number	A5353455
Year	2014
Make	Genie
Model	S-85
Serial Number	S8514-10620
Serial Plate Photo

Date/Time	09-10-2024
Inspector Name	Javier Bocanegra

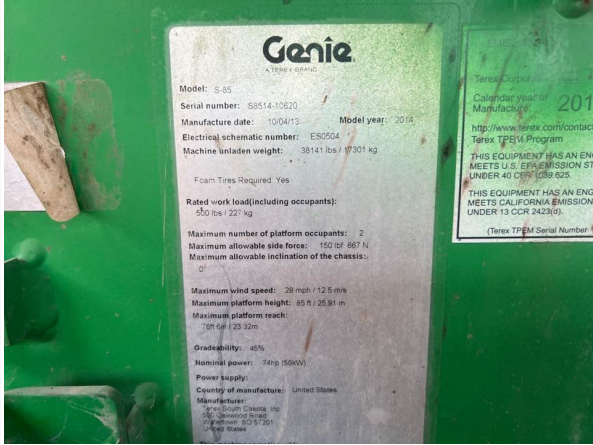
<p>The serial plate photo shows a green metal plate with the following text:</p> <p>Genie A Tenex BRAND</p> <p>Model: S-85 Serial number: S8514-10620 Manufacture date: 10/04/13 Model year: 2014 Electrical schematic number: ES0504 Machine unladen weight: 38141 lbs / 17301 kg</p> <p>Foam Tires Required: Yes</p> <p>Rated work load(including occupants): 550 lbs / 227 kg</p> <p>Maximum number of platform occupants: 2 Maximum allowable side force: 150 lbf / 667 N Maximum allowable inclination of the chassis: 0°</p> <p>Maximum wind speed: 28 mph / 12.5 m/s Maximum platform height: 85 ft / 25.91 m Maximum platform reach: 76 ft 6 in / 23.32 m</p> <p>Gradeability: 45% Nominal power: 74hp (55kW) Power supply:</p> <p>Country of manufacture: United States Manufacturer: Genie South Carolina, Inc. 2000 Lakeshore Drive Littleton, SC 29570 United States</p> <p>To the right of the serial plate is a TPEM label with the following text:</p> <p>Tenex TPEM Program Calendar year of Manufacture: 2014 http://www.tenex.com/contact Tenex TPEM Program THIS EQUIPMENT HAS AN ENGINE MEETS U.S. EPA EMISSION STAGE UNDER 40 CFR 100.425 THIS EQUIPMENT HAS AN ENGINE MEETS CALIFORNIA EMISSION UNDER 13 CCR 2423(d) (Tenex TPEM Serial Number:)</p>

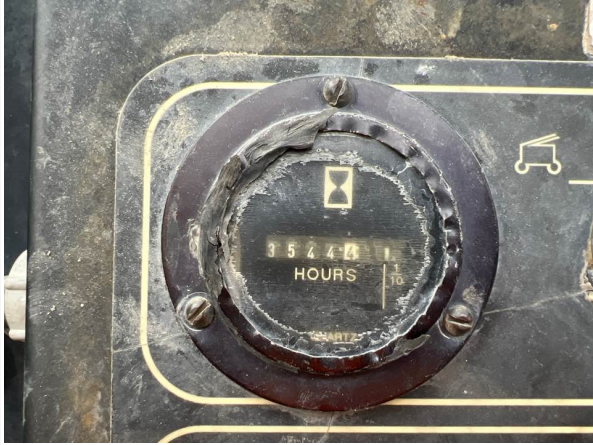
<p>The hour meter photo shows a circular digital display with a yellow border. The display shows the number 3544.4 and the word HOURS below it. There is a small icon of a boom lift to the right of the display.</p>
Previous Application (e.g., earth moving, mining, demolition, etc)	High reach

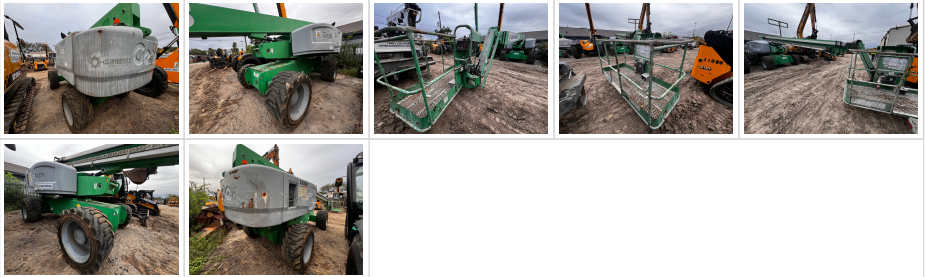
Exterior Walkaround Photos

Body Panel Condition	Expected chipped paint or dents for its age.
Doors / Canopy Latches	4 - Expected Wear - Fully Operable
Steps / Ladders	0
Handrails	3 - Notable Wear - Fully Operable
Glass	0
Mirrors	0
Exterior Lights	0
Overall Exterior	4 - Expected Wear - Fully Operable
Comments	Expected wear and tear due to age of the machine no major issues to report

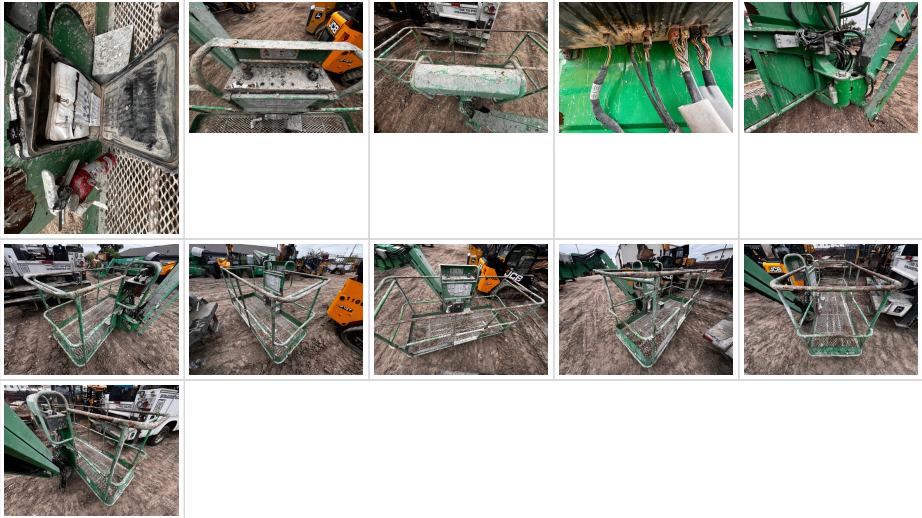
Control Station Photos

Control Station Type	Platform
Control Type	Pilot Controls
Control Configuration	N/A
Seat	0
Cabin Lights	0
Safety Lock Out / Stop	4 - Expected Wear - Fully Operable
Controls & Switches	3 - Notable Wear - Fully Operable
Controls & Switches Condition	Switches have good functionality, expected cosmetic damage for a machine this age
Hour Meter Activity	4 - Expected Wear - Fully Operable
Other Gauge Activity	0
Heater & A/C	0

Travel Alarm	0
Horn	2 - Heavy Wear - Needs Attention
Horn Condition	One or more elements of the horn assembly are missing
Backup Camera	0
Control Station Overall Rating	4 - Expected Wear - Fully Operable

29.771545, -95.174248
Control Station Overall Condition	Minor cosmetic wear to cabin surfaces, floors, panels, and ceiling
Comments	Expected wear and tear due to age of machine platform control decal needs replacing

What Needs Work	The things that need work on this machine are platform control box decal, main lift leak at wiper seal

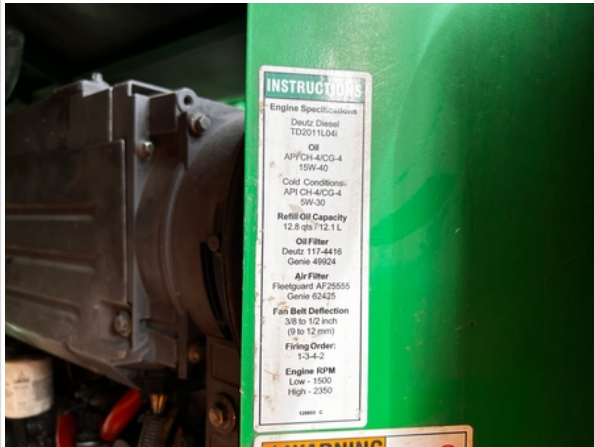
Engine Data Plate

Engine Type (Make, Model, Cylinders, Hp)	Deutz
Emissions Tier	Undetermined
Engine Fuel Type	Diesel
Blow-by (Visual Observation Check)	No
Unusual Noises (Upon Start-up, Idle, Shutdown)	No
Engine Smoke (Upon Start-up, Idle, Shutdown)	No
Engine Exhaust Color	Clear
Battery	4 - Expected Wear - Fully Operable

Battery Condition	Clean & dry appearance, tight connections
Radiator	4 - Expected Wear - Fully Operable
Radiator Condition	Radiator fins & components appear to be in good working order, no signs of damage or leaks
Belts	4 - Expected Wear - Fully Operable
Belt Condition	Belts appear in good condition & alignment with proper tension
Hoses	4 - Expected Wear - Fully Operable
Hose Condition	Firm, pliant hoses with no signs of wear or leaks
Water Pump	4 - Expected Wear - Fully Operable
Water Pump Condition	No unusual pump noises heard
Cooling System Leaks	No
Coolant Appearance	4 - Expected Wear - Fully Operable
Coolant Appearance Notes	Normal Translucent appearance, no visual signs of contamination
Oil Leaks	No
Oil Appearance	4 - Expected Wear - Fully Operable
Oil Appearance Notes	Clean oil appearance, no signs of cross contamination, Appropriate oil level
Fuel Leaks	No
Equipped with DPF (Diesel Particulate Filter)	No

Requires DEF (Diesel Exhaust Fluid)	No
Overall Engine Rating	4 - Expected Wear - Fully Operable
Overall Engine Appearance	Dusty & dry
Overall Engine Comments	Expected wear and tear due to machines age no major issues to report

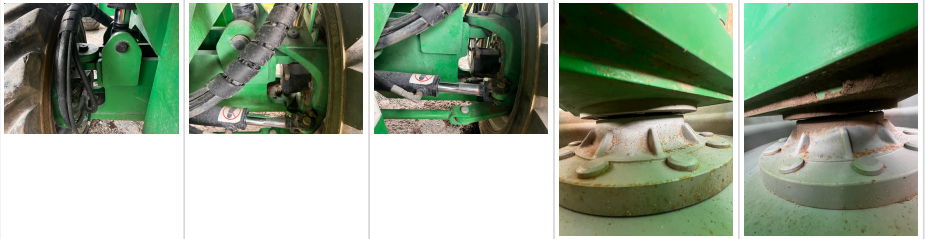
Drivetrain Photos

Speeds	2 Speed
Drive Type	2WD
Differential Lock	No
Transmission Components	0
Drive Motors	4 - Expected Wear - Fully Operable
Parking Brake	0
Overall Drivetrain Rating	4 - Expected Wear - Fully Operable
Overall Drivetrain Comments	Expected wear and tear due to machines age no major issues to report

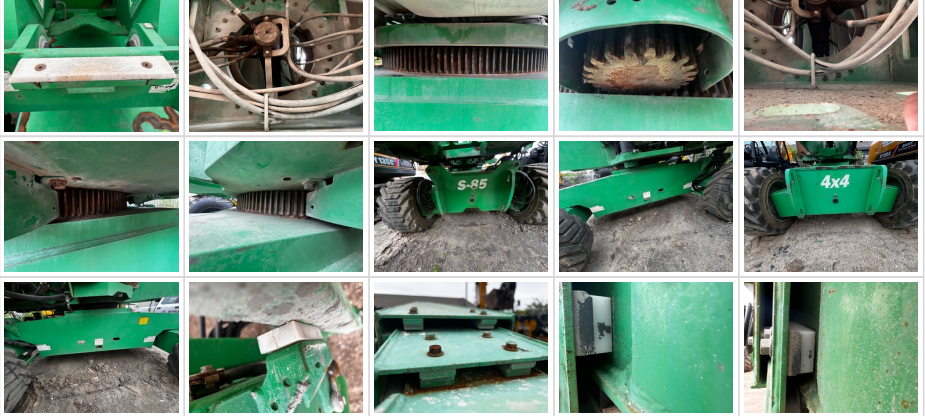
Chassis Photos

Frame	4 - Expected Wear - Fully Operable
Stance	4 - Expected Wear - Fully Operable
Swing Table	4 - Expected Wear - Fully Operable
Boom	4 - Expected Wear - Fully Operable
Front Axle Appearance	4 - Expected Wear - Fully Operable
Rear Axle Appearance	4 - Expected Wear - Fully Operable
