Inspection Report (Wheel Loader)

General Into		
B&B Stock Number	A1525939	
Year	2023	
Make	Sany	
Model	SW405	
Serial Number	SW4054CC08258	
Serial Plate Photo	WHEEL LOADER MODELITYPE: OPERATING MASS (kg): ENGINE POWER &): PRODUCT ID NUMBER WOOEL YEAR Langsang Road, No 318 Ferginan Shangsa, 201413.PR China.	
Hour Meter Reading	794	
Single Photo	AUTO AUTO 1 20 30 40 1 25 10 50 E F N 0 120 DEF 120

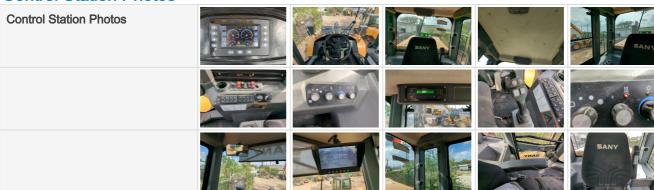
Control Station Photos

Control Station Type	Enclosed Cab (EROPS)	
Control Type	Pilot Controls	
Control Configuration	N/A	
Seat	4 - Expected Wear - Fully Operable	
Seat Condition	Seat has expected stains or small tears for its usage	
Cabin Lights	1 - Service Required - Inoperable	
Cabin Lights Condition	Cabin light system is not operational	
Safety Lock Out / Stop	4 - Expected Wear - Fully Operable	
Safety Lock Out / Stop Condition	Safety lock out device is present, in good condition, and functional	
Controls & Switches	3 - Notable Wear - Fully Operable	
Controls & Switches Condition	One or more switches are inoperative or missing, Other (see comments)	
Comments	washer fluid squirters for both front and rear glass does not work	
Hour Meter Activity	4 - Expected Wear - Fully Operable	
Hour Meter Condition	Hour meter is functional and in good condition	
Other Gauge Activity	4 - Expected Wear - Fully Operable	
Other Gauge Condition	All cockpit gauges are functional and in good condition

Heater & A/C	4 - Expected Wear - Fully Operable	
Heater & A/C Condition	Heater and A/C work as expected	
Travel Alarm	4 - Expected Wear - Fully Operable	
Travel Alarm Condition	Travel alarm is installed and functioning as expected	
Horn	4 - Expected Wear - Fully Operable	
Horn Condition	Horn is installed and functioning as expected	
Backup Camera	4 - Expected Wear - Fully Operable	
Backup Camera Condition	Back up camera is installed and functioning as expected	
Control Station Overall Rating	4 - Expected Wear - Fully Operable	
	9 29.771678, -95.174345	
Control Station Overall Condition	Good cabin appearance, solid floors, panels, and ceiling

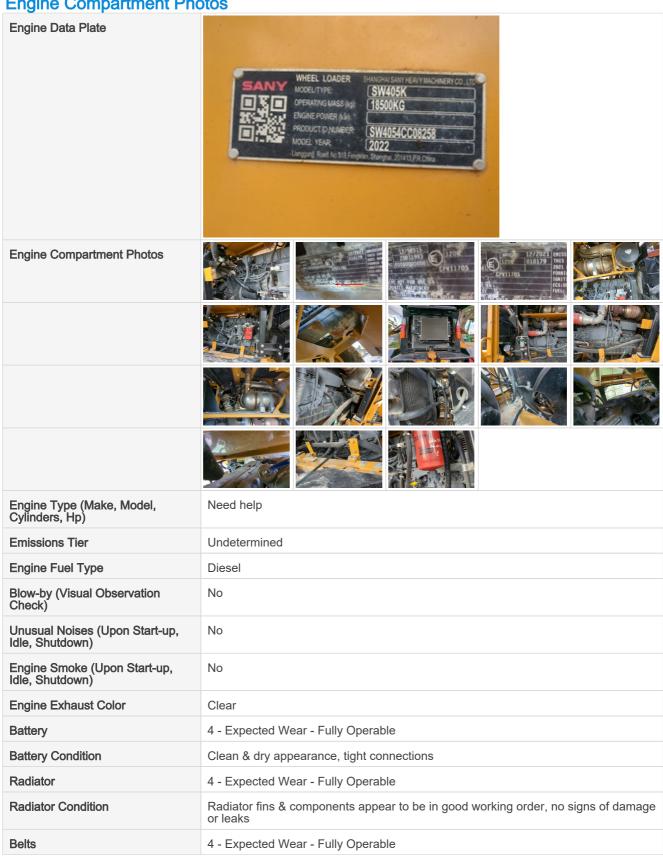
Engine Compartment Photos

Belt Condition	Belts appear in good condition & alignment with proper tension
Hoses	4 - Expected Wear - Fully Operable
Hose Condition	Twisted, kinked or flattened hoses, Firm, pliant hoses with no signs of wear or leaks
Water Pump	4 - Expected Wear - Fully Operable
Cooling System Leaks	No
Coolant Appearance	4 - Expected Wear - Fully Operable
Oil Leaks	No
Oil Appearance	4 - Expected Wear - Fully Operable
Oil Appearance Notes	Clean oil appearance, no signs of cross contamination, Appropriate oil level
Fuel Leaks	No
Equipped with DPF (Diesel Particulate Filter)	Yes
DPF Condition	4 - Expected Wear - Fully Operable
Requires DEF (Diesel Exhaust Fluid)	Yes
Overall Engine Rating	4 - Expected Wear - Fully Operable
Overall Engine Appearance	Clean & dry
Overall Engine Comments	Engine bay looks dry and engine starts up without any unusual noises or smoke.
