Inspection Report (Boom Lift)

B&B Stock Number	A9166655
Year	2013
Make	Genie
Model	S60X
Serial Number	S60X13-25390
Serial Plate Photo

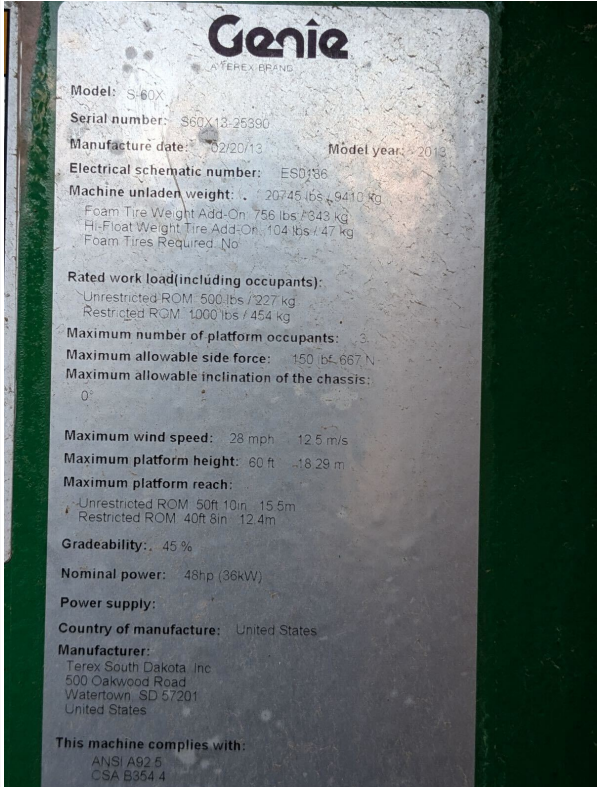
<p> Genie <small>A TEREX BRAND</small> Model: S60X Serial number: S60X13-25390 Manufacture date: 02/20/13 Model year: 2013 Electrical schematic number: ES0136 Machine unladen weight: 20745 lbs / 9410 kg Foam Tire Weight Add-On: 756 lbs / 343 kg Hi-Float Weight Tire Add-On: 104 lbs / 47 kg Foam Tires Required: No Rated work load(including occupants): Unrestricted ROM: 500 lbs / 227 kg Restricted ROM: 1000 lbs / 454 kg Maximum number of platform occupants: 3 Maximum allowable side force: 150 lbf / 667 N Maximum allowable inclination of the chassis: 0° Maximum wind speed: 28 mph / 12.5 m/s Maximum platform height: 60 ft / 18.29 m Maximum platform reach: Unrestricted ROM: 50ft 10in / 15.5m Restricted ROM: 40ft 8in / 12.4m Gradeability: 45 % Nominal power: 48hp (36kW) Power supply: Country of manufacture: United States Manufacturer: Terex South Dakota, Inc 500 Oakwood Road Watertown, SD 57201 United States This machine complies with: ANSI A92.5 CSA B354.4 </p>

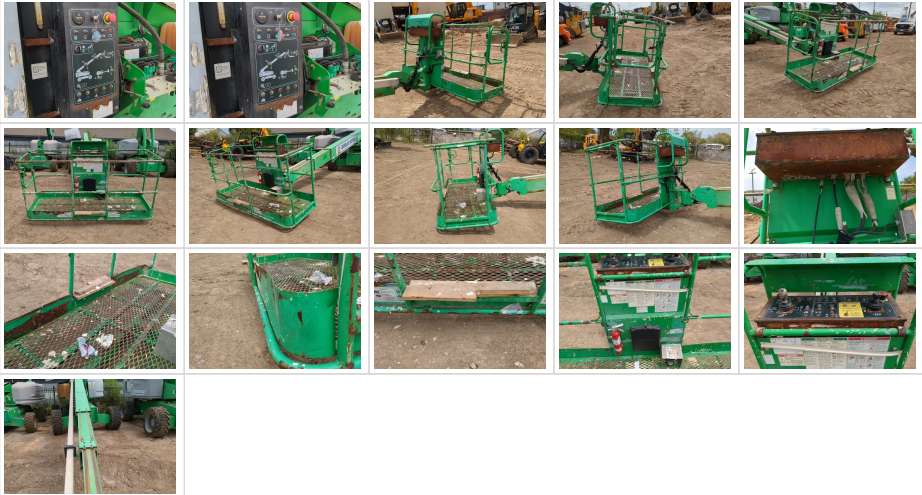
Control Station Photos

Control Station Type	Platform, Remote
Control Type	Lever Controls
Seat	-1
Cabin Lights	-1
Safety Lock Out / Stop	4 - Expected Wear - Fully Operable
Safety Lock Out / Stop Condition	Safety lock out device is present, in good condition, and functional
Controls & Switches	3 - Notable Wear - Fully Operable
Controls & Switches Condition	One or more switches are inoperative or missing, Other (see comments)
Comments	during inspection the vehicle did not move forward or backward, the emergency brake was locked in and not releasing.
Hour Meter Activity	4 - Expected Wear - Fully Operable
Hour Meter Condition	Hour meter is functional and in good condition
Other Gauge Activity	-1

Heater & A/C	-1
Travel Alarm	4 - Expected Wear - Fully Operable
Travel Alarm Condition	Travel alarm is installed and functioning as expected
Horn	4 - Expected Wear - Fully Operable
Horn Condition	Horn is installed and functioning as expected
Backup Camera	-1
Control Station Overall Rating	2 - Heavy Wear - Needs Attention

29.771517, -95.174136
Control Station Overall Condition	Other (see comments)
Comments	Operability wise, the platform seems to perform as expected. But, the floor of the jib as well as the entry gate needs to be addressed. The gate is not open, and floor is starting to rust.

What Needs Work	The jib has some exterior issues that need to be addressed like the gate and the lower frame corrosion. The e-brake issue also needs to be addressed for the vehicle to be fully functional.	
Date/Time	09-25-2024	
Inspector Name	Neal Waas

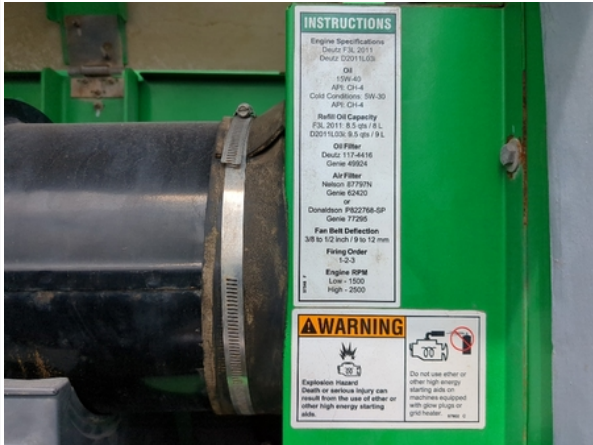
Engine Data Plate

<p>INSTRUCTIONS</p> <p>Engine Specifications Dealer P/N: 2011 Deutz D2011L03 Oil 15W-40 API: CH-4 Cold Conditions: SAE-30 API: CH-4 Return Oil Capacity F3L 2011: 8.5 gal / 8 L D2011L03: 9.5 gal / 9 L Oil Filter Deutz 117-4416 Genie 49524 Air Filter Nelson 87737N Genie 42402 or Donaldson P922768-SP Genie 77295 Fan Belt Deflection 3/8 to 1/2 inch / 9 to 12 mm Firing Order 1-2-3 Engine RPM Low - 1500 High - 2000</p> <p>WARNING</p> <p>Explosion Hazard Death or serious injury can result from the use of other or other high energy starting aids.</p> <p>Do not use ether or other high energy starting aids on machines equipped with glow plugs or glow starters. See 2.</p>				
Engine Compartment Photos

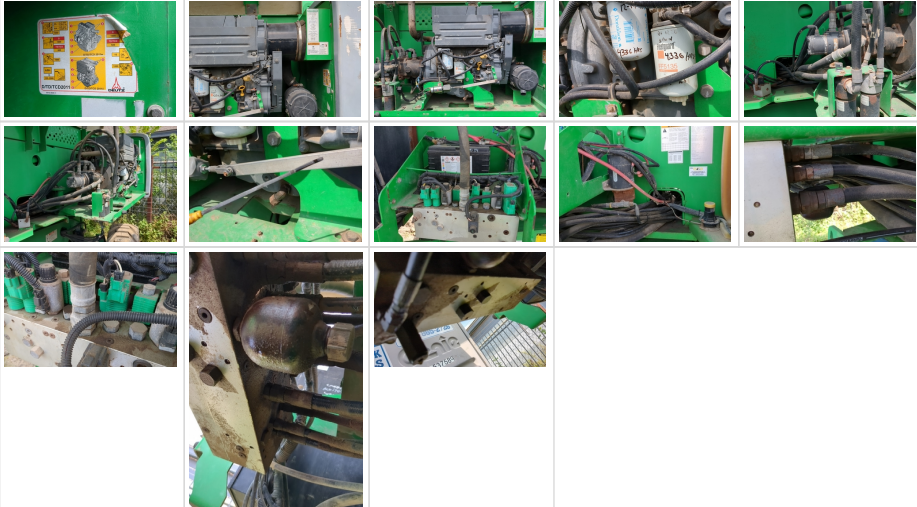
Engine Type (Make, Model, Cylinders, Hp)	Deutz
Emissions Tier	Undetermined
Engine Fuel Type	Diesel
Blow-by (Visual Observation Check)	No
Unusual Noises (Upon Start-up, Idle, Shutdown)	No
Engine Smoke (Upon Start-up, Idle, Shutdown)	Yes
Engine Smoke Notes	Engine smoke observed upon start up
Engine Exhaust Color	Other (see comments)
Comments	Black smoke observed upon startup
Battery	4 - Expected Wear - Fully Operable
Radiator	4 - Expected Wear - Fully Operable
Belts	4 - Expected Wear - Fully Operable
Hoses	3 - Notable Wear - Fully Operable
Hose Condition	Leaks in one or more hoses or fittings observed, Other (see comments)
Comments	hydraulic manifold has three noticeable drips. please see photos.
Water Pump	4 - Expected Wear - Fully Operable
Cooling System Leaks	No
Coolant Appearance	4 - Expected Wear - Fully Operable
Oil Leaks	No
Oil Appearance	4 - Expected Wear - Fully Operable
Fuel Leaks	No
Equipped with DPF (Diesel Particulate Filter)	No

Requires DEF (Diesel Exhaust Fluid)	No
Overall Engine Rating	3 - Notable Wear - Fully Operable
Overall Engine Appearance	Areas of dried seepage seen on engine hoses & components
Overall Engine Comments	Engine operation is normal for its age. Multiple hoses have seepage.
