Inspection Report (Skid Steer/Track Loader)

B&B Stock Number	A8112125
Year	2018
Make	Bobcat
Model	S650
Serial Number	ALJ822627
Serial Plate Photo

Hour Meter Reading	1043.6
Hour Meter Photo

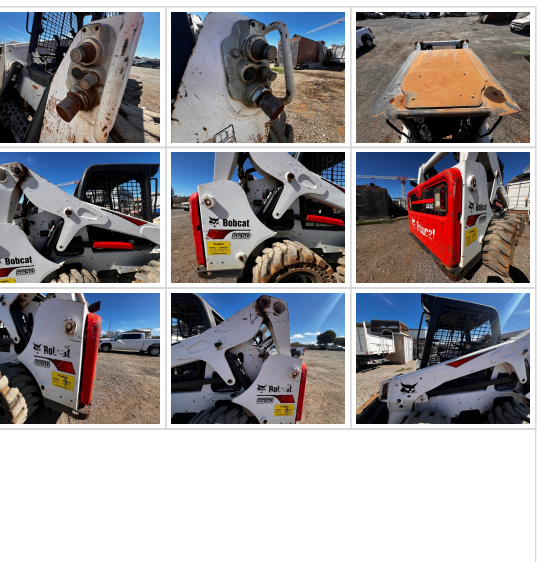
Close-up Exterior Photos

Inspection Rating Criteria	Rating	Explanation
	5	Light or minimal wear for its age
	4	Expected wear and tear for its age, operates as expected
	3	Above average wear and tear for its age, still operates as expected
	2	Heavy wear, is operable but needs attention
	1	Requires repair(s) to function as expected
Body Panels	4 - Expected Wear - Fully Operable	
Body Panel Condition	Some areas of surface rust observed, Expected chipped paint or dents for its age.	
Doors / Canopy Latches	0	
Steps / Ladders	4 - Expected Wear - Fully Operable	
Steps / Ladders Condition	Steps/ladders are fully intact and appear structurally sound	
Handrails	4 - Expected Wear - Fully Operable	
Handrails Condition	Handrails are fully intact and appear structurally sound	
Glass	1 - Service Required - Inoperable	
Glass Condition	Not applicable, no glass	
Comments	Rear glass missing	
Mirrors	0	
Exterior Lights	4 - Expected Wear - Fully Operable

Exterior Lights Condition	Some chips or cracks seen on light casings - see photos	
Overall Exterior	4 - Expected Wear - Fully Operable	
Comments	Expected where in tear due to age of machine

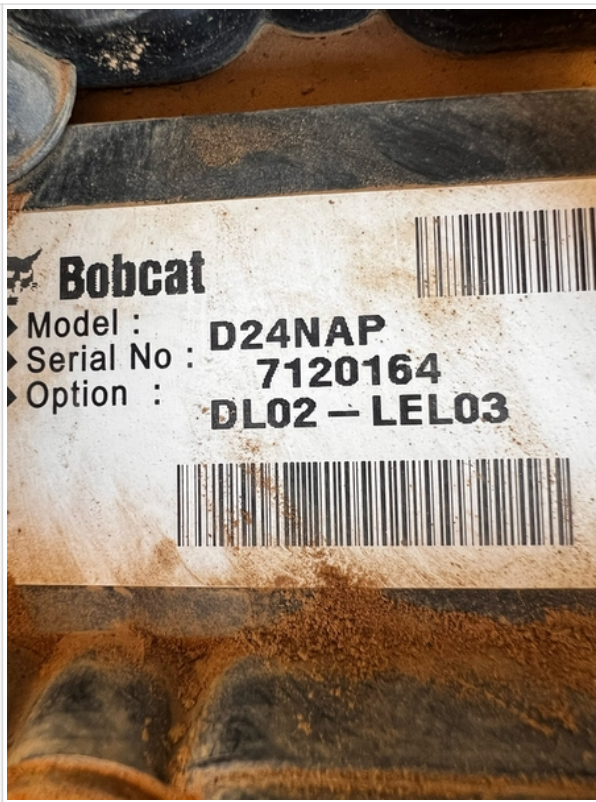
Engine Data Plate

Engine Type (Make, Model, Cylinders, Hp)	Doosan, D24NAP
Emissions Tier	Undetermined
Engine Serial Number	7120164
Engine Fuel Type	Diesel
Blow-by (Visual Observation Check)	No
Unusual Noises (Upon Start-up, Idle, Shutdown)	No
Engine Smoke (Upon Start-up, Idle, Shutdown)	No
Engine Exhaust Color	Clear
