Inspection Report (Trailer)

B&B Stock Number	Test
Year	Test
Make	Test
Model	Test
Serial Number	123

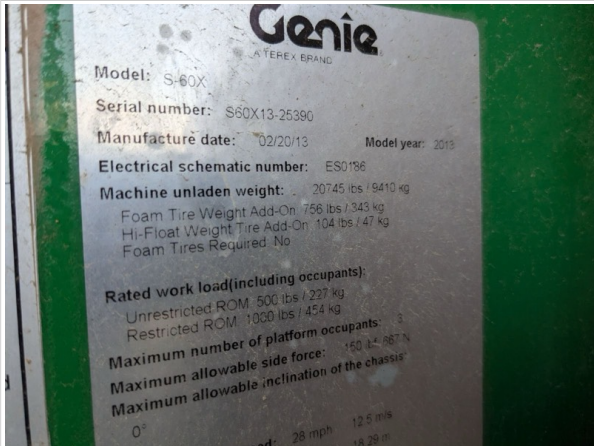
Data Plate Photo

<p>Model: S-60X Serial number: S60X13-25390 Manufacture date: 02/20/13 Model year: 2013 Electrical schematic number: ES0136 Machine unladen weight: 20745 lbs / 9410 kg Foam Tire Weight Add-On: 756 lbs / 343 kg Hi-Float Weight Tire Add-On: 104 lbs / 47 kg Foam Tires Required: No Rated work load (including occupants): Unrestricted ROM: 500 lbs / 227 kg Restricted ROM: 1000 lbs / 454 kg Maximum number of platform occupants: 3 Maximum allowable side force: 150 LBS / 68.7 N Maximum allowable inclination of the chassis: 0° 28 mph 12.5 m/s 18.29 m</p>
Length (ft and inches)	1
Width (ft and inches)	2
Max Height (ft and inches)	3
Dock Height (ft and inches)	4
GVWR (lbs)	5000
