Inspection Report (Forklift)

B&B Stock Number	A1507305
Year	2022
Make	Doosan
Model	G25e-7
Serial Number	Fga1m-1290-02529
Serial Plate Photo

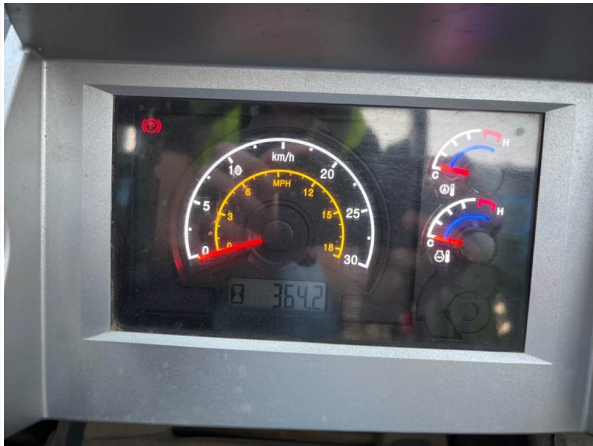
Engine Hour Meter Reading	364
Engine Hour Meter Photo

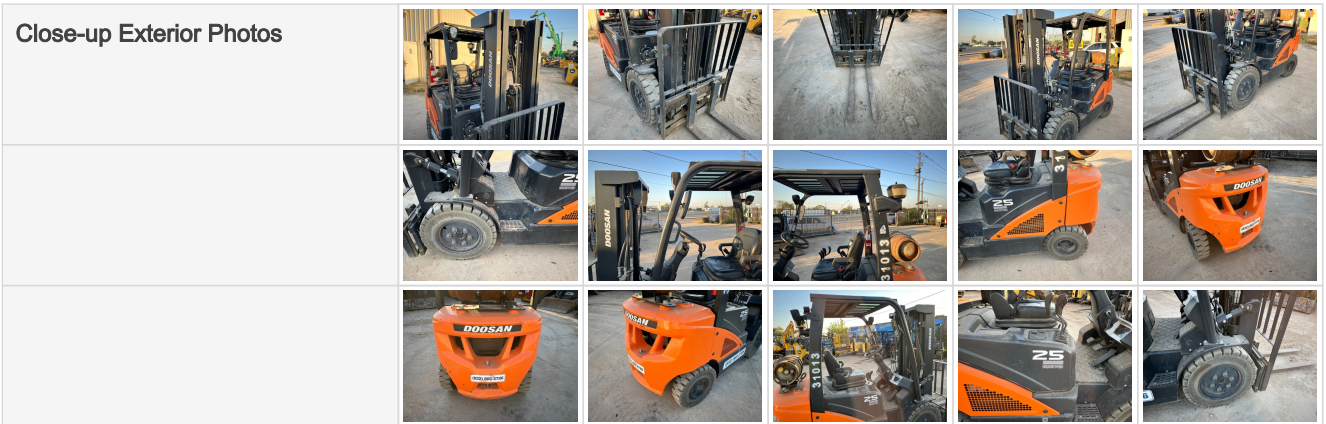
General Appearance Photos

Inspection Rating Criteria	Rating	Explanation
	5	Light or minimal wear for its age
	4	Expected wear and tear for its age, operates as expected
	3	Above average wear and tear for its age, still operates as expected
	2	Heavy wear, is operable but needs attention
	1	Requires repair(s) to function as expected
Body Panels	4 - Expected Wear - Fully Operable	
Body Panel Condition	Good paint condition and panel fitment	
Doors / Canopy Latches	4 - Expected Wear - Fully Operable	
Steps / Ladders	4 - Expected Wear - Fully Operable	
Handrails	4 - Expected Wear - Fully Operable	
Glass	4 - Expected Wear - Fully Operable	
Mirrors	4 - Expected Wear - Fully Operable	
Exterior Lights	4 - Expected Wear - Fully Operable	
Overall Exterior	4 - Expected Wear - Fully Operable	
Comments	Lightly used and exterior is in great shape. Expected scrapes from usage but nothing notable.

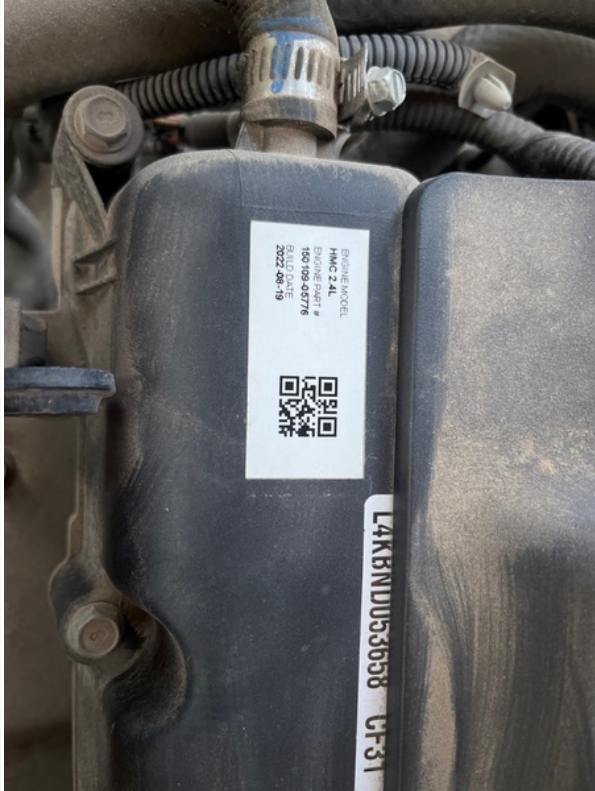
Engine Data Plate

Engine Type (Make, Model, Cylinders, Hp)	Doosan HMC 2.4L				
Emissions Tier	Other (see comments)				
Comments	See plate - propane				
Engine Serial Number	L4kbnd053658				
Engine Fuel Type	LPG				
Blow-by (Visual Observation Check)	No				
Unusual Noises (Upon Start-up, Idle, Shutdown)	No				
Engine Smoke (Upon Start-up, Idle, Shutdown)	No				
Engine Exhaust Color	Clear				
Battery	4 - Expected Wear - Fully Operable				
Battery Condition	Clean & dry appearance, tight connections

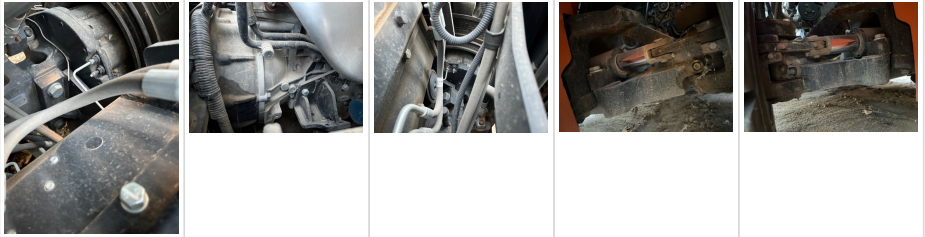
Drivetrain Photos

Hydrostatic Transmission?	N/A				
Drive Type	2WD				
Differential Lock	No				
Transmission Components	4 - Expected Wear - Fully Operable				
Parking Brake	4 - Expected Wear - Fully Operable				
Overall Drivetrain Rating	4 - Expected Wear - Fully Operable				
Overall Drivetrain Comments	Appears to be in good working order.				
Front Axle	4 - Expected Wear - Fully Operable				
Rear Axle	4 - Expected Wear - Fully Operable
