Inspection Report (Vibratory Compactor)

B&B Stock Number	A7321020
Year	2000
Make	Caterpillar
Model	CP-563D
Serial Number	9ZW00198
Serial Plate Photo

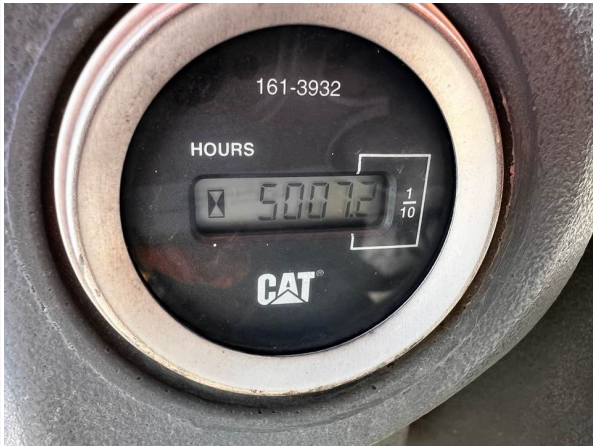
Hour Meter Reading	5007.2
Hour Meter Photo

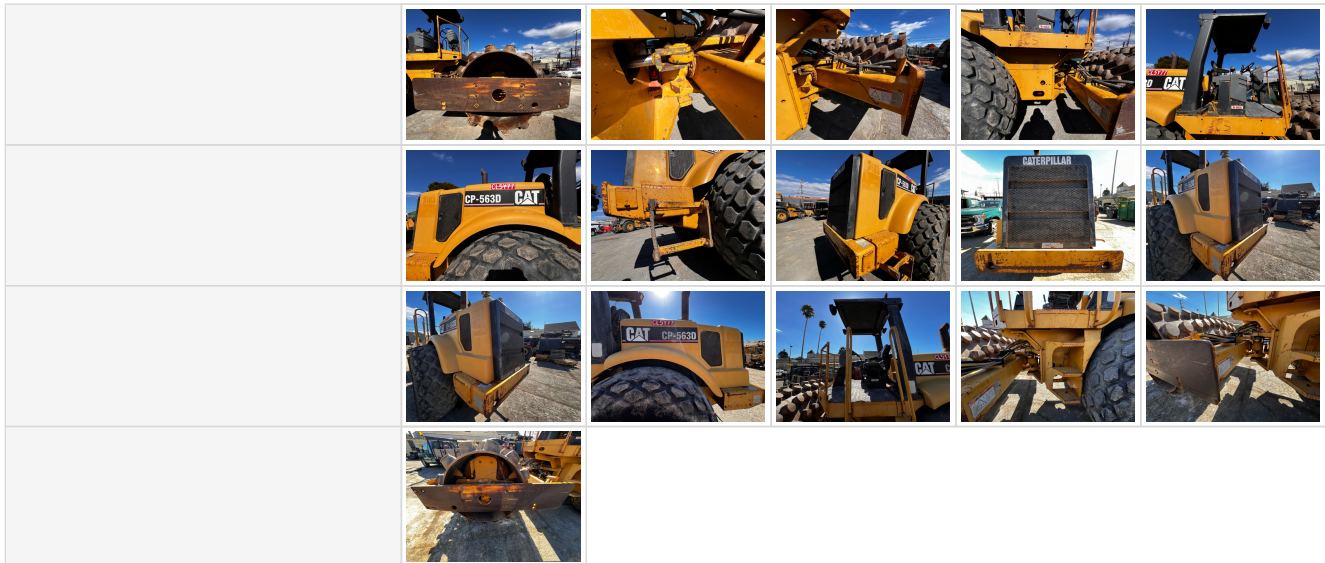
Close-up Exterior Photos

Inspection Rating Criteria	Rating	Explanation
	5	Light or minimal wear for its age
	4	Expected wear and tear for its age, operates as expected
	3	Above average wear and tear for its age, still operates as expected
	2	Heavy wear, is operable but needs attention
	1	Requires repair(s) to function as expected
Body Panels	4 - Expected Wear - Fully Operable	
Body Panel Condition	Some areas of surface rust observed	
Doors / Canopy Latches	0	
Steps / Ladders	3 - Notable Wear - Fully Operable	
Steps / Ladders Condition	One or more steps or rungs are bent	
Handrails	4 - Expected Wear - Fully Operable	
Handrails Condition	Handrails are fully intact and appear structurally sound	
Glass	0	
Mirrors	0	
Exterior Lights	4 - Expected Wear - Fully Operable	
Exterior Lights Condition	No visible damage, lighting system is operational	
Overall Exterior	4 - Expected Wear - Fully Operable	
Comments	Expected where in tear due to machines age no major issues to report

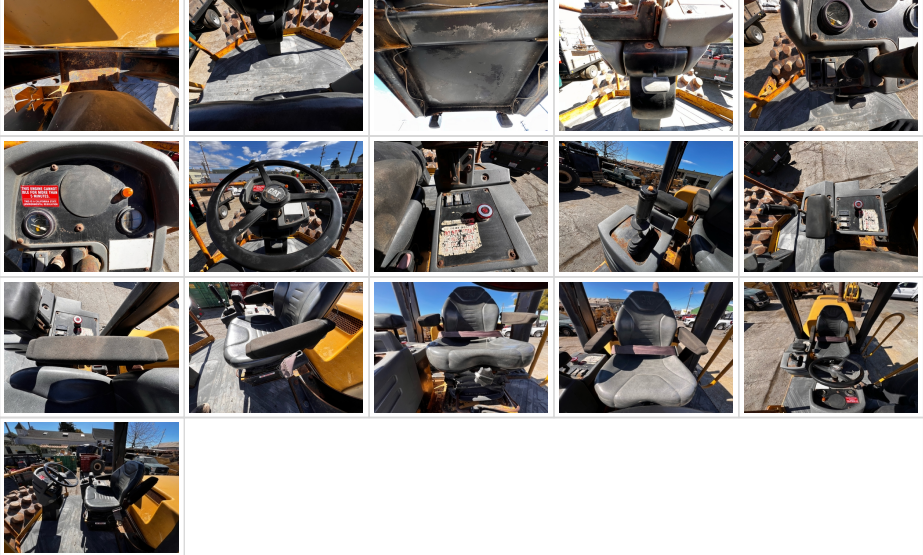
Control Station Photos

Control Station Type	Open Cab (OROPS)				
Control Type	Lever Controls				
Control Configuration	N/A				
Seat	4 - Expected Wear - Fully Operable				
Seat Condition	Seat in good condition, no stains or tears in upholstery				
Cabin Lights	0				
Safety Lock Out / Stop	4 - Expected Wear - Fully Operable				
Safety Lock Out / Stop Condition	Safety lock out device is present, in good condition, and functional				
Controls & Switches	3 - Notable Wear - Fully Operable				
Controls & Switches Condition	Switches have good functionality, expected cosmetic damage for a machine this age				
Hour Meter Activity	4 - Expected Wear - Fully Operable				
Hour Meter Condition	Hour meter is functional and in good condition				
Other Gauge Activity	4 - Expected Wear - Fully Operable				
Other Gauge Condition	All cockpit gauges are functional and in good condition				
Heater & A/C	0				
Travel Alarm	0

Horn	4 - Expected Wear - Fully Operable				
Horn Condition	Horn is installed and functioning as expected				
Backup Camera	0				
Control Station Overall Rating	4 - Expected Wear - Fully Operable

37.874559, -122.302384				
Control Station Overall Condition	Minor cosmetic wear to cabin surfaces, floors, panels, and ceiling

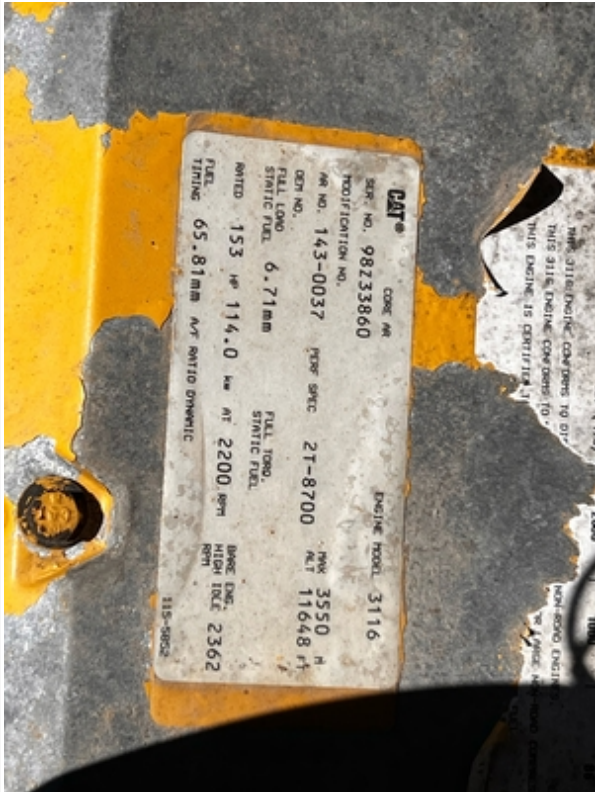
Engine Data Plate

Engine Type (Make, Model, Cylinders, Hp)	Cat, 3116				
Emissions Tier	Undetermined				
Engine Serial Number	98Z33860

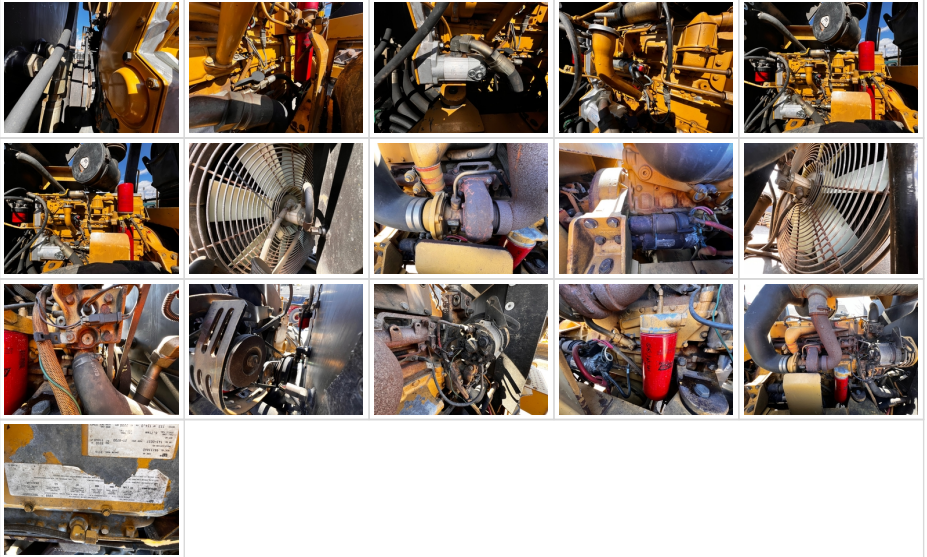
Engine Compartment Photos

Engine Fuel Type	Diesel
Blow-by (Visual Observation Check)	No
Unusual Noises (Upon Start-up, Idle, Shutdown)	No
Engine Smoke (Upon Start-up, Idle, Shutdown)	Yes
Engine Smoke Notes	Engine smoke observed upon start up
Engine Exhaust Color	Black
Battery	4 - Expected Wear - Fully Operable
Battery Condition	Inaccessible, unable to determine condition
Radiator	4 - Expected Wear - Fully Operable
Radiator Condition	Radiator fins & components appear to be in good working order, no signs of damage or leaks
Belts	4 - Expected Wear - Fully Operable
Belt Condition	Belts appear in good condition & alignment with proper tension
Hoses	4 - Expected Wear - Fully Operable
Hose Condition	Firm, pliant hoses with no signs of wear or leaks
Water Pump	4 - Expected Wear - Fully Operable
Water Pump Condition	No unusual pump noises heard
Cooling System Leaks	No
Coolant Appearance	4 - Expected Wear - Fully Operable
Coolant Appearance Notes	Normal Translucent appearance, no visual signs of contamination

Oil Leaks	No
Oil Appearance	4 - Expected Wear - Fully Operable
Oil Appearance Notes	Appropriate oil level
Fuel Leaks	No
Equipped with DPF (Diesel Particulate Filter)	No
Requires DEF (Diesel Exhaust Fluid)	No
Overall Engine Rating	4 - Expected Wear - Fully Operable
Overall Engine Appearance	Very dirty
Overall Engine Comments	Expected wear and tear due to machines age no major issues to report
