Inspection Report (Skid Steer/Track Loader)

B&B Stock Number	A7106235
Year	2018
Make	Kubota
Model	SVL75-2
Serial Number	35489
Serial Plate Photo

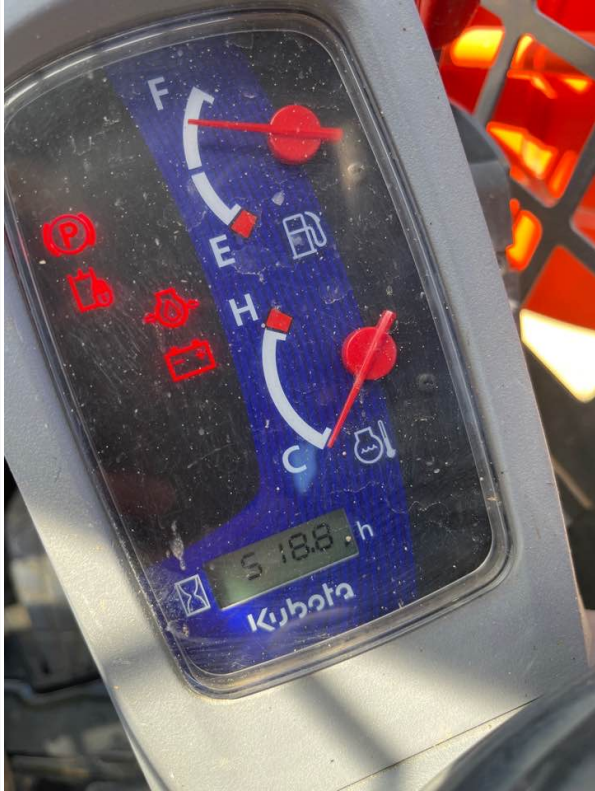
Hour Meter Photo

Hour Meter Reading	518

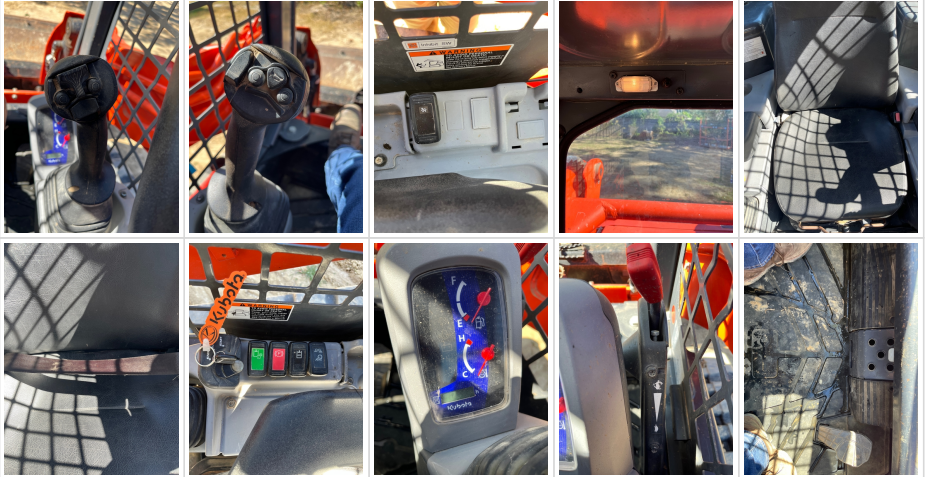
Control Station Photos

Control Station Type	Open Cab (OROPS), Canopy				
Control Type	Pilot Controls				
Control Configuration	Configurable (SAE and ISO)				
Comments	Air ride seat				
Seat	3 - Notable Wear - Fully Operable				
Seat Condition	Seat has expected stains or small tears for its usage, Seat belt secures properly				
Cabin Lights	5 - Very Light or Minimal Wear				
Safety Lock Out / Stop	5 - Very Light or Minimal Wear				
Controls & Switches	5 - Very Light or Minimal Wear				
Hour Meter Activity	5 - Very Light or Minimal Wear				
Hour Meter Condition	Hour meter is functional and in good condition				
Other Gauge Activity	0				
Heater & A/C	0				
Travel Alarm	5 - Very Light or Minimal Wear				
Horn	5 - Very Light or Minimal Wear				
Backup Camera	0				
Control Station Overall Rating	4 - Expected Wear - Fully Operable

30.066272, -95.175893
Control Station Overall Condition	Good cabin appearance, solid floors, panels, and ceiling

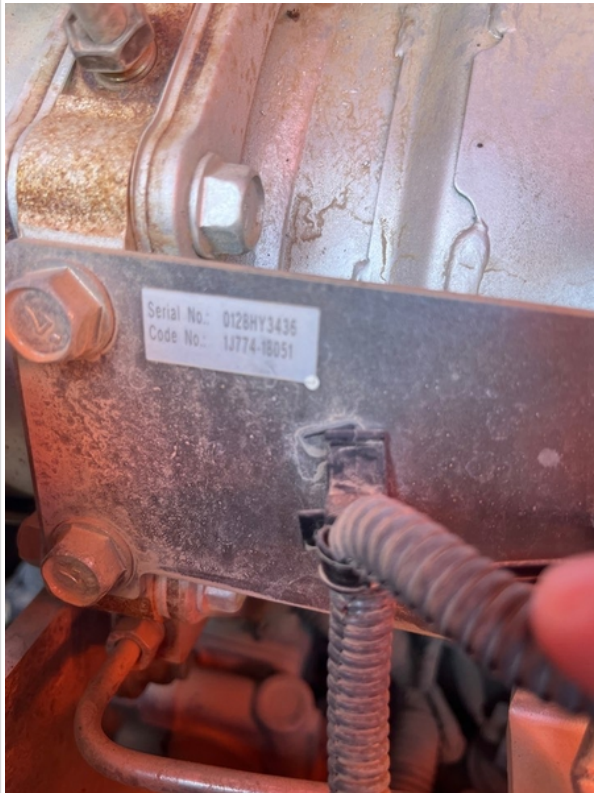
Engine Data Plate

Engine Type (Make, Model, Cylinders, Hp)	Kubota			
Emissions Tier	Tier 4i			
Engine Serial Number	0128HY3436			
Engine Fuel Type	Diesel			
Blow-by (Visual Observation Check)	No			
Unusual Noises (Upon Start-up, Idle, Shutdown)	No			
Engine Smoke (Upon Start-up, Idle, Shutdown)	No			
Engine Exhaust Color	Clear
