Inspection Report (Wheel Loader)

B&B Stock Number	A3808914
Year	2014
Make	Volvo
Model	L90G
Serial Number	VCE0L90GJ00003847
Serial Plate Photo

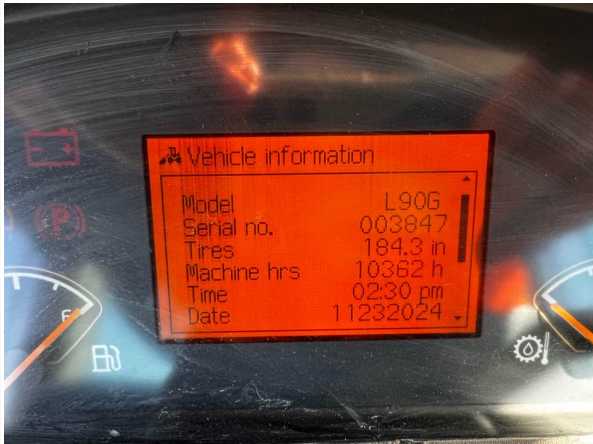
Hour Meter Reading	10362
Single Photo

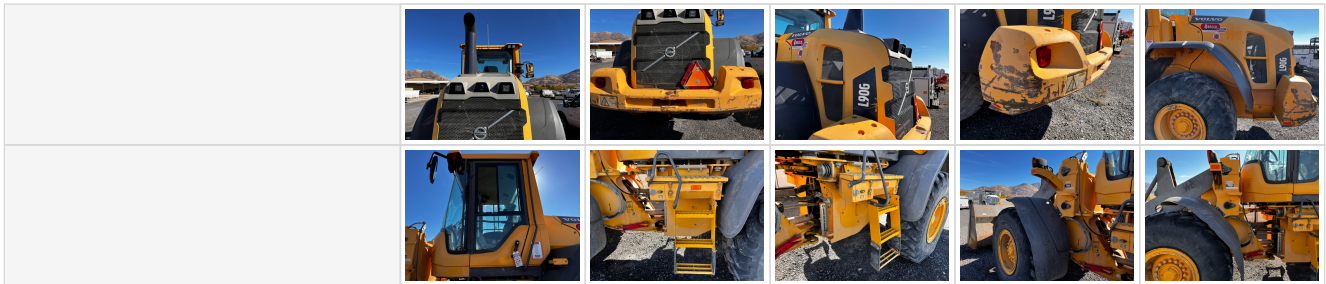
Exterior Lights	4 - Expected Wear - Fully Operable	
Exterior Lights Condition	No visible damage, lighting system is operational	
Overall Exterior	4 - Expected Wear - Fully Operable	
Comments	Expected wear and tear due to machines age Right side steps bent

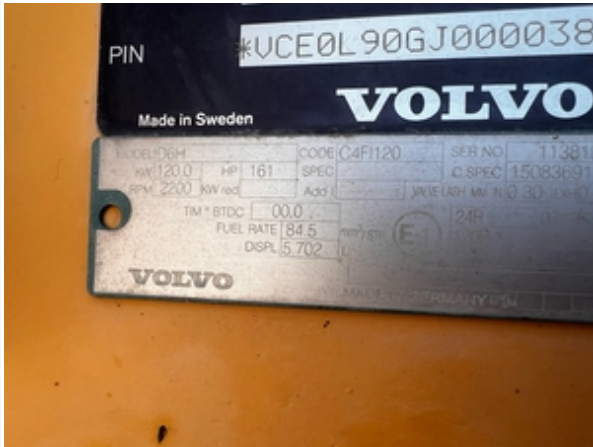
Engine Data Plate

Engine Type (Make, Model, Cylinders, Hp)	Volvo , D6H

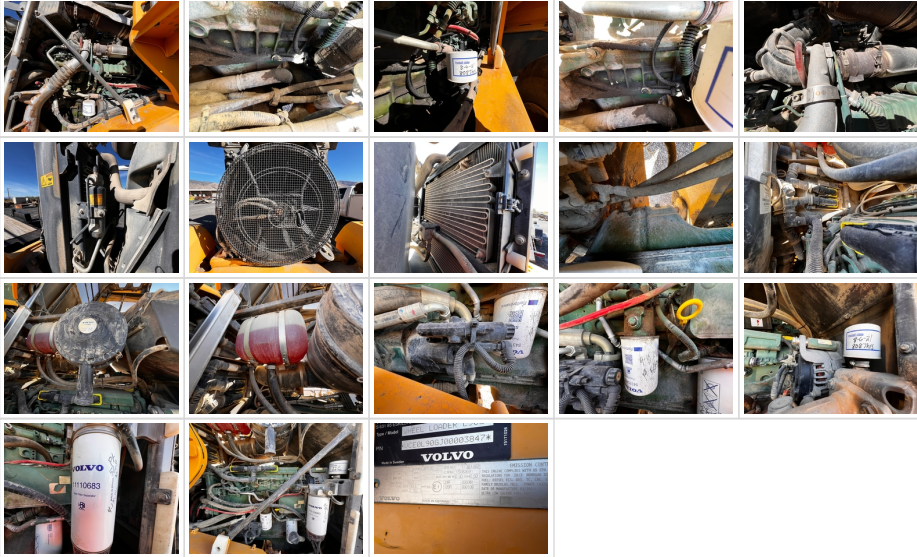
Engine Compartment Photos

Oil Leaks	No
Oil Appearance	4 - Expected Wear - Fully Operable
Oil Appearance Notes	Appropriate oil level
Fuel Leaks	No
Equipped with DPF (Diesel Particulate Filter)	Yes
DPF Condition	4 - Expected Wear - Fully Operable
DPF Condition Notes	Filter housing is intact with no signs of damage or malfunction, DPF indicator is not illuminated
Overall Engine Rating	3 - Notable Wear - Fully Operable
Overall Engine Appearance	Areas of dried seepage seen on engine hoses & components
Overall Engine Comments	Dried seepage found throughout and your compartment
