Inspection Report (Skid Steer/Track Loader)

B&B Stock Number	A5105639
Year	2015
Make	Caterpillar
Model	279D
Serial Number	CAT0279DVGTL01518
Serial Plate Photo

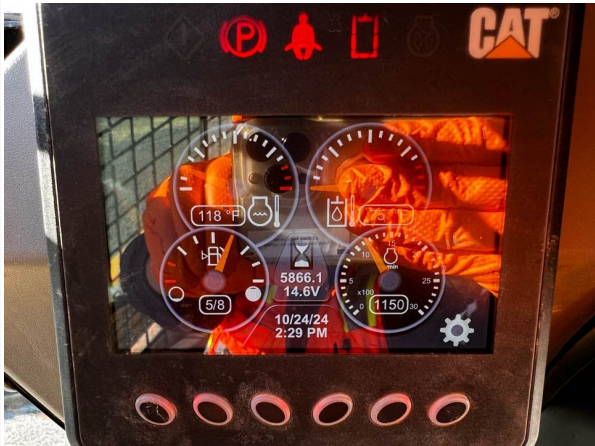
Hour Meter Reading	5866.1
Hour Meter Photo

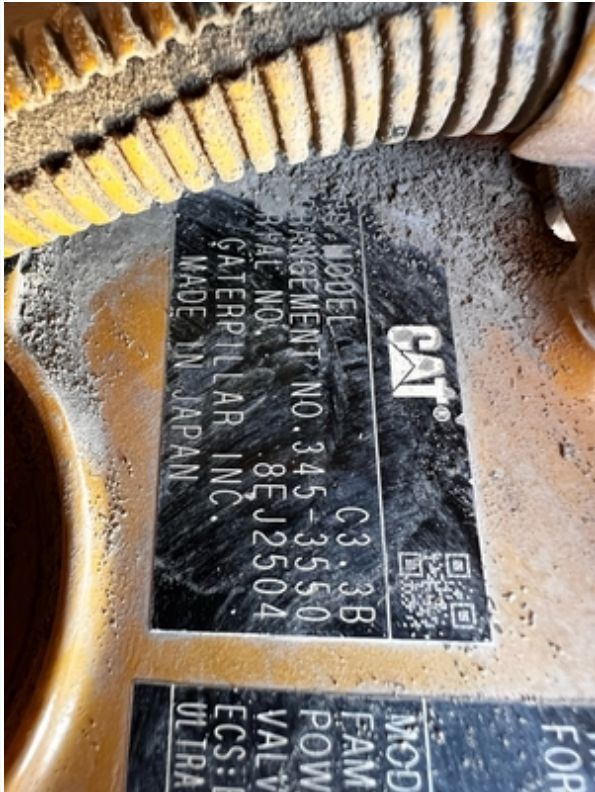
Engine Data Plate

Engine Type (Make, Model, Cylinders, Hp)	Caterpillar, c3.3B				
Emissions Tier	Undetermined				
Engine Serial Number	8EJ2504				
Engine Fuel Type	Diesel

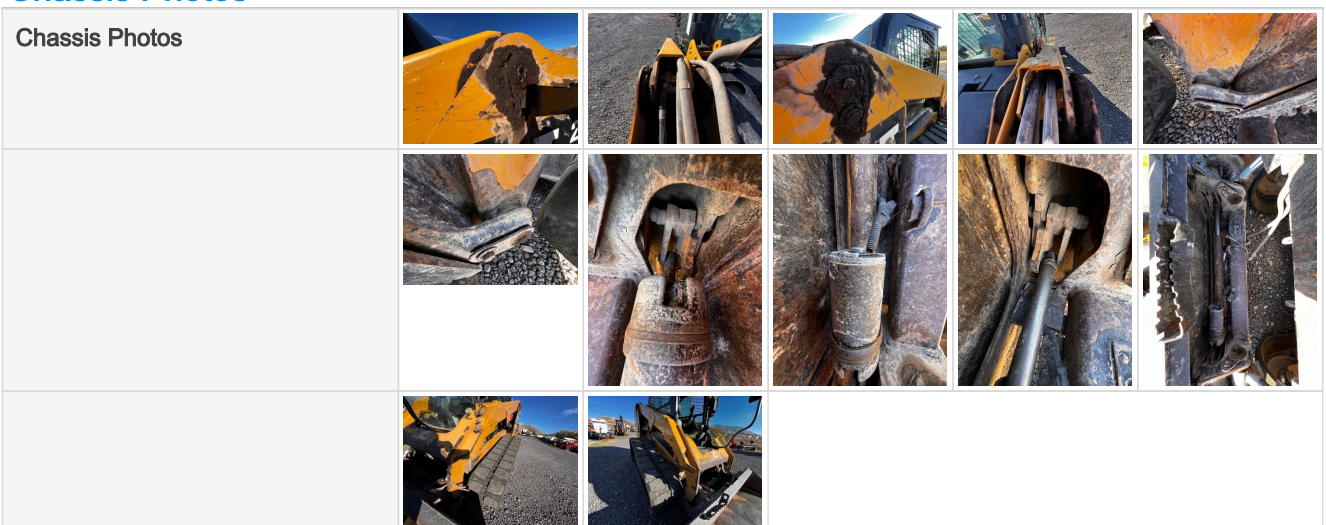
Chassis Photos

Frame	4 - Expected Wear - Fully Operable
Stance	4 - Expected Wear - Fully Operable
Lift Arms	4 - Expected Wear - Fully Operable

Chassis to Arm Pins	4 - Expected Wear - Fully Operable
Quick Coupler	4 - Expected Wear - Fully Operable
Quick Coupler to Arms Pins	4 - Expected Wear - Fully Operable
Overall Chassis	4 - Expected Wear - Fully Operable
Overall Chassis Comments	Expected wear and tear due to age of machine no major issues to report
