## Inspection Report (Wheel Loader)

B&B Stock Number	A9047581
Year	2006
Make	John Deere
Model	544KJ
Serial Number	DW544JZ605529
Serial Plate Photo

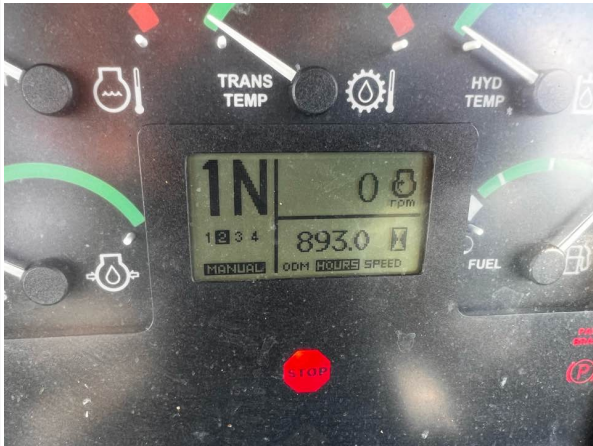
Hour Meter Reading	893
Single Photo

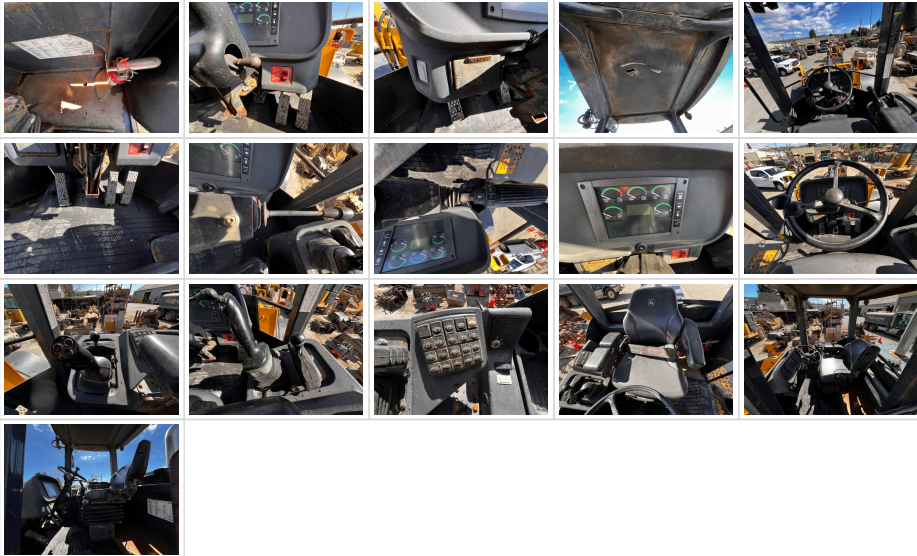
Control Station Photos

Seat	4 - Expected Wear - Fully Operable
Seat Condition	Seat in good condition, no stains or tears in upholstery
Cabin Lights	N/A
Safety Lock Out / Stop	4 - Expected Wear - Fully Operable
Safety Lock Out / Stop Condition	Safety lock out device is present, in good condition, and functional
Controls & Switches	4 - Expected Wear - Fully Operable
Hour Meter Activity	4 - Expected Wear - Fully Operable
Other Gauge Activity	4 - Expected Wear - Fully Operable
Heater & A/C	N/A
Travel Alarm	N/A
Horn	4 - Expected Wear - Fully Operable
Backup Camera	N/A
Control Station Overall Rating	4 - Expected Wear - Fully Operable

37.874549, -122.302617
Control Station Overall Condition	Good cabin appearance, solid floors, panels, and ceiling

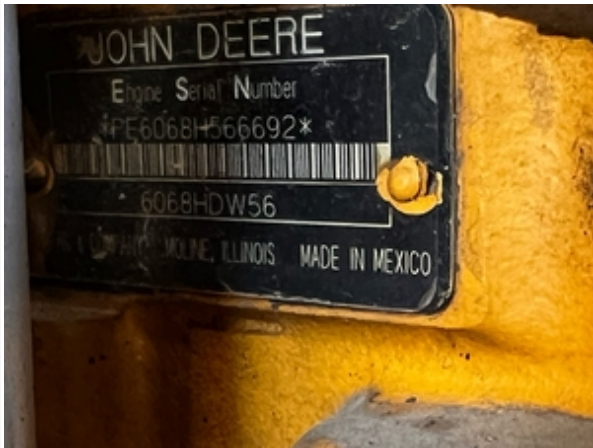
Engine Data Plate

Engine Type (Make, Model, Cylinders, Hp)	John Deere, 6068HDW56
Emissions Tier	Undetermined
Engine Serial Number	PE6068H566692
Engine Fuel Type	Diesel
Blow-by (Visual Observation Check)	No
Unusual Noises (Upon Start-up, Idle, Shutdown)	No
Engine Smoke (Upon Start-up, Idle, Shutdown)	Yes
Engine Smoke Notes	Engine smoke observed upon start up
Engine Exhaust Color	Black
Battery	4 - Expected Wear - Fully Operable
Battery Condition	Inaccessible, unable to determine condition
Radiator	4 - Expected Wear - Fully Operable
Radiator Condition	Radiator fins & components appear to be in good working order, no signs of damage or leaks
Belts	4 - Expected Wear - Fully Operable
Belt Condition	Belts appear in good condition & alignment with proper tension
Hoses	4 - Expected Wear - Fully Operable
Hose Condition	Firm, pliant hoses with no signs of wear or leaks
Water Pump	4 - Expected Wear - Fully Operable
