## Inspection Report (Boom Lift)

B&B Stock Number	A2596761
Year	2011
Make	Genie
Model	Z-40/23N
Serial Number	Z40N11-1409
Serial Plate Photo

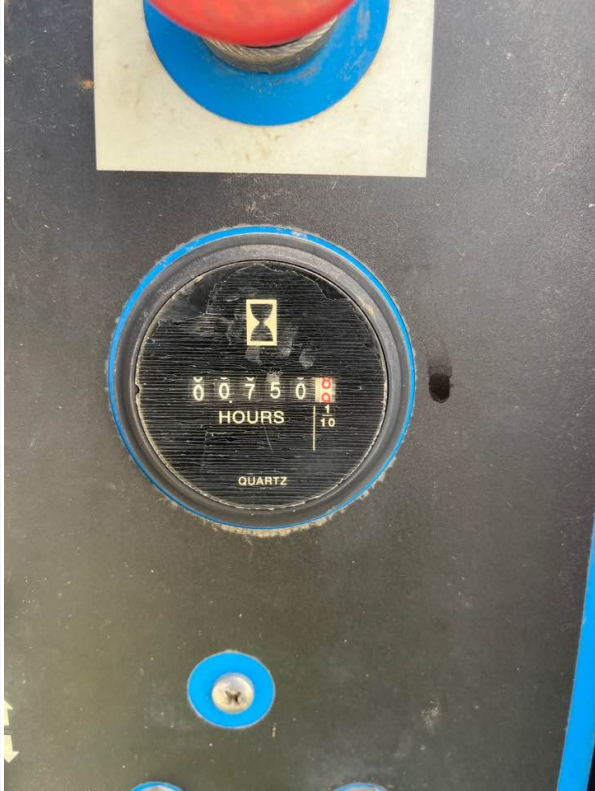
Hour Meter Photo

Hour Meter Reading	750
