## Inspection Report (Trailer)

B&B Stock Number	A2512746
Year	2019
Make	PJ Trailers
Model	Retractable tarp system
Serial Number	4P5FD3620K1305588
Serial Plate Photo

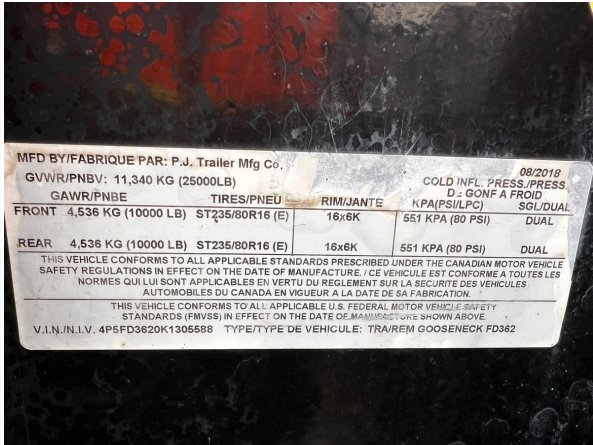
Data Plate Photo

Length (ft and inches)	45'
Width (ft and inches)	9'
Max Height (ft and inches)	13'
Dock Height (ft and inches)	3'3"
GVWR (lbs)	25000
GAWR (lbs)	10000

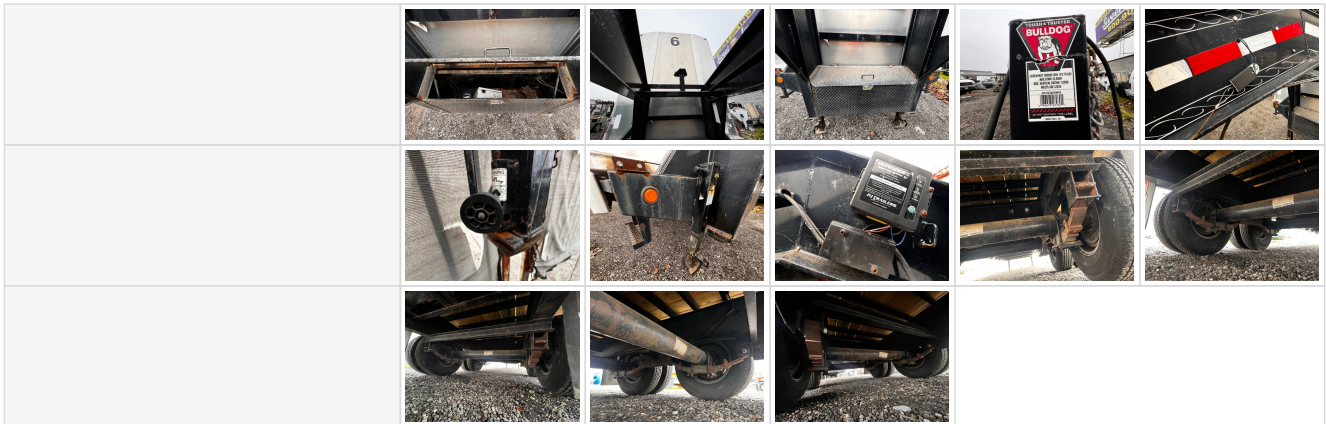
Overall Trailer & Underside Photos

Frame & Deck Condition	4 - Expected Wear - Fully Operable
Trailer Lights/Wiring (Stop, Tail, Turn)	4 - Expected Wear - Fully Operable
Frame & Body Overall Rating	4 - Expected Wear - Fully Operable
