Inspection Report (Trailer)

B&B Stock Number	A7248348
Year	2021
Make	PJ Trailers
Model	Soft side tarp trailer
Serial Number	4P5LD4029M1352073
Serial Plate Photo

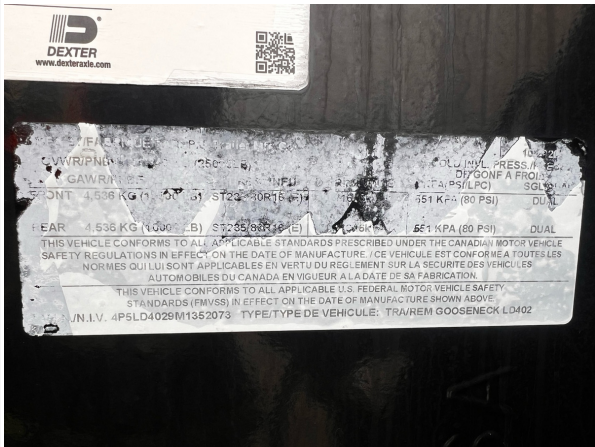
Data Plate Photo

Length (ft and inches)	36'
Width (ft and inches)	108"
Max Height (ft and inches)	13'
Dock Height (ft and inches)	2'9"
GVWR (lbs)	25,000
GAWR (lbs)	10000
