Inspection Report (Wheel Loader)

B&B Stock Number	A1525939
Year	2023
Make	Sany
Model	SW405
Serial Number	SW4054CC08258
Serial Plate Photo

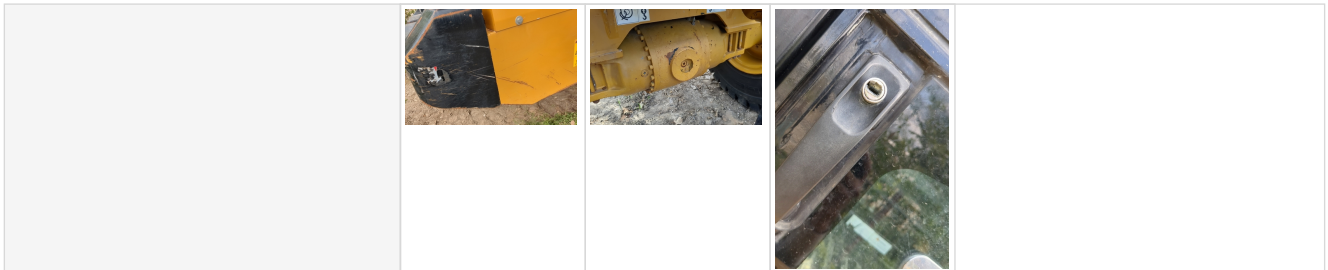
Inspection Rating Criteria	Rating	Explanation
	5	Light or minimal wear for its age
	4	Expected wear and tear for its age, operates as expected
	3	Above average wear and tear for its age, still operates as expected
	2	Heavy wear, is operable but needs attention
	1	Requires repair(s) to function as expected
Body Panels	4 - Expected Wear - Fully Operable	
Doors / Canopy Latches	3 - Notable Wear - Fully Operable	
Doors / Canopy Latches Condition	Other (see comments)	
Comments	lock cylinder for driver's door has been drilled out	
Steps / Ladders	3 - Notable Wear - Fully Operable	
Handrails	4 - Expected Wear - Fully Operable	
Glass	4 - Expected Wear - Fully Operable	
Mirrors	4 - Expected Wear - Fully Operable	
Exterior Lights	4 - Expected Wear - Fully Operable	
Overall Exterior	4 - Expected Wear - Fully Operable	
Comments	Exterior of the vehicles in good shape, normal wear and tear on rear bumper and lower chassis

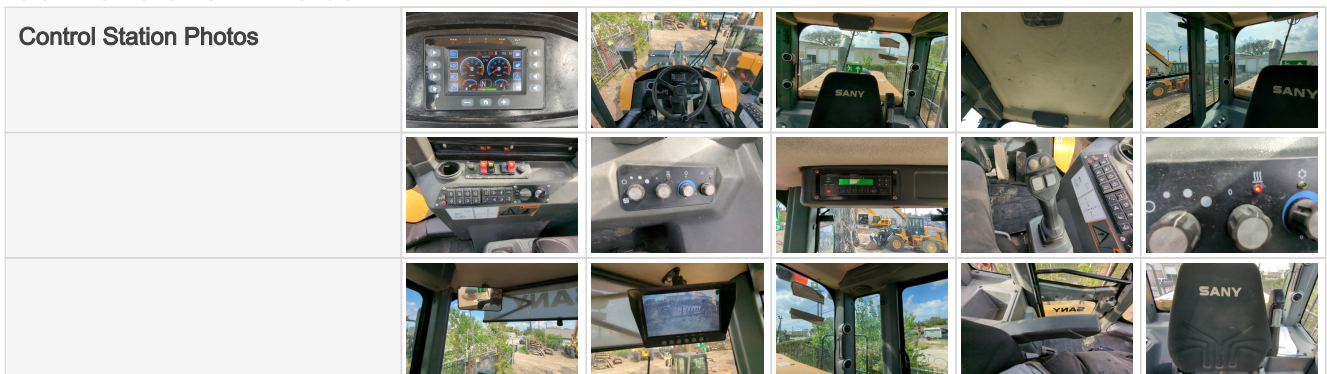
Control Station Photos

Control Station Type	Enclosed Cab (EROPS)
Control Type	Pilot Controls
Control Configuration	N/A
Seat	4 - Expected Wear - Fully Operable
Seat Condition	Seat has expected stains or small tears for its usage
Cabin Lights	1 - Service Required - Inoperable
Cabin Lights Condition	Cabin light system is not operational
Safety Lock Out / Stop	4 - Expected Wear - Fully Operable
Safety Lock Out / Stop Condition	Safety lock out device is present, in good condition, and functional
Controls & Switches	3 - Notable Wear - Fully Operable
Controls & Switches Condition	One or more switches are inoperative or missing, Other (see comments)
Comments	washer fluid squirters for both front and rear glass does not work
Hour Meter Activity	4 - Expected Wear - Fully Operable
Hour Meter Condition	Hour meter is functional and in good condition
Other Gauge Activity	4 - Expected Wear - Fully Operable

29.771678, -95.174345
Control Station Overall Condition	Good cabin appearance, solid floors, panels, and ceiling

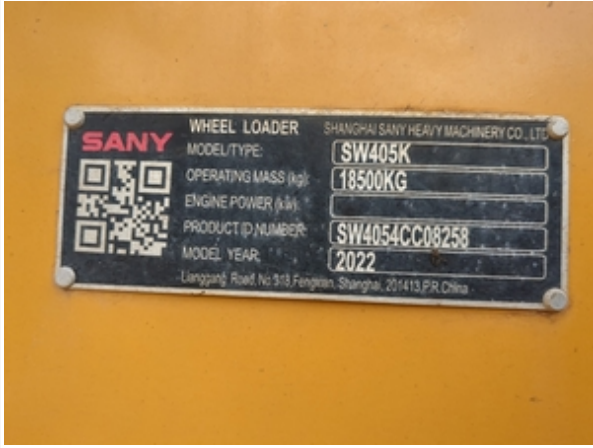
Engine Data Plate

Engine Type (Make, Model, Cylinders, Hp)	Need help				
Emissions Tier	Undetermined				
Engine Fuel Type	Diesel				
Blow-by (Visual Observation Check)	No				
Unusual Noises (Upon Start-up, Idle, Shutdown)	No				
Engine Smoke (Upon Start-up, Idle, Shutdown)	No				
Engine Exhaust Color	Clear				
Battery	4 - Expected Wear - Fully Operable				
Battery Condition	Clean & dry appearance, tight connections				
Radiator	4 - Expected Wear - Fully Operable				
Radiator Condition	Radiator fins & components appear to be in good working order, no signs of damage or leaks				
Belts	4 - Expected Wear - Fully Operable

Belt Condition	Belts appear in good condition & alignment with proper tension
Hoses	4 - Expected Wear - Fully Operable
Hose Condition	Twisted, kinked or flattened hoses, Firm, pliant hoses with no signs of wear or leaks
Water Pump	4 - Expected Wear - Fully Operable
Cooling System Leaks	No
Coolant Appearance	4 - Expected Wear - Fully Operable
Oil Leaks	No
Oil Appearance	4 - Expected Wear - Fully Operable
Oil Appearance Notes	Clean oil appearance, no signs of cross contamination, Appropriate oil level
Fuel Leaks	No
Equipped with DPF (Diesel Particulate Filter)	Yes
DPF Condition	4 - Expected Wear - Fully Operable
Requires DEF (Diesel Exhaust Fluid)	Yes
Overall Engine Rating	4 - Expected Wear - Fully Operable
Overall Engine Appearance	Clean & dry
Overall Engine Comments	Engine bay looks dry and engine starts up without any unusual noises or smoke.

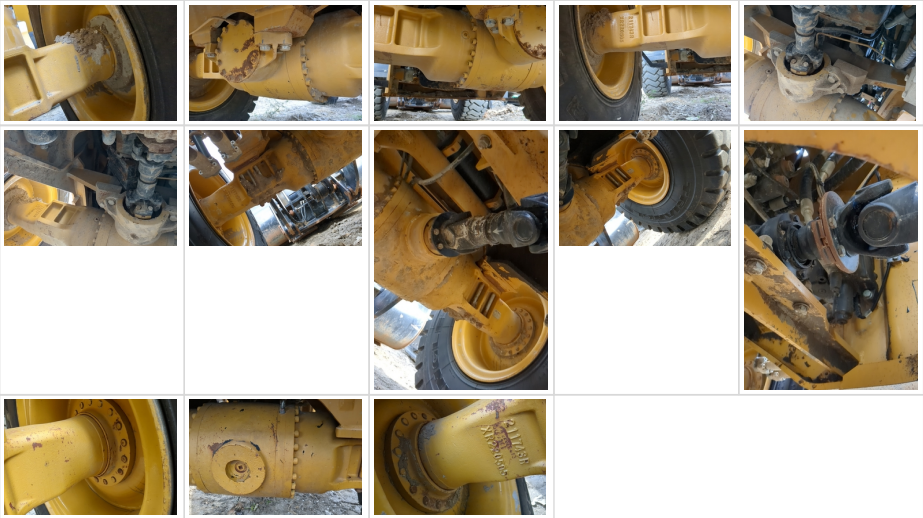
Drivetrain Photos

Hydrostatic Transmission?	No				
Drive Type	4WD				
Transmission Components	4 - Expected Wear - Fully Operable				
Transmission Condition	Good forward and reverse function, No unusual noises or vibrations

Parking Brake	4 - Expected Wear - Fully Operable
Parking Brake Function	Good brake function
Overall Drivetrain Rating	4 - Expected Wear - Fully Operable
Overall Drivetrain Comments	Drivetrain works as intended, no unusual delays in performance or movement. I did not observe any binding or issues within propulsion.
