Inspection Report (On-Highway Truck Cab + Chassis)

B&B Stock Number	A9653085
Year	2007
Make	Freightliner
Model	Columbia
Serial Number	1FUJA6CK97LX83192
Serial Plate

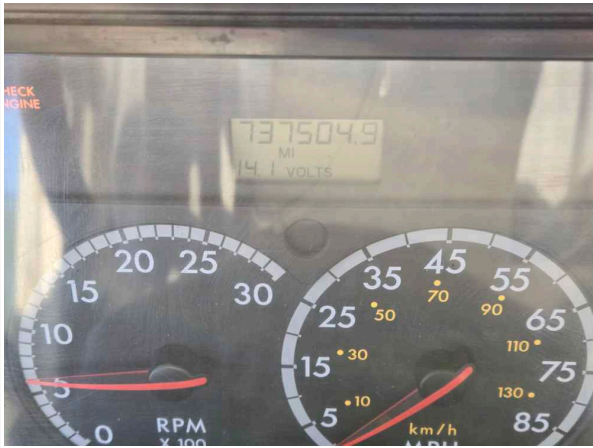
Odometer Reading	737504
Odometer
