Inspection Report (Forklift)

B&B Stock Number	A5747994
Year	2014
Make	Hyundai
Model	70D-9
Serial Number	HFA03LC0000631
Hour Meter Reading	14913.8
Previous Application (e.g., earth moving, mining, demolition, etc)	Warehouse

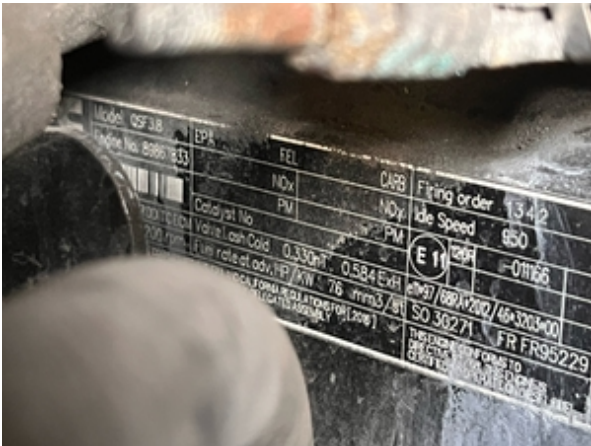
Engine Data Plate

Engine Type (Make, Model, Cylinders, Hp)	Cummins, QSF 3.8				
Emissions Tier	Tier 4F				
Engine Serial Number	89867833				
Engine Fuel Type	Diesel				
Blow-by (Visual Observation Check)	No

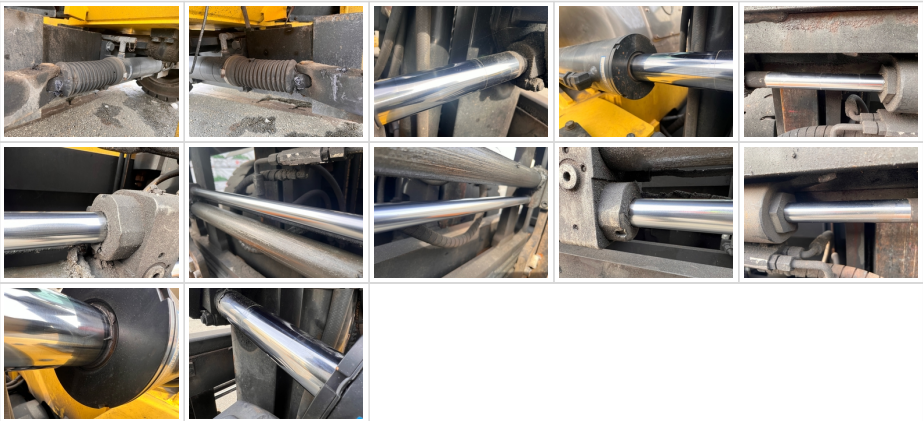
Hydraulic Cylinder Photos

Mounting Pins	3 - Normal Wear & Tear				
Cylinder Oil Leaks	No				
Hydraulic System Overall	3 - Normal Wear & Tear
