## Inspection Report (Trailer)

B&B Stock Number	A9936526
Year	2022
Make	EBY
Model	LP14k Trailer
Serial Number	4A2MB2020N3008339
Serial Plate Photo

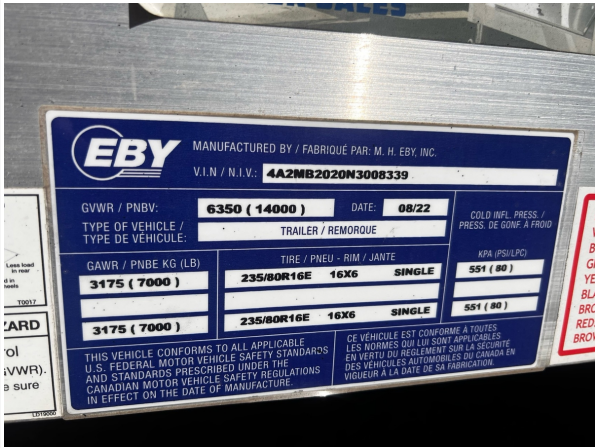
Data Plate Photo

Length (ft and inches)	82"
Width (ft and inches)	20"
Max Height (ft and inches)	0
Dock Height (ft and inches)	2'2"
GVWR (lbs)	14000
GAWR (lbs)	7000
